# "The House with Blood-Stained Walls"

*Pokleku Holocaust*

House  
Museum

*Village of Poklek, Glllogoc; Kosova*

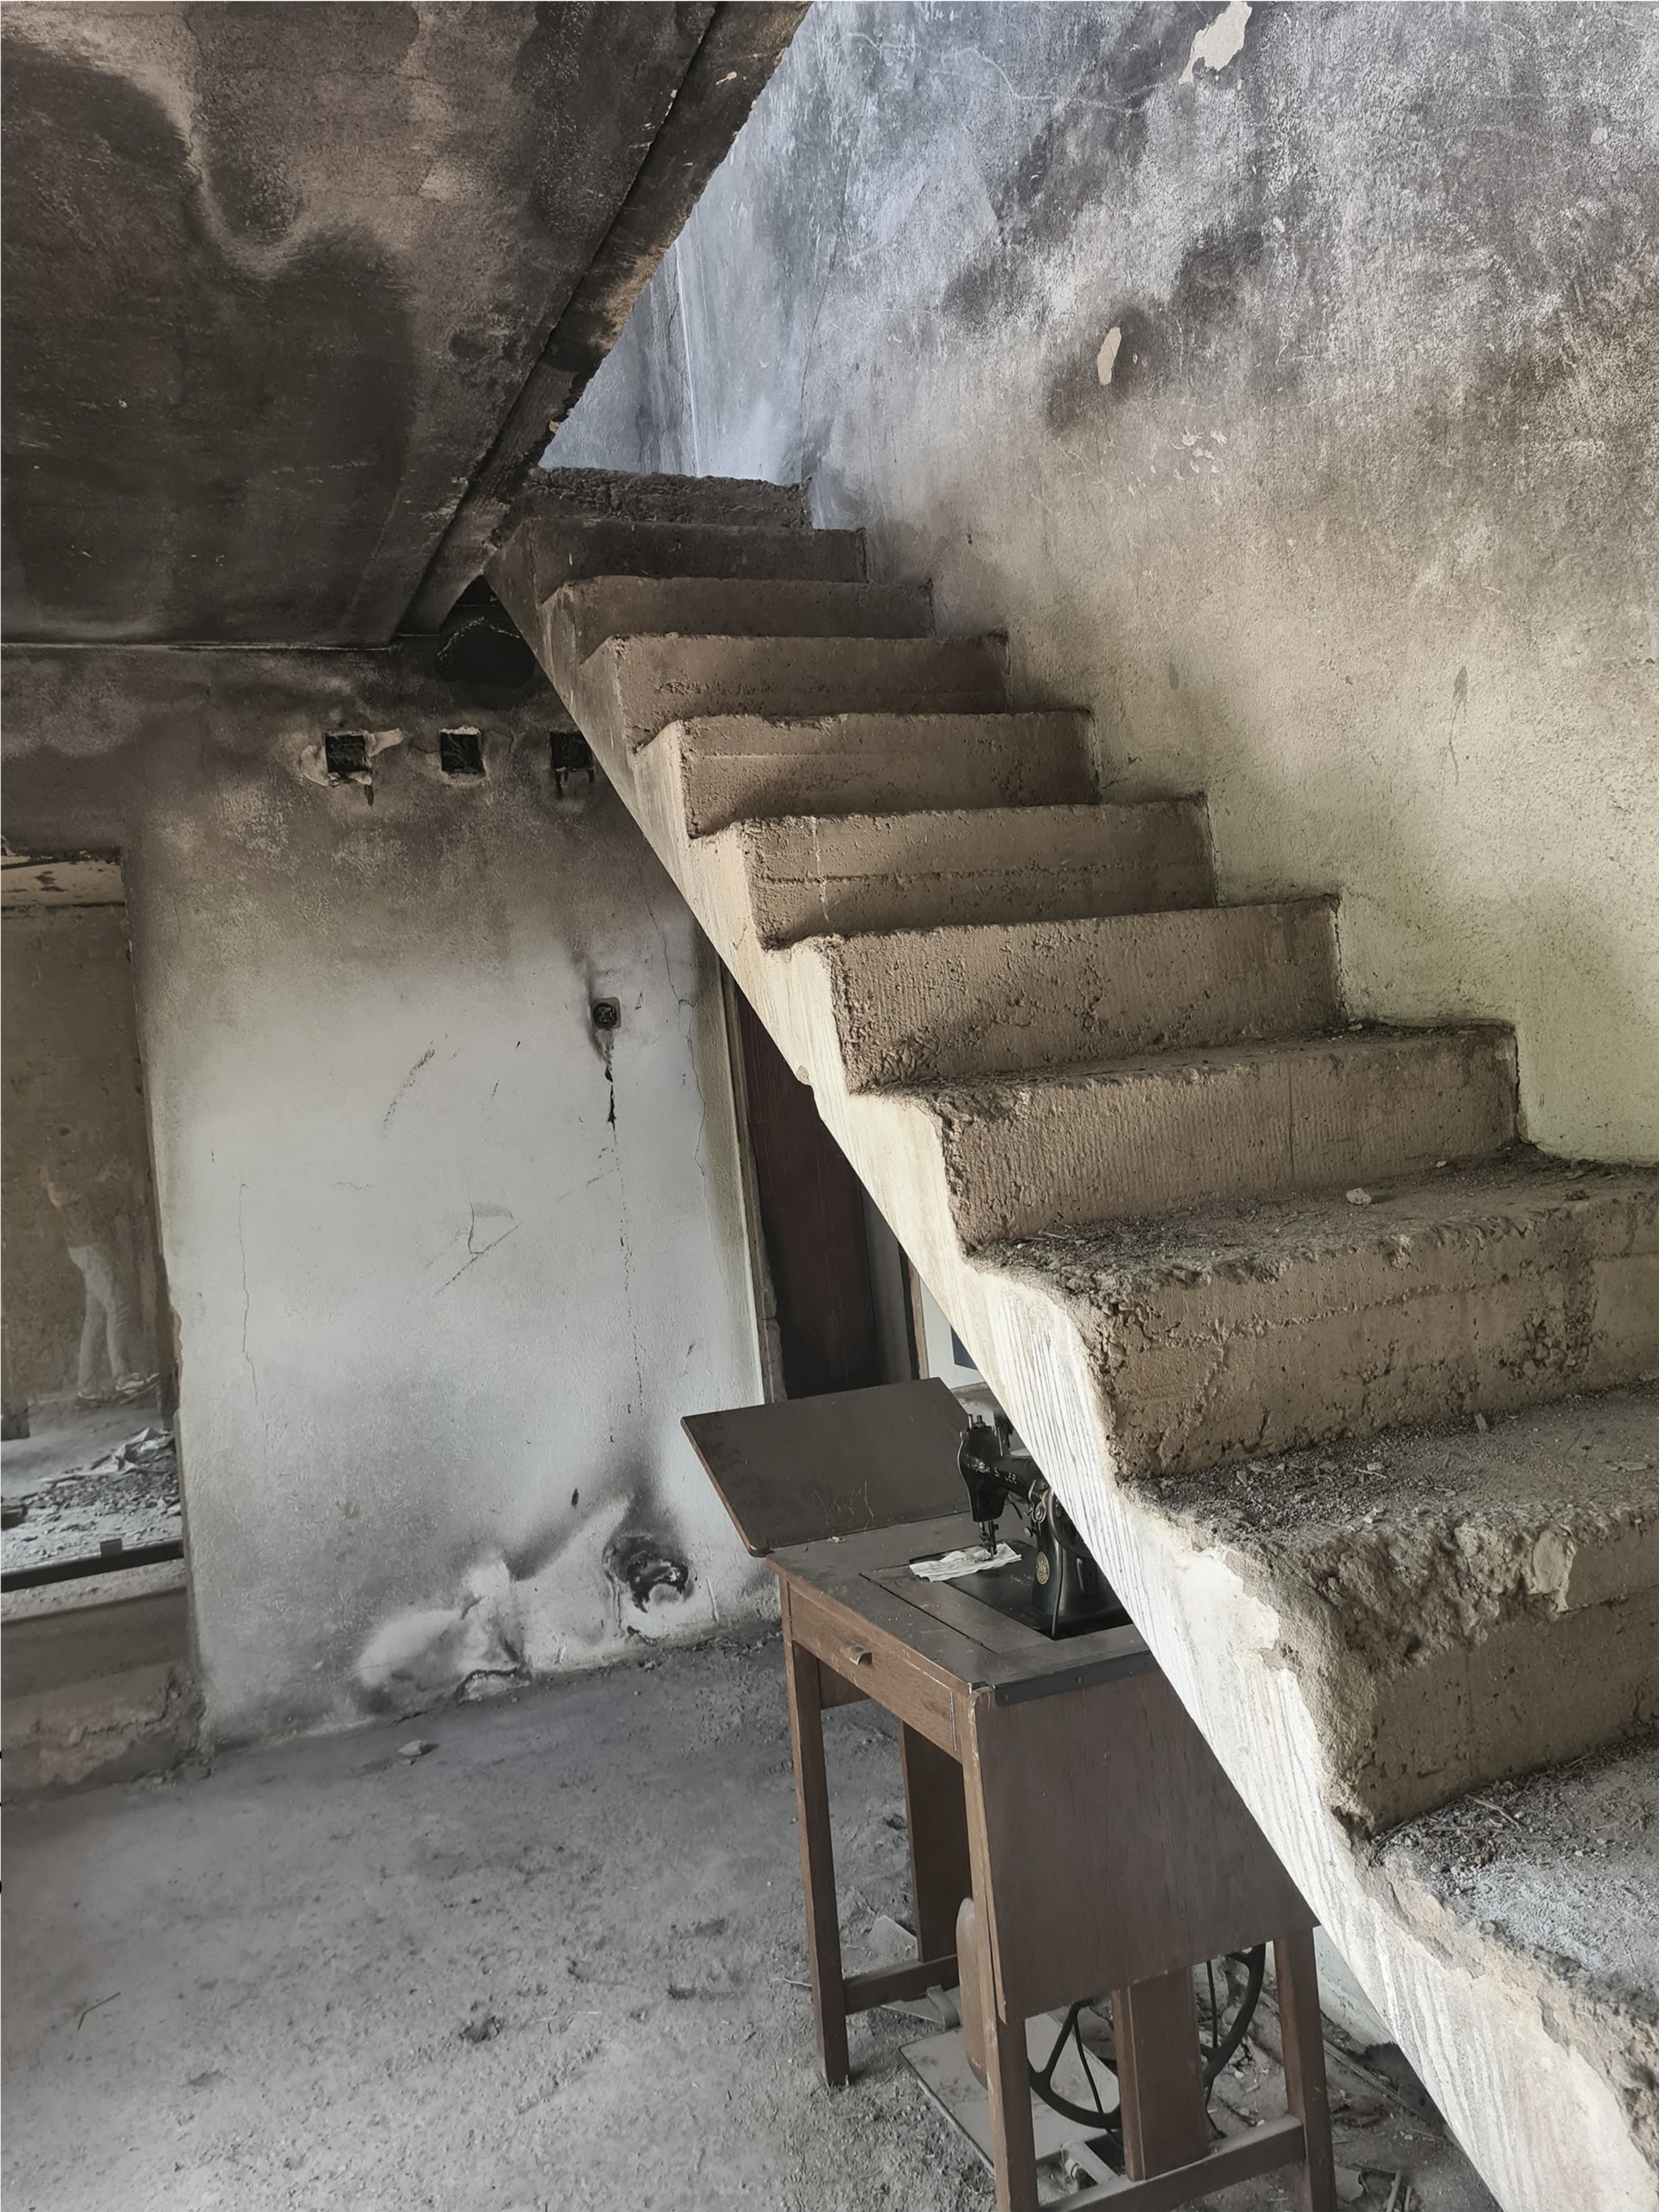
Traces of fire and flight ©project team

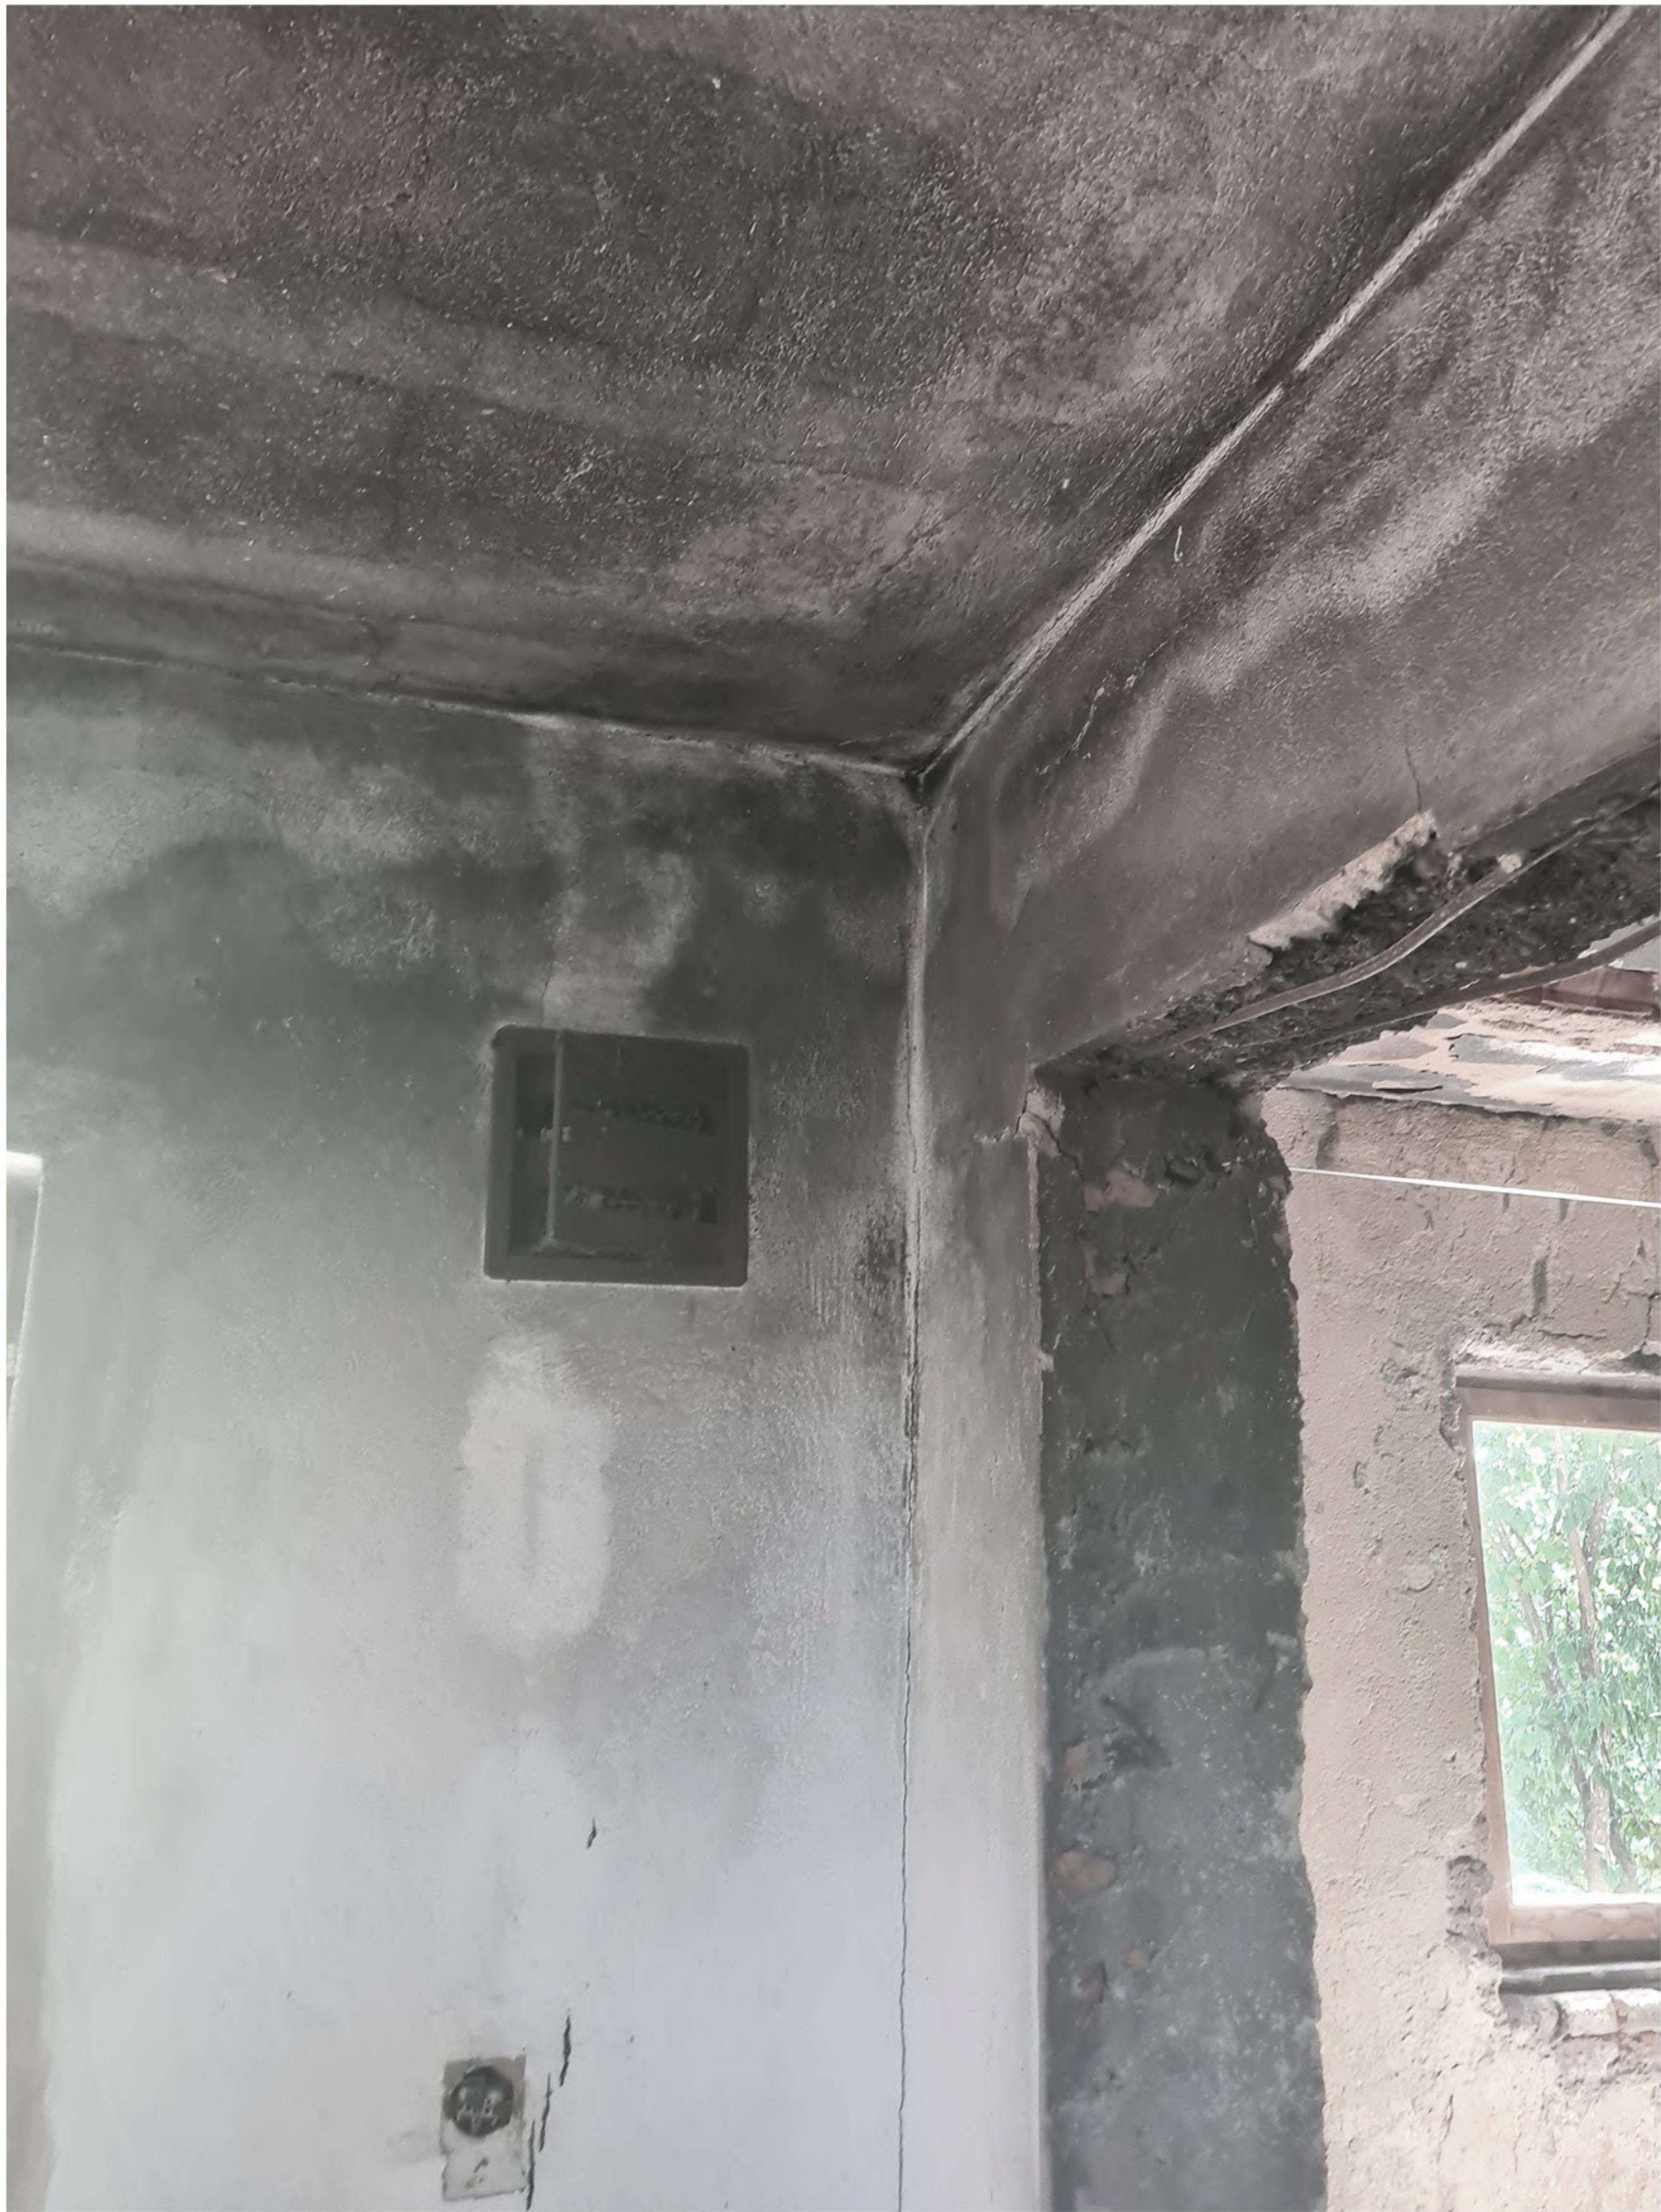
*Burnt grey surfaces ©project team*

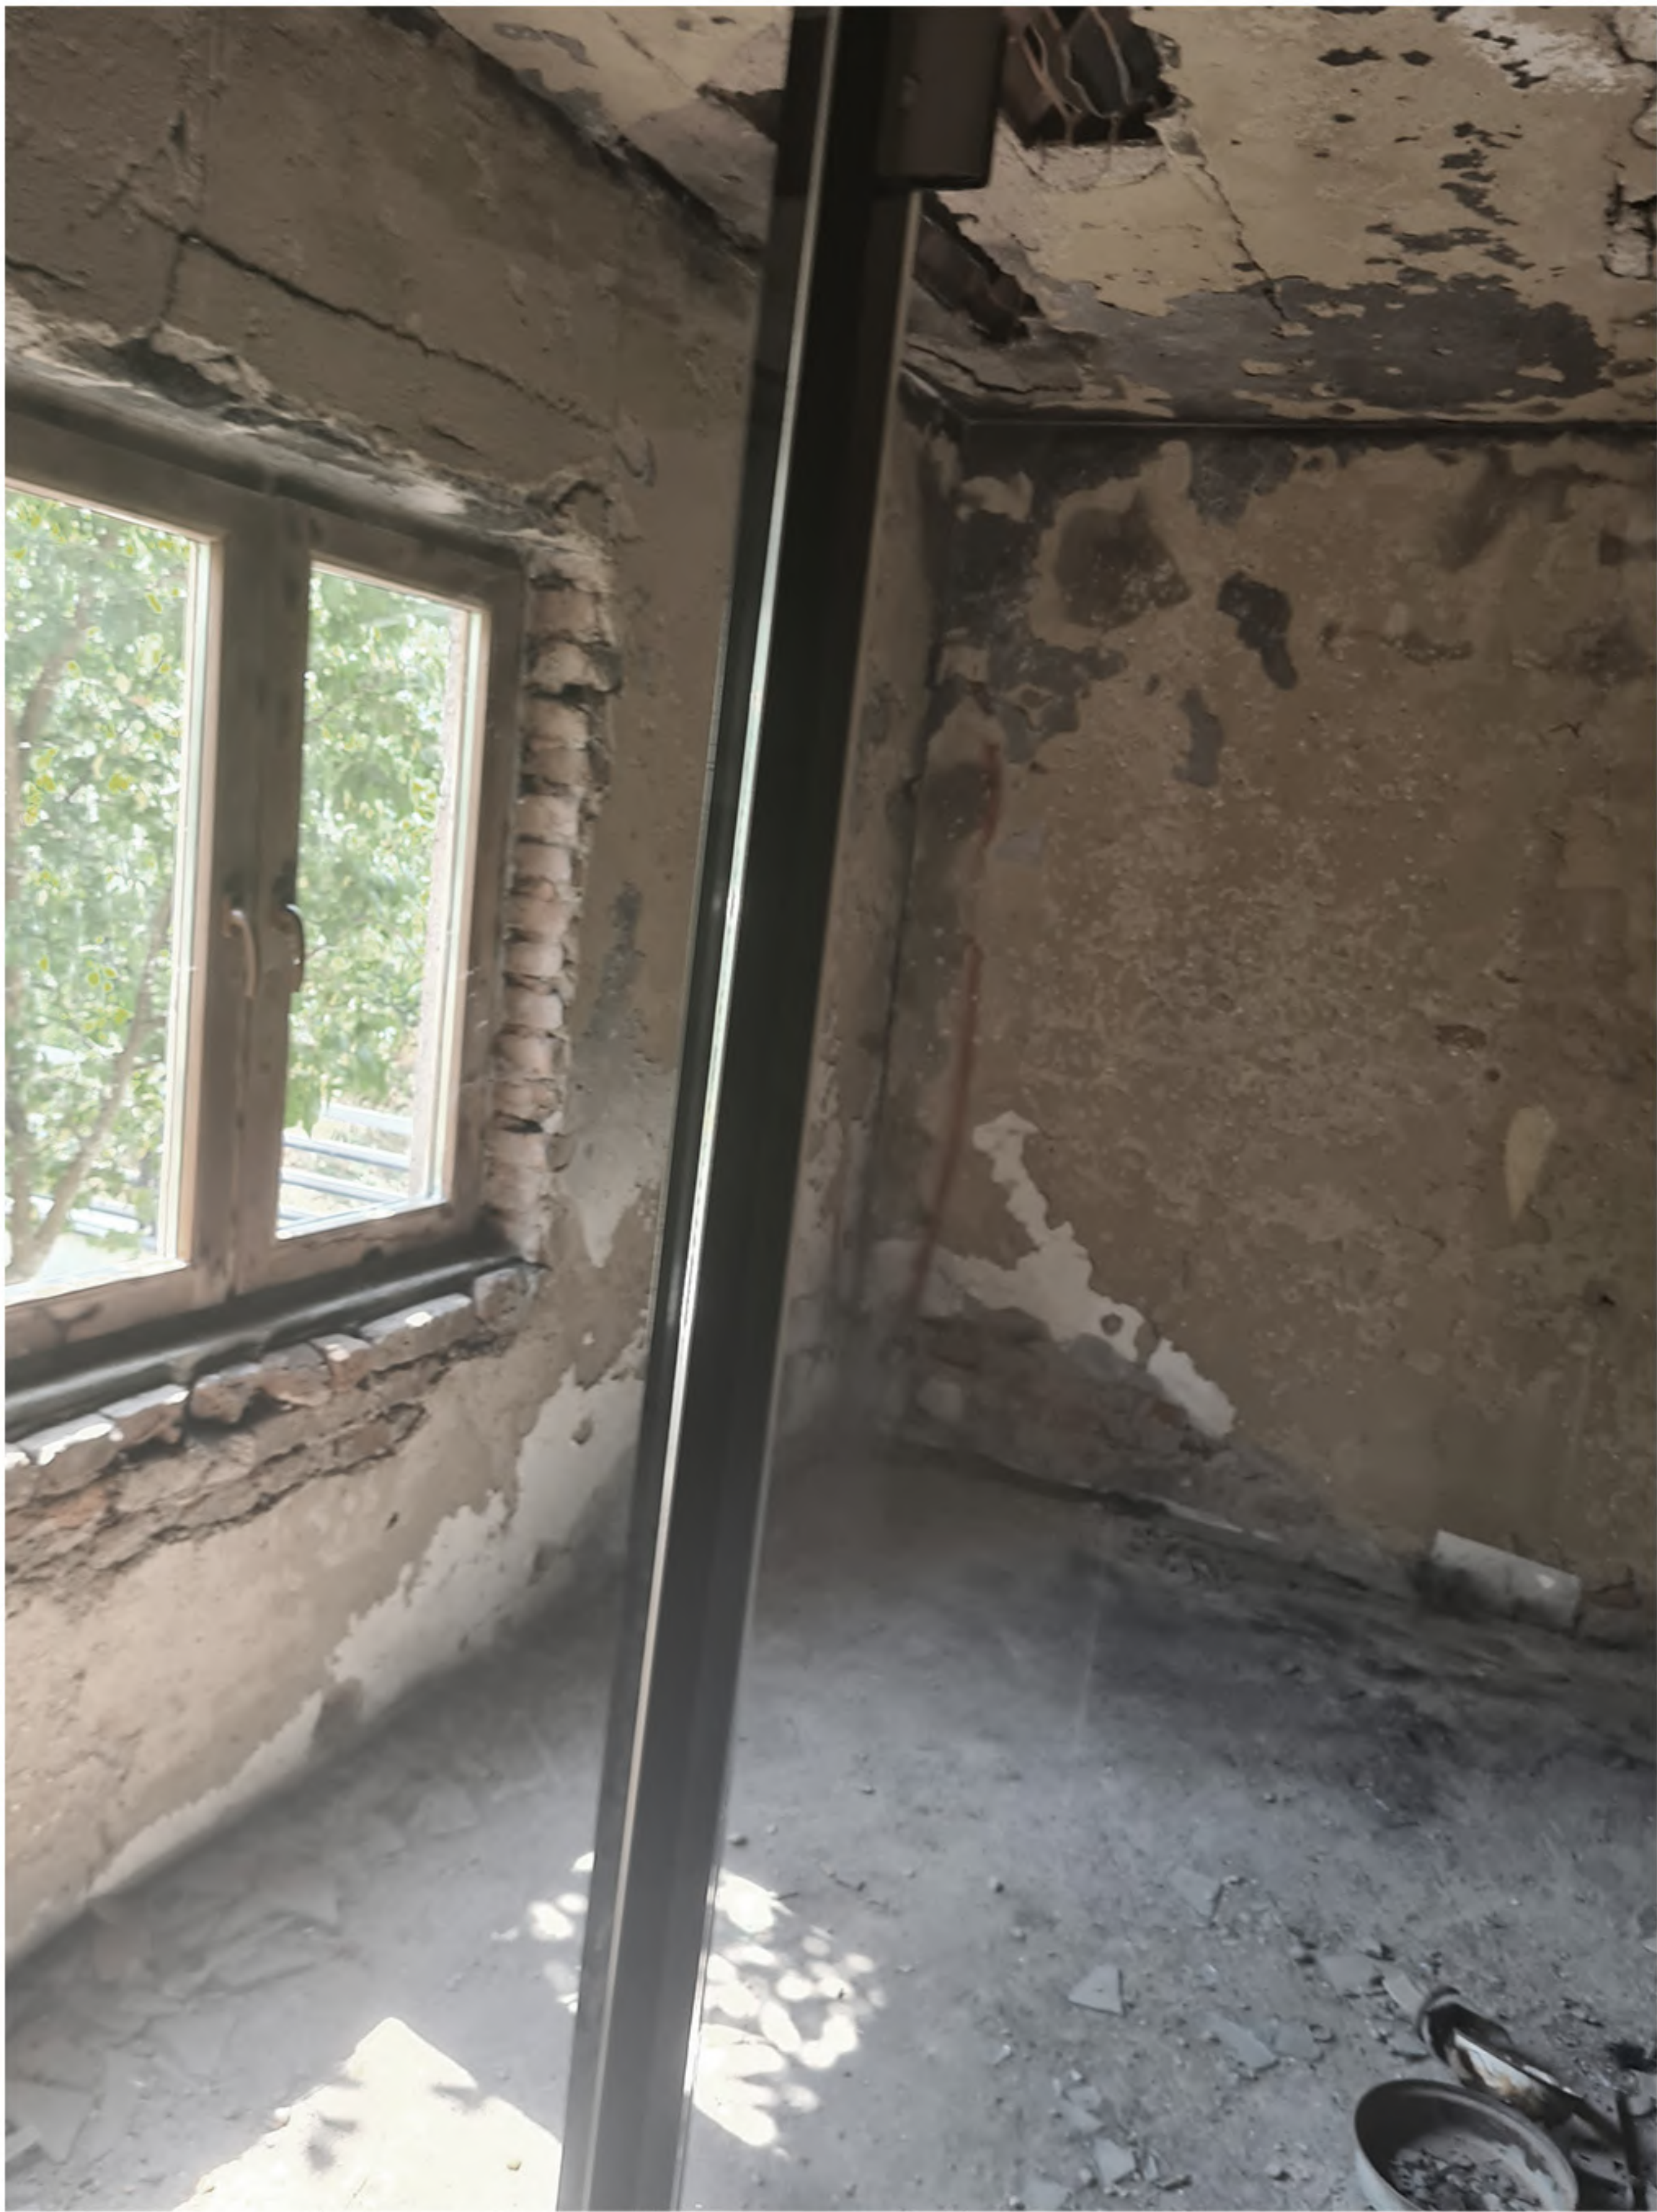
*Traces of fire etched in crumbling walls ©project team*

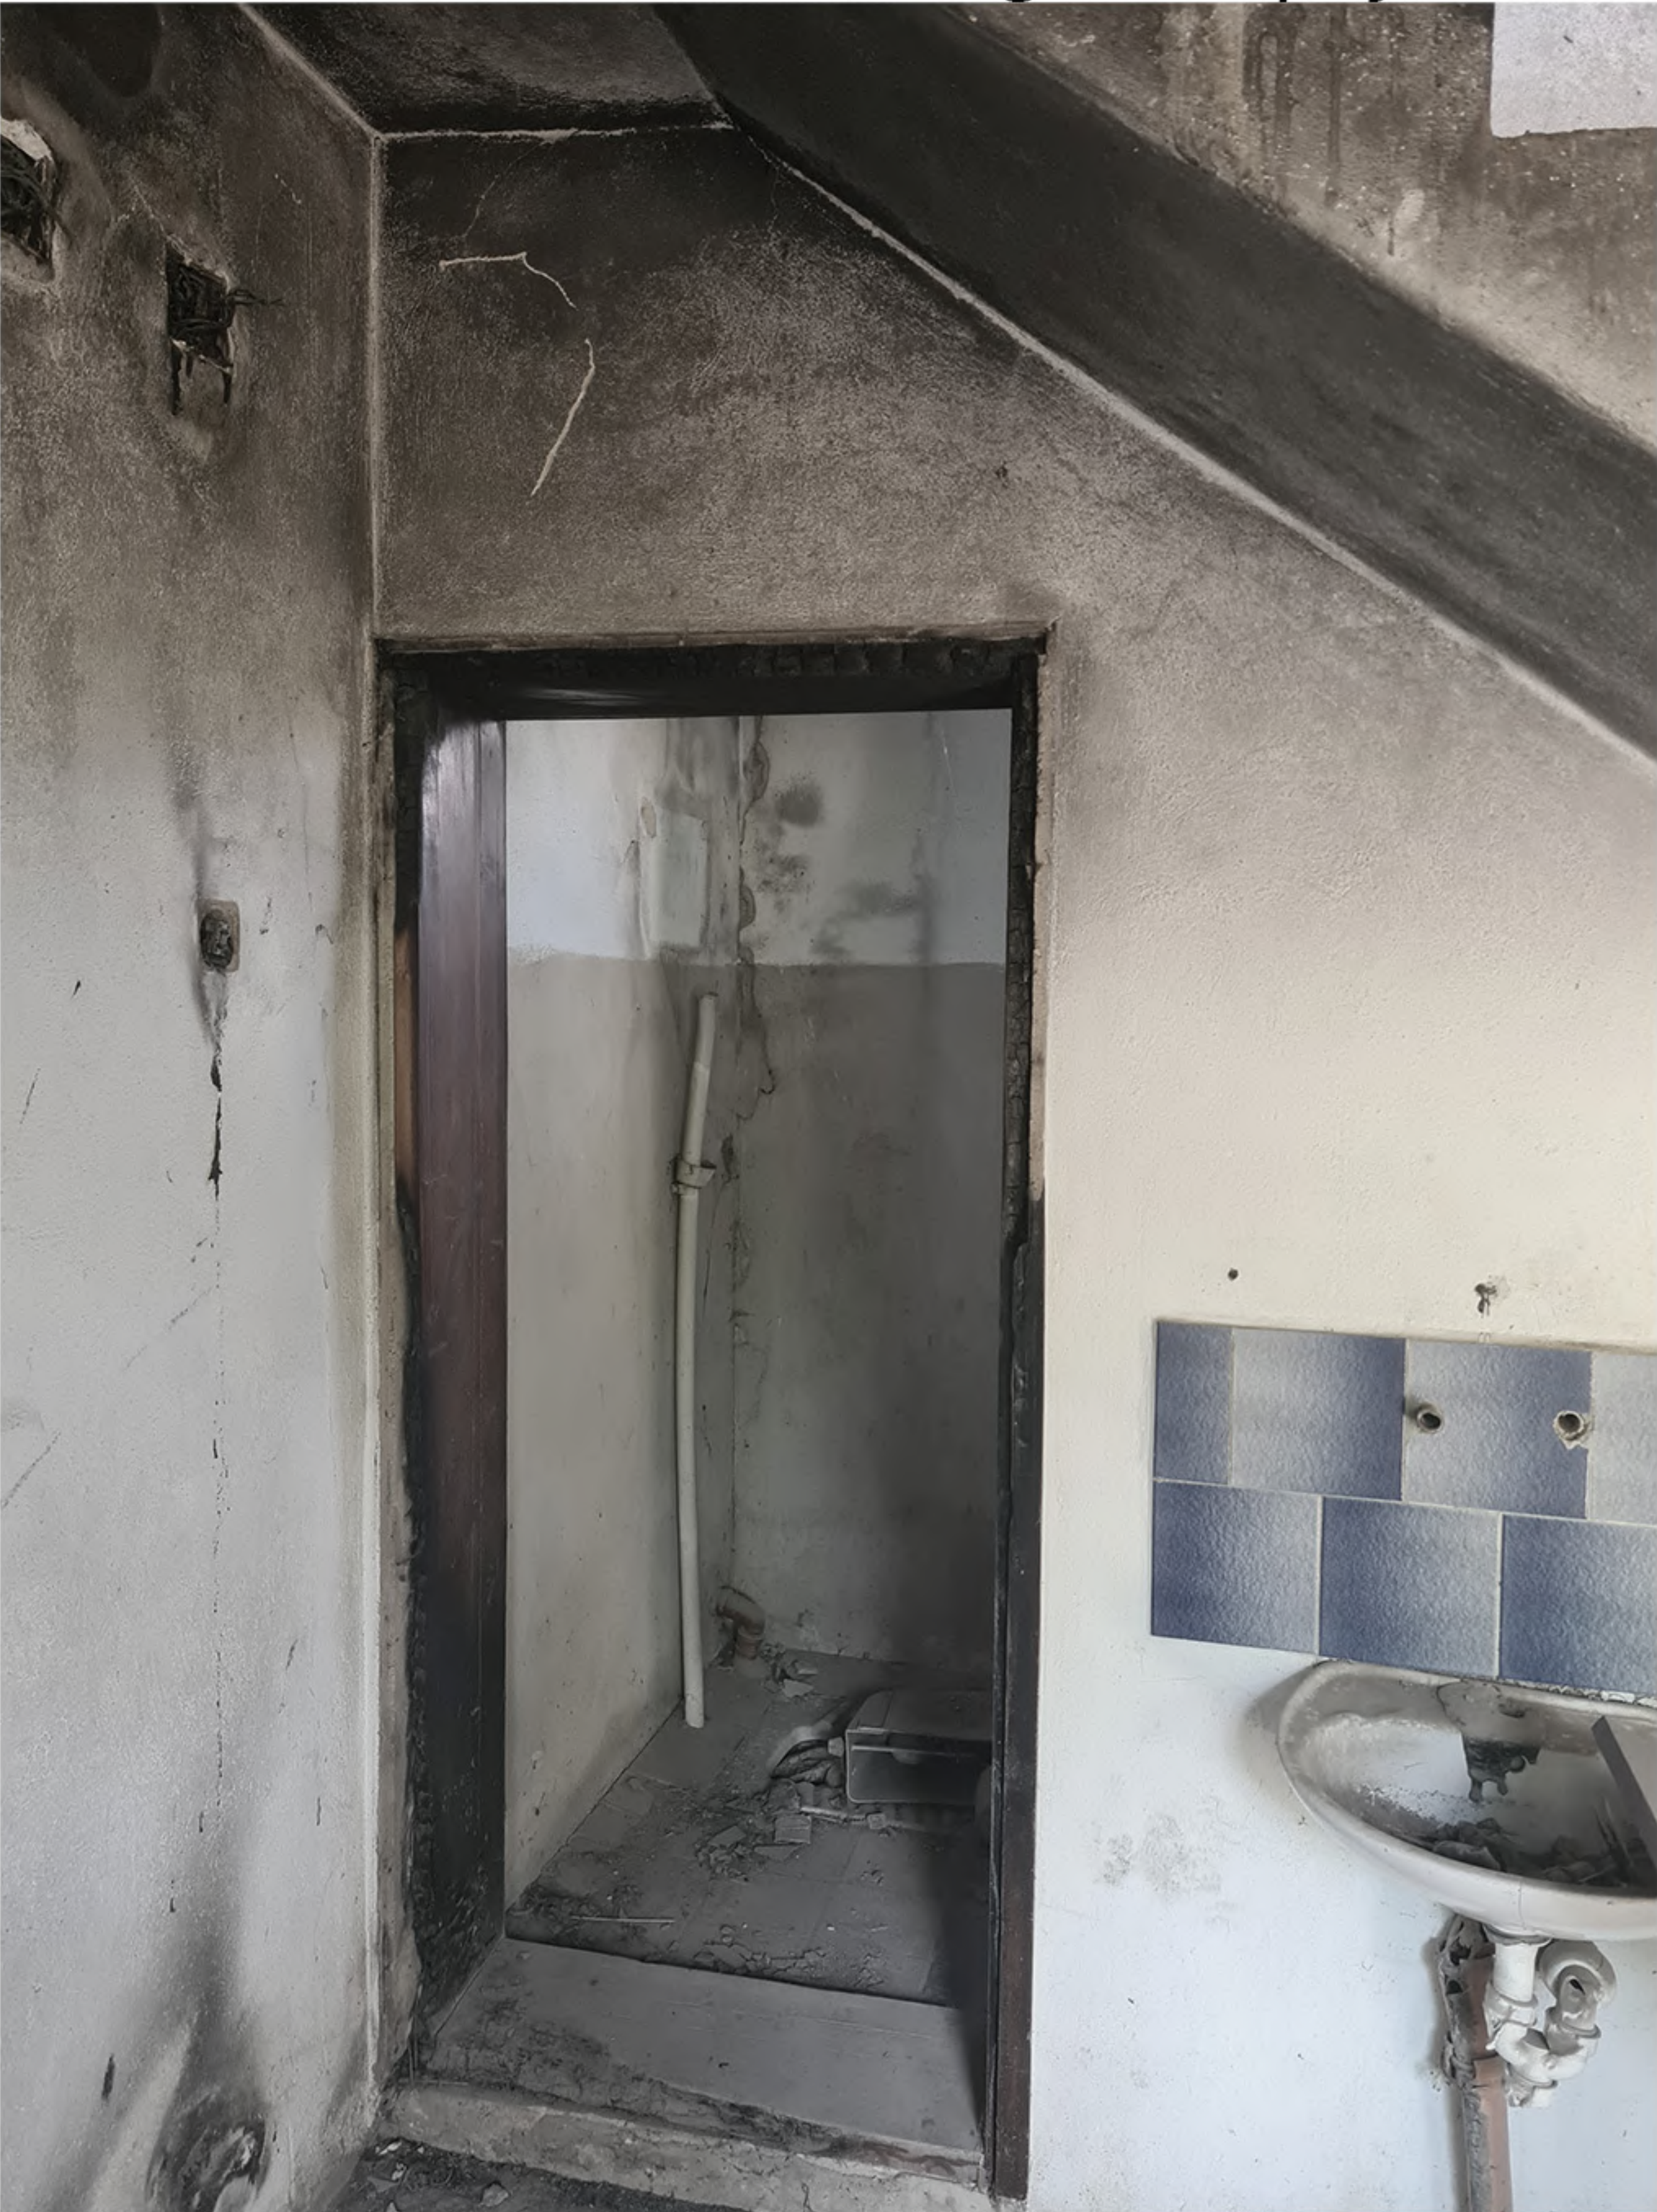
*Broken sanitary fixtures—still in place ©project team*

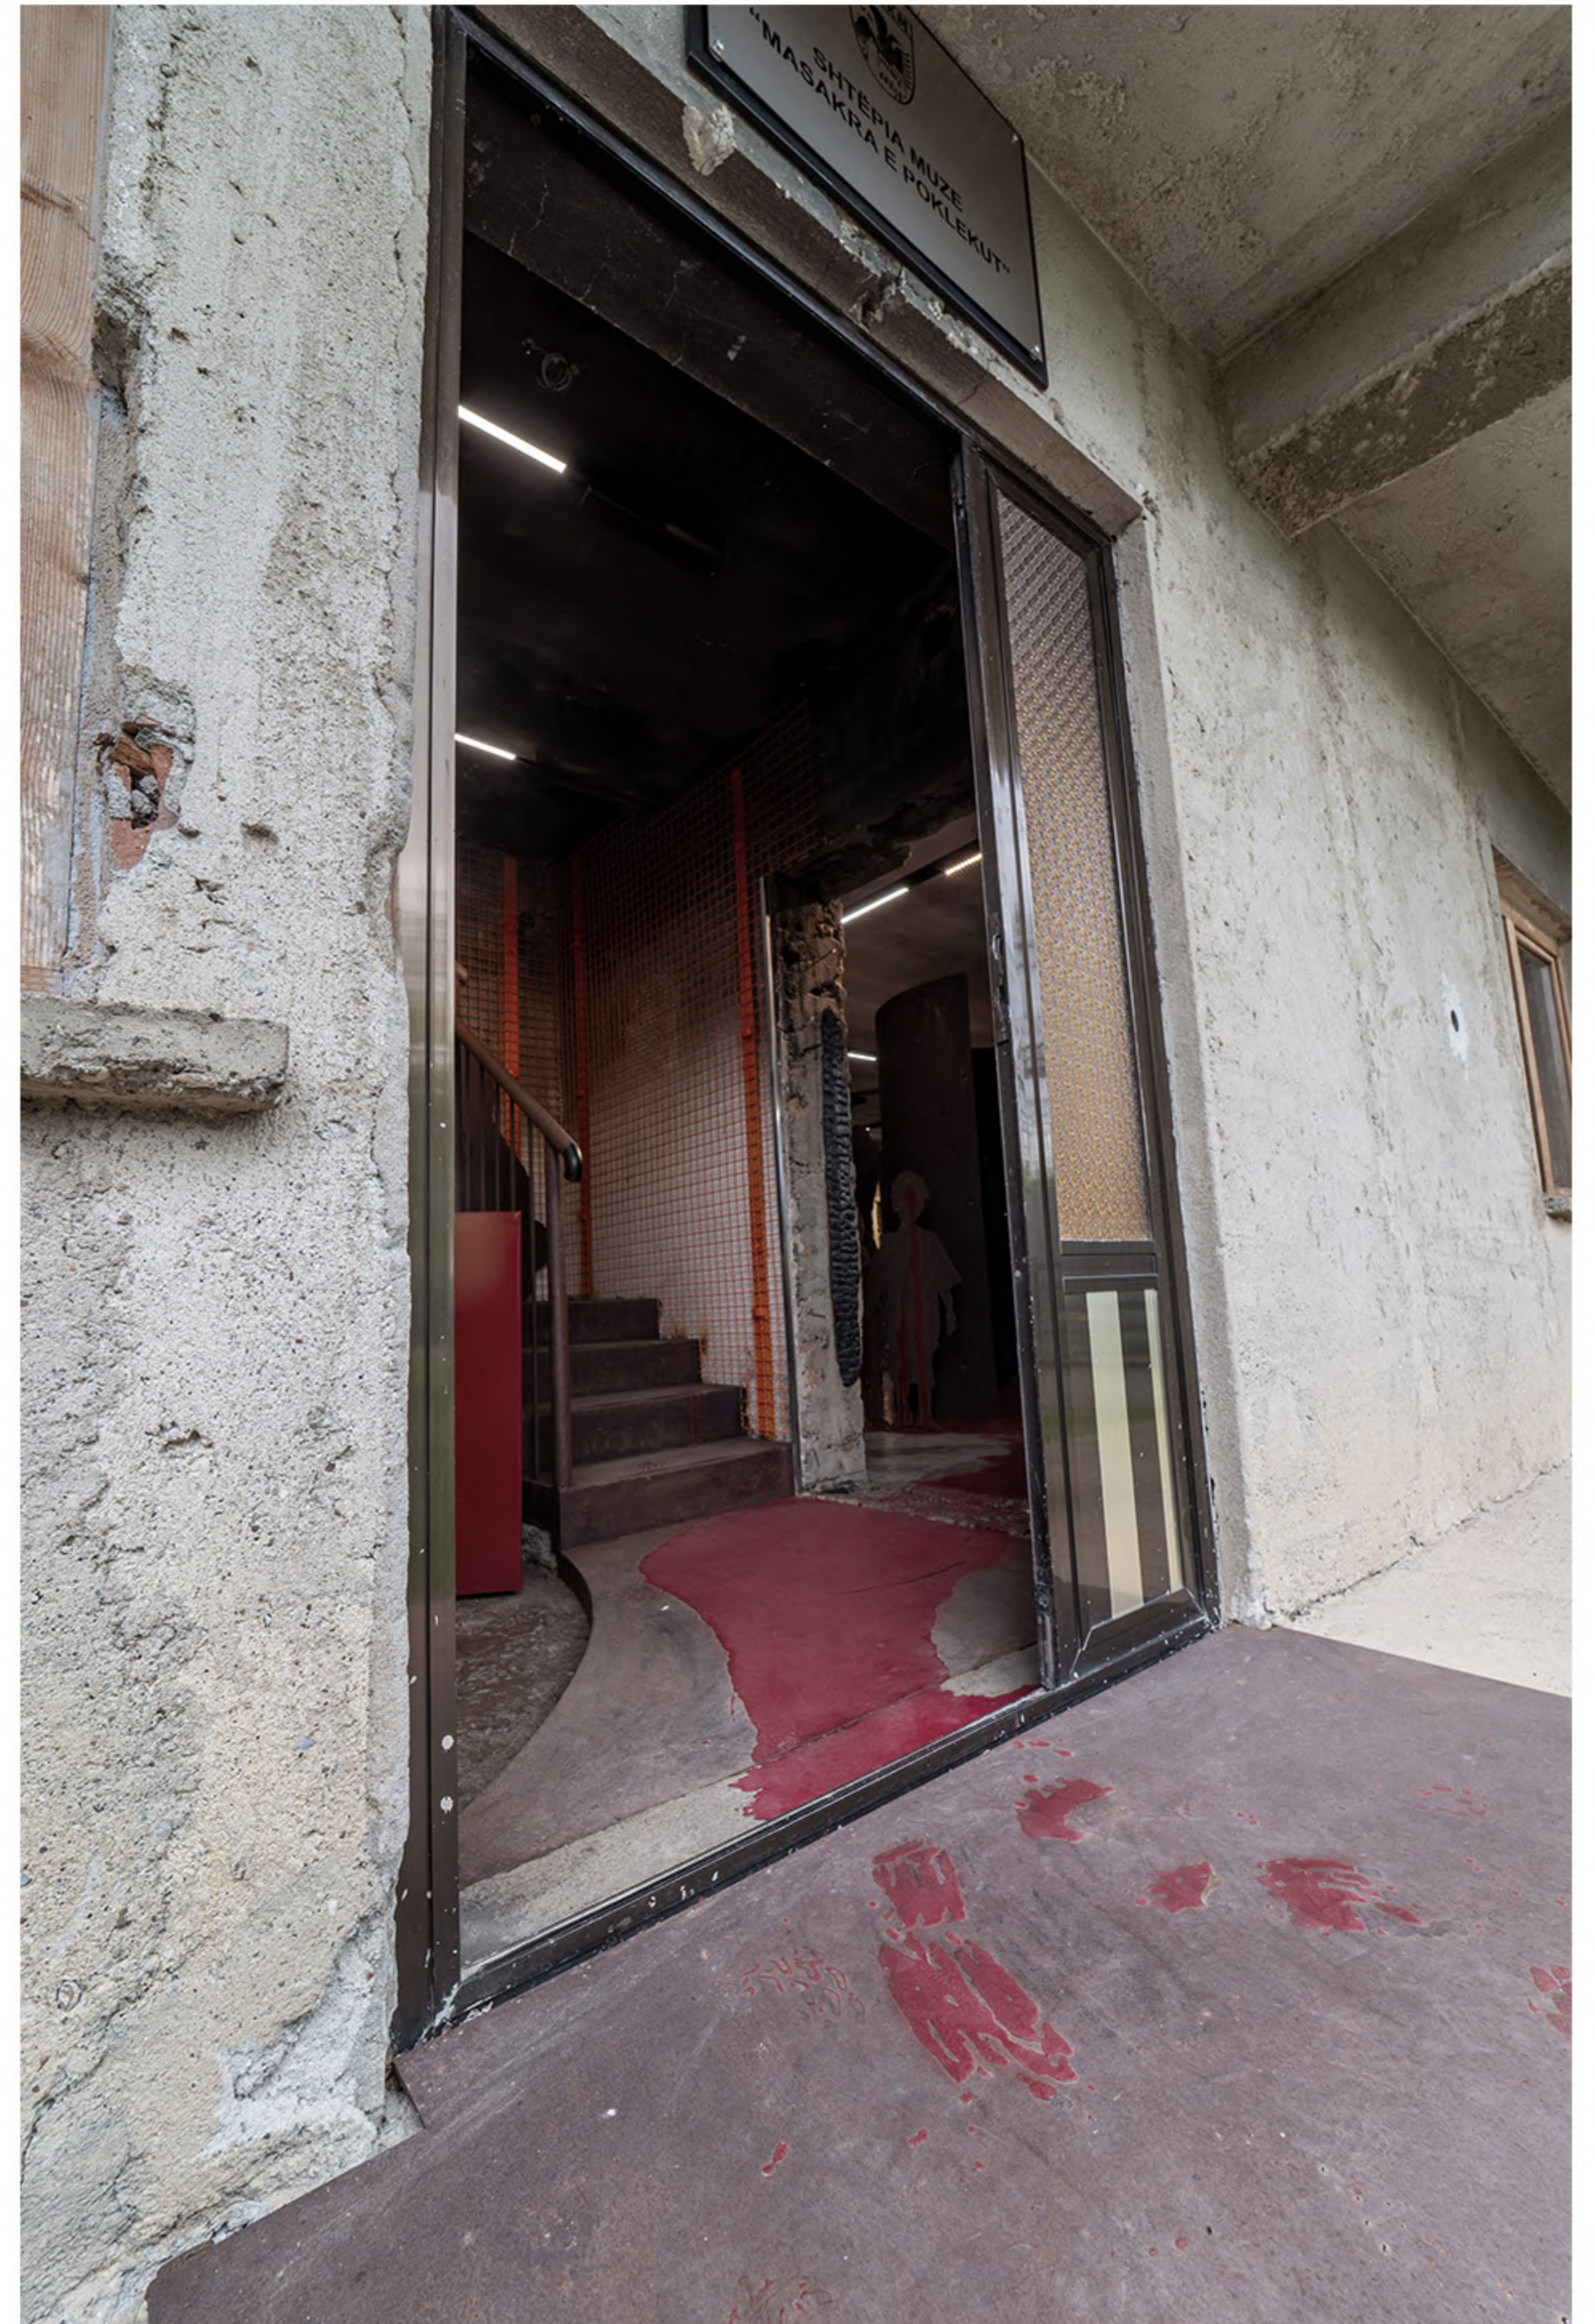
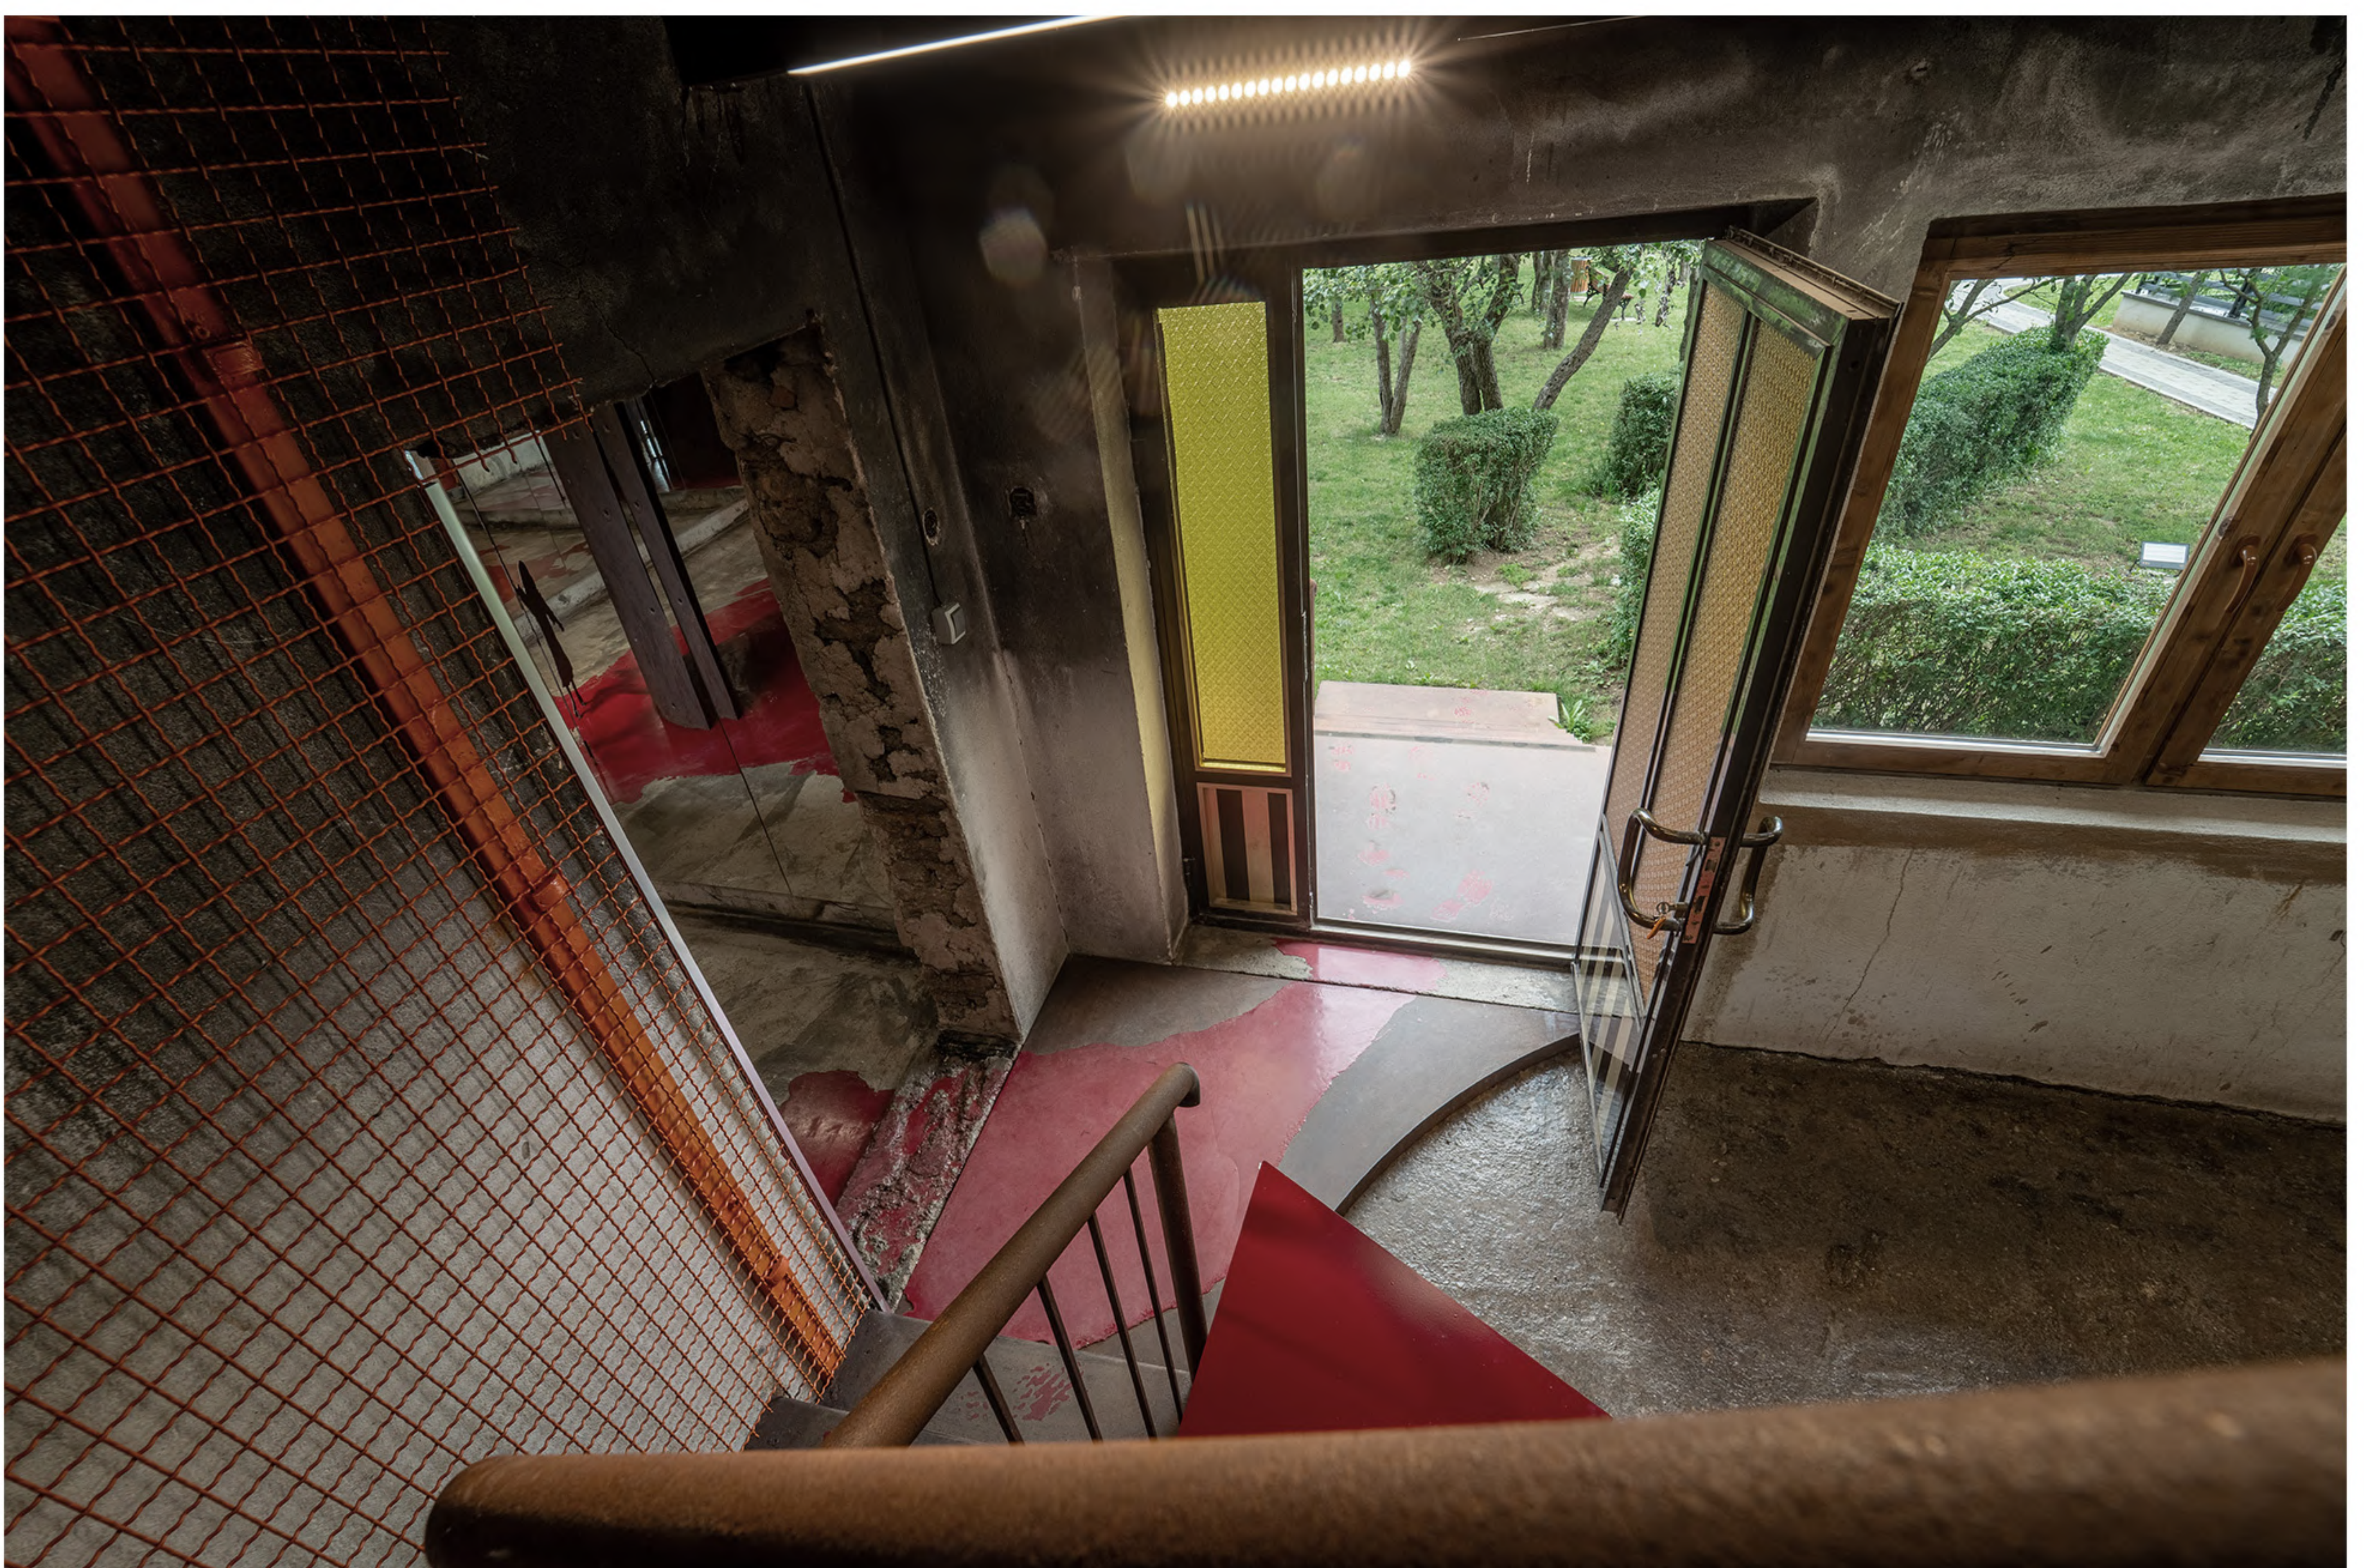
# The entrance

features corten steel steps with rusted surfaces. Red-painted footprints on the metal evoke the bloodshed of the massacre, guiding visitors toward the house museum.
