# "The House with Blood-Stained Walls"

*Pokleku Holocaust*

House  
Museum

*Village of Poklek, Glllogoc; Kosova*

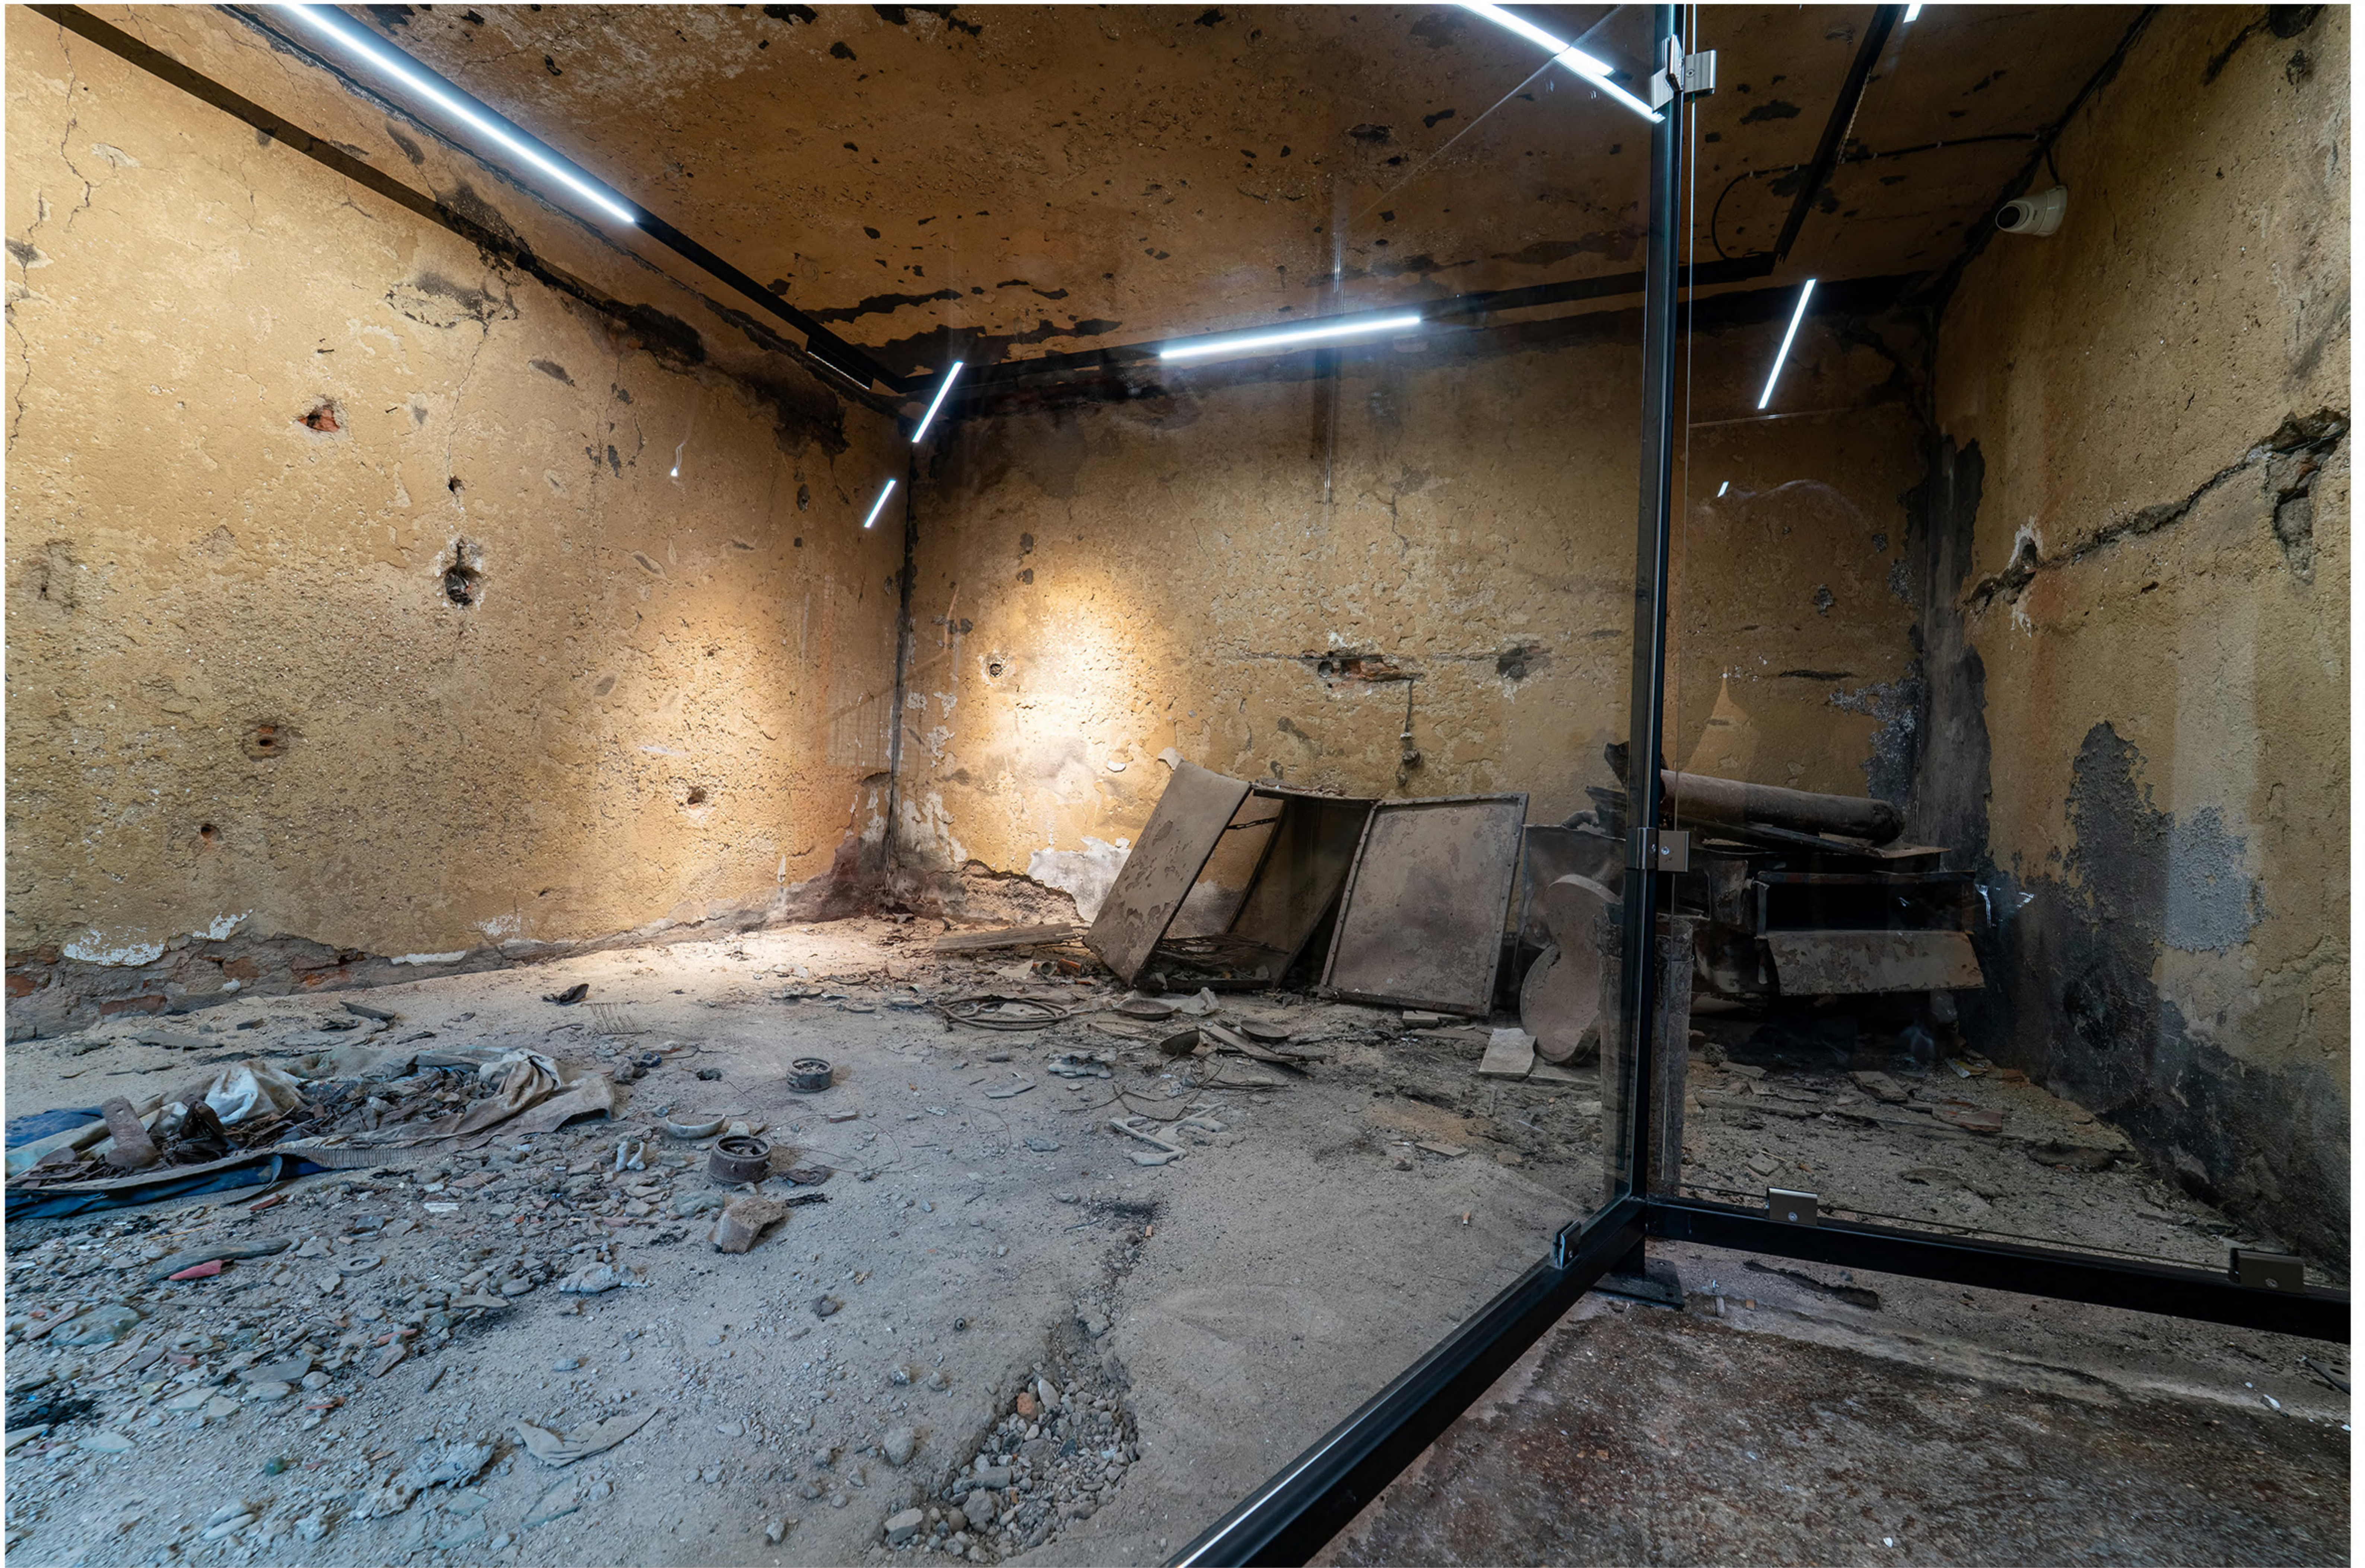
# untouched.

No restorative interventions have been made in the massacre room, preserving the original condition of the walls and floor. The only addition is a surrounding glass barrier, allowing visitors to witness the space respectfully without altering its authenticity.

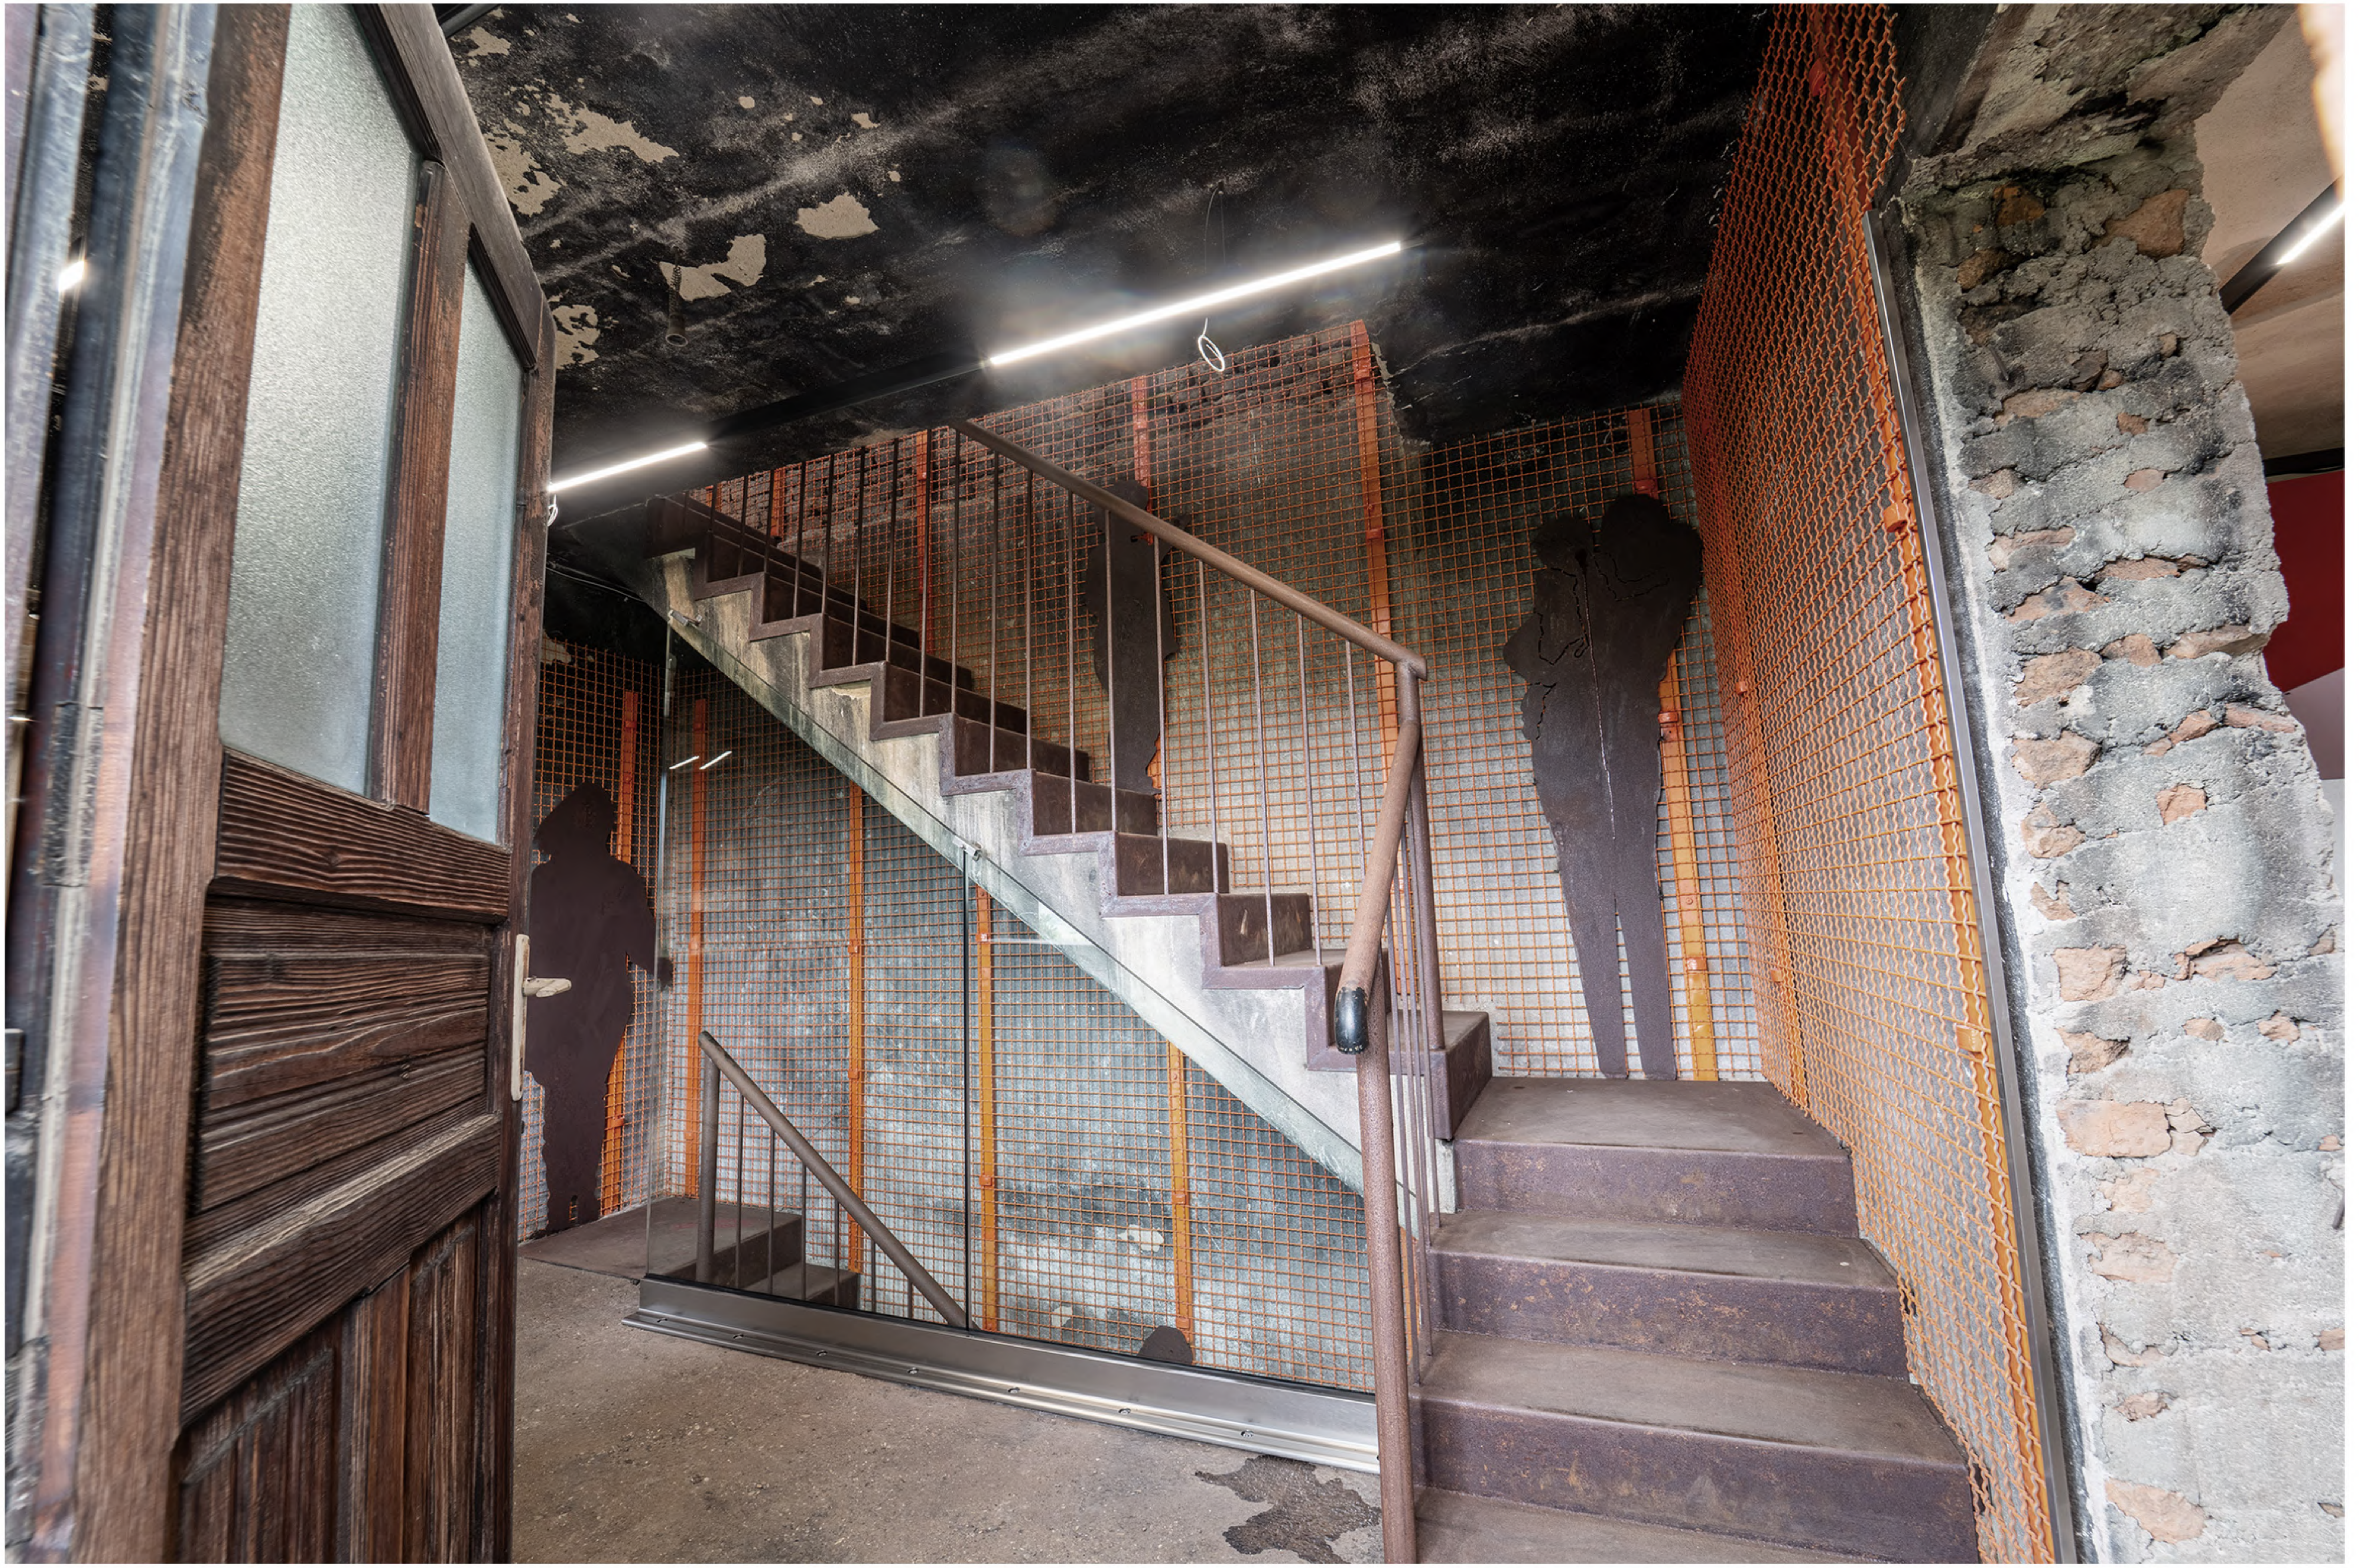
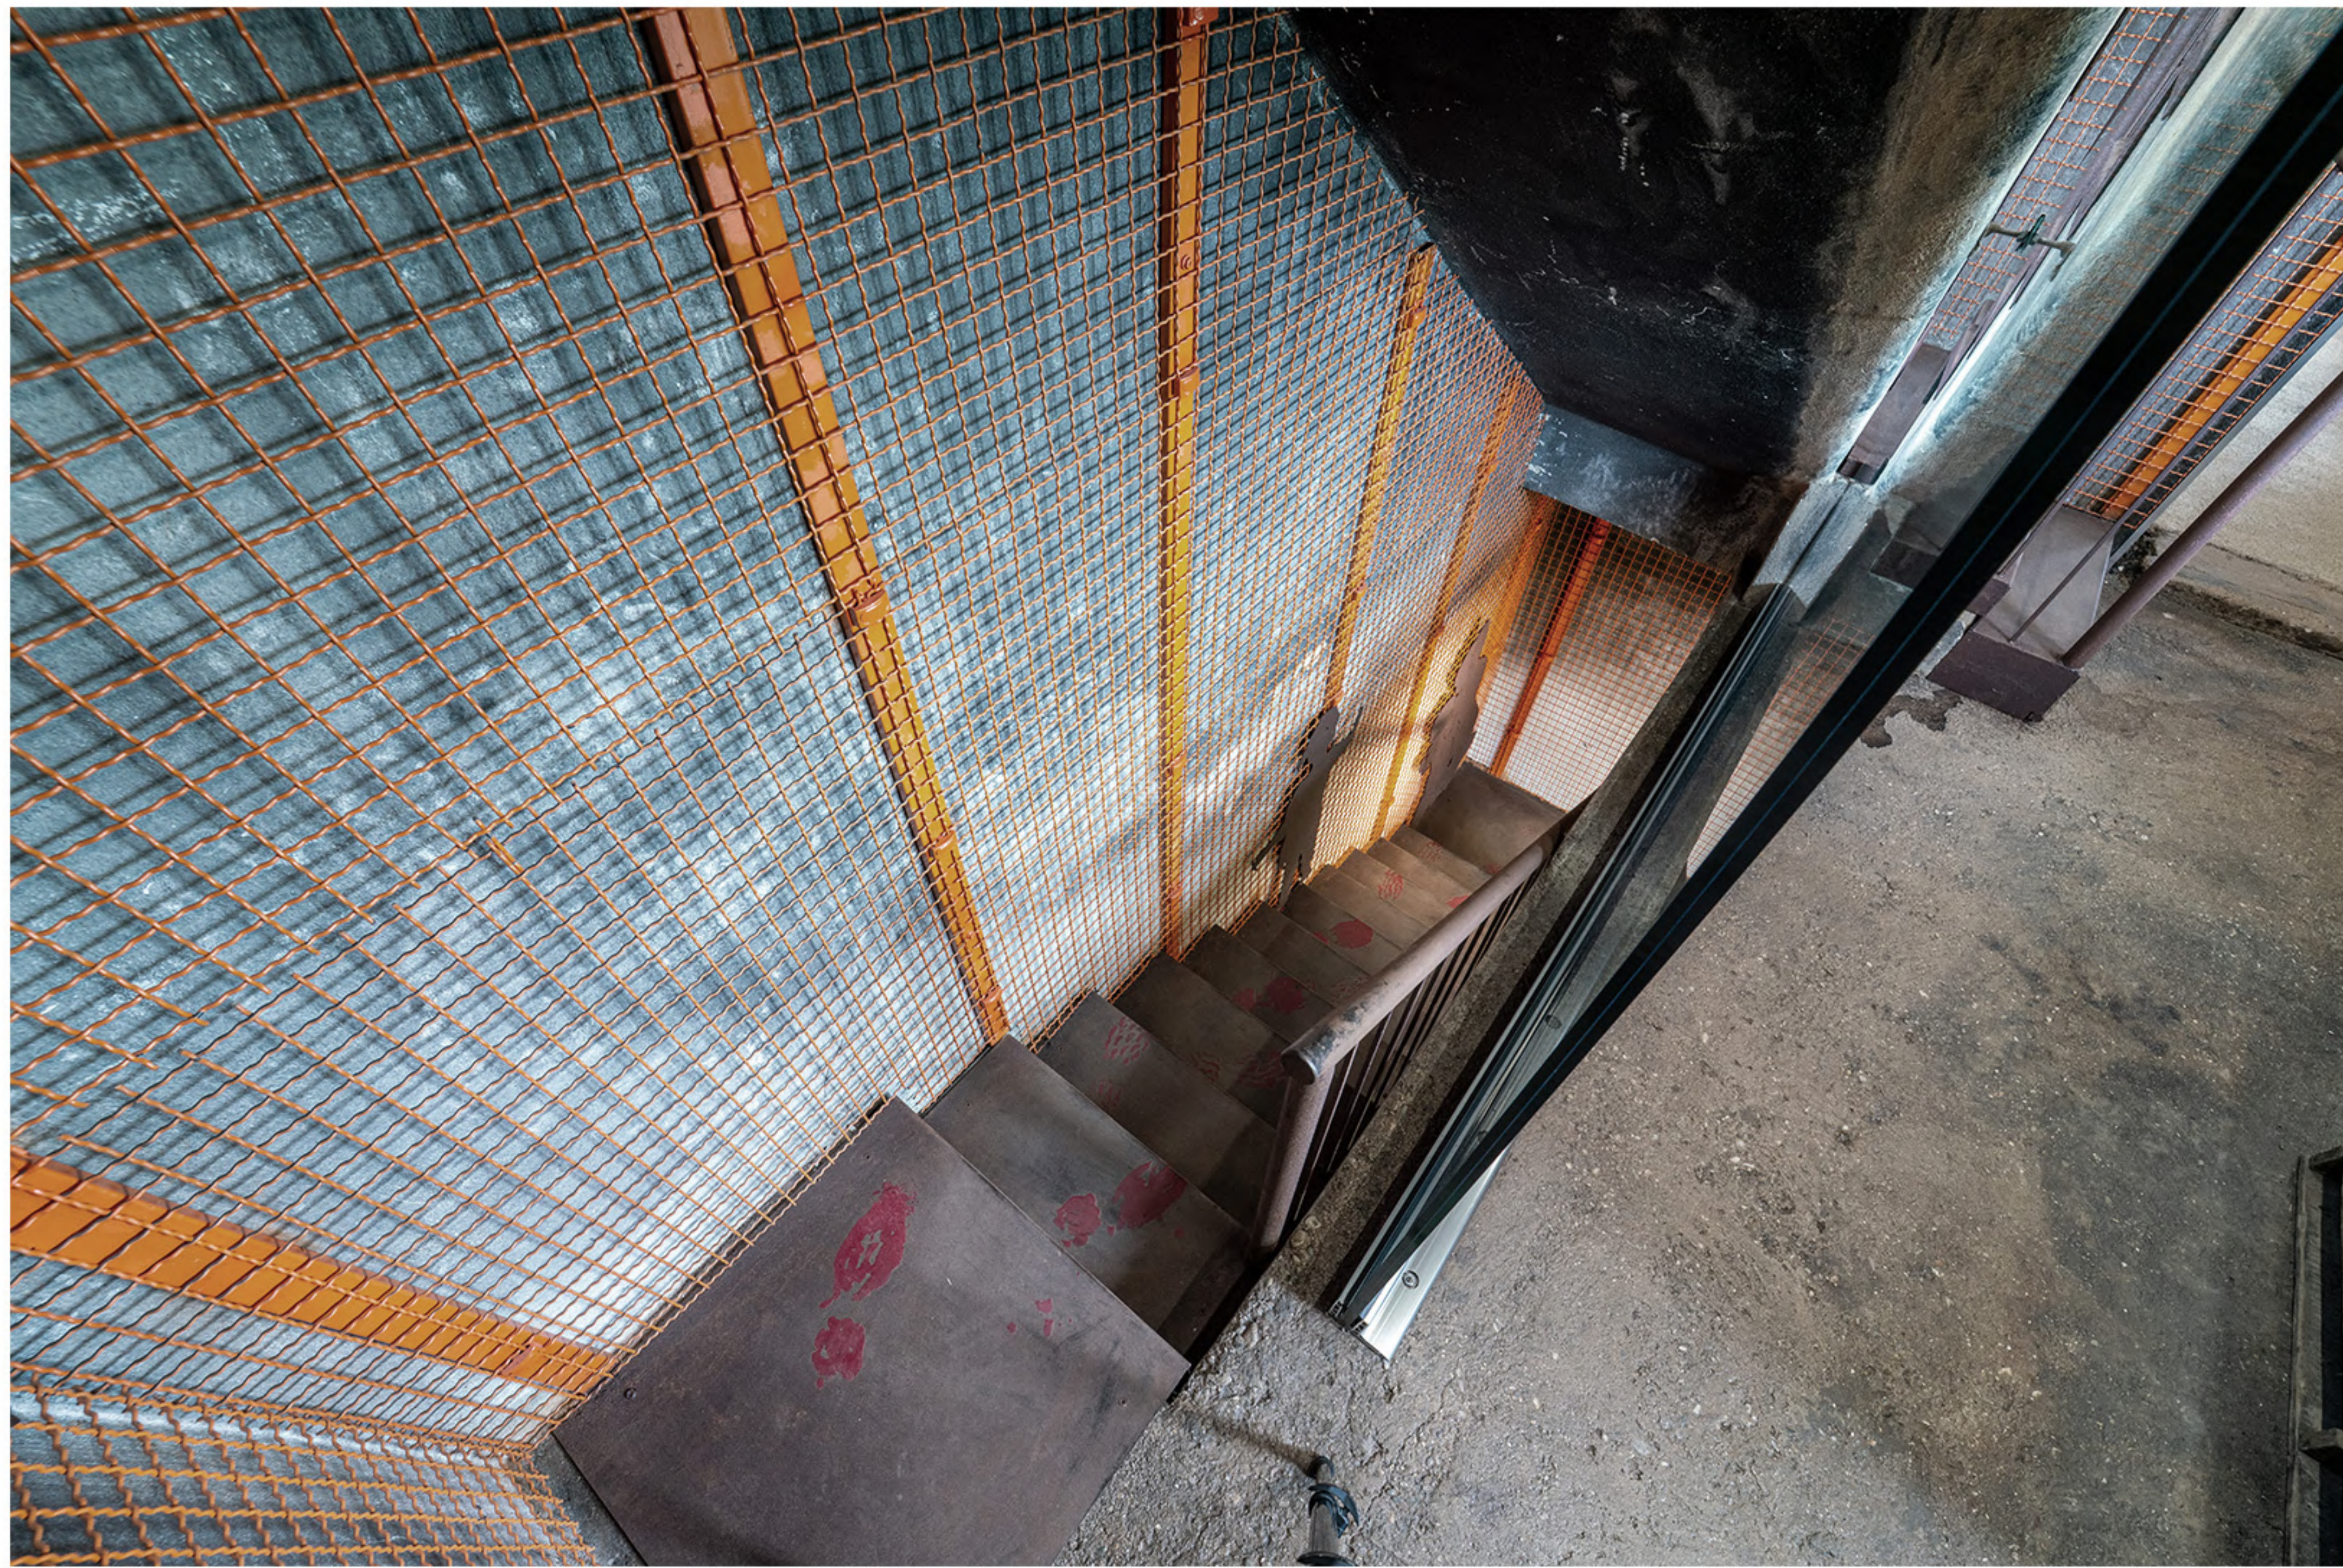
The corten steel **staircase** continues through the corridor, matching the materiality of the entrance. Metal mesh cladding protects the original walls and supports archival photographs. Most striking are the metal silhouettes integrated along the route—abstract figures representing family members who once moved through this corridor to discreetly alert others of the approaching enemy. These sculptural elements animate the space with narrative presence and spatial memory.

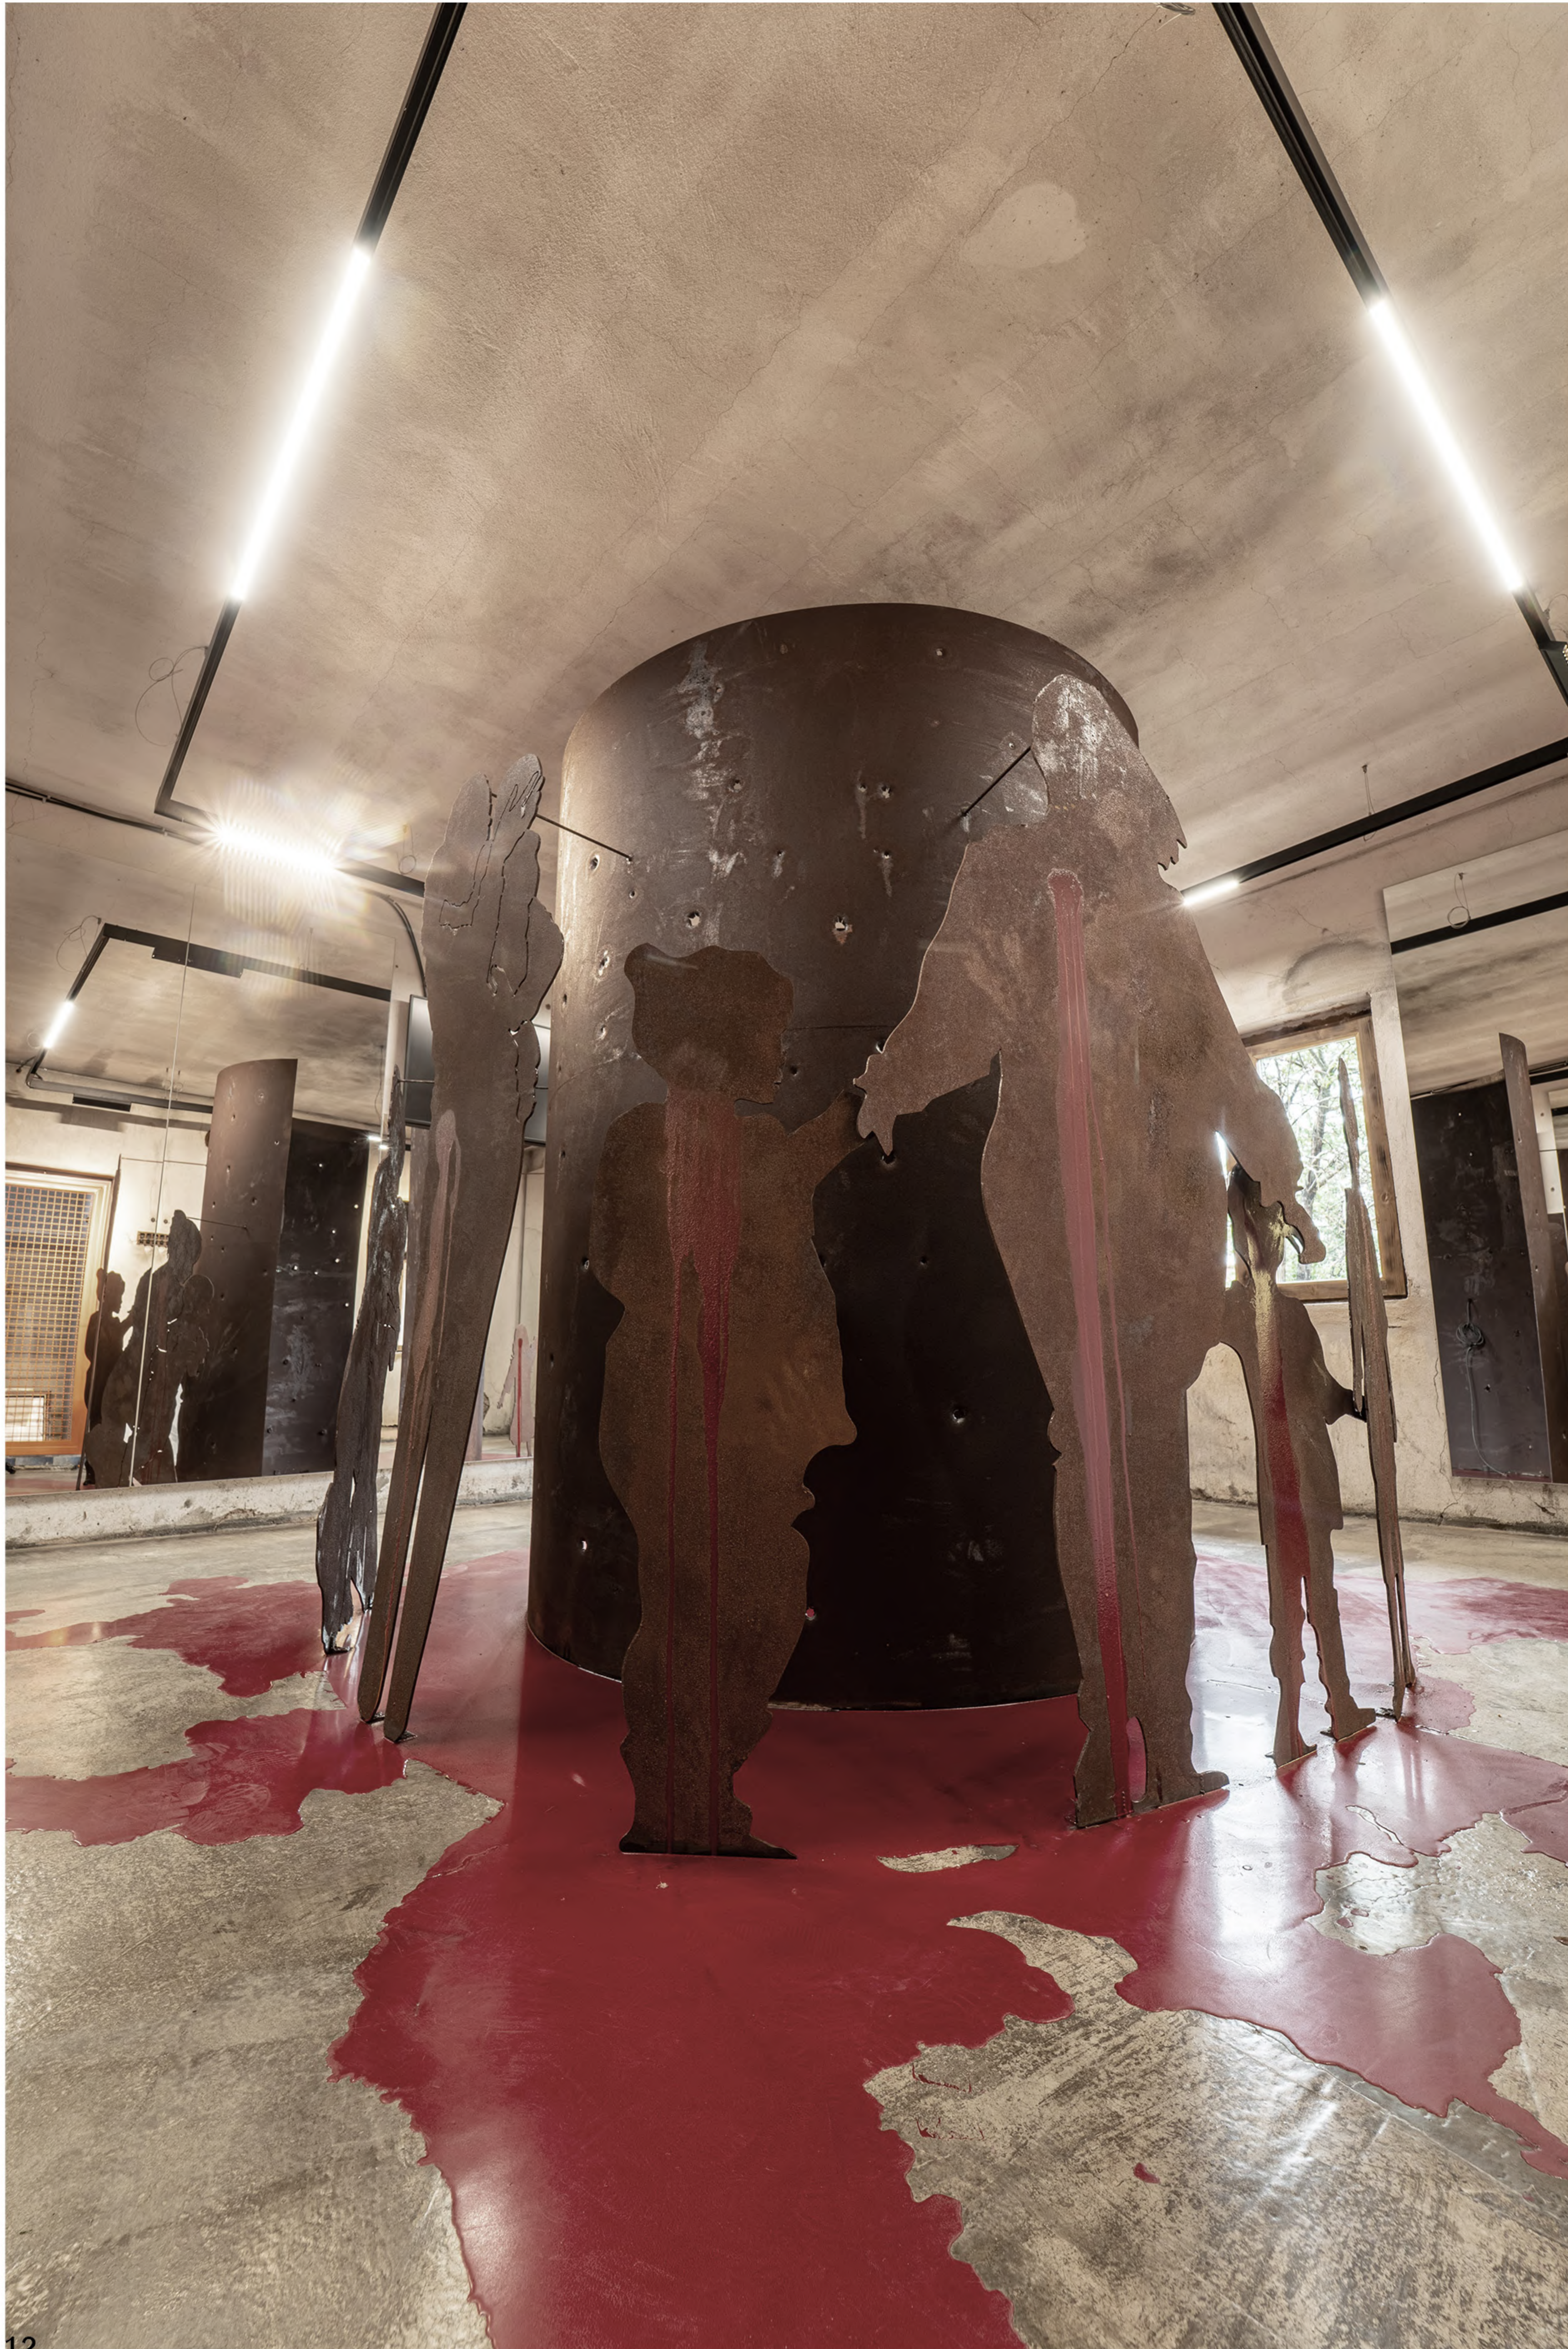
Red epoxy spreads across the concrete floor, evoking the presence of blood and tragedy. Mirrors along the walls deepen the space and reflect the silhouettes, creating a haunting, immersive atmosphere. The raw materials – steel, concrete, and resin – convey a powerful narrative of absence, memory and collective trauma.

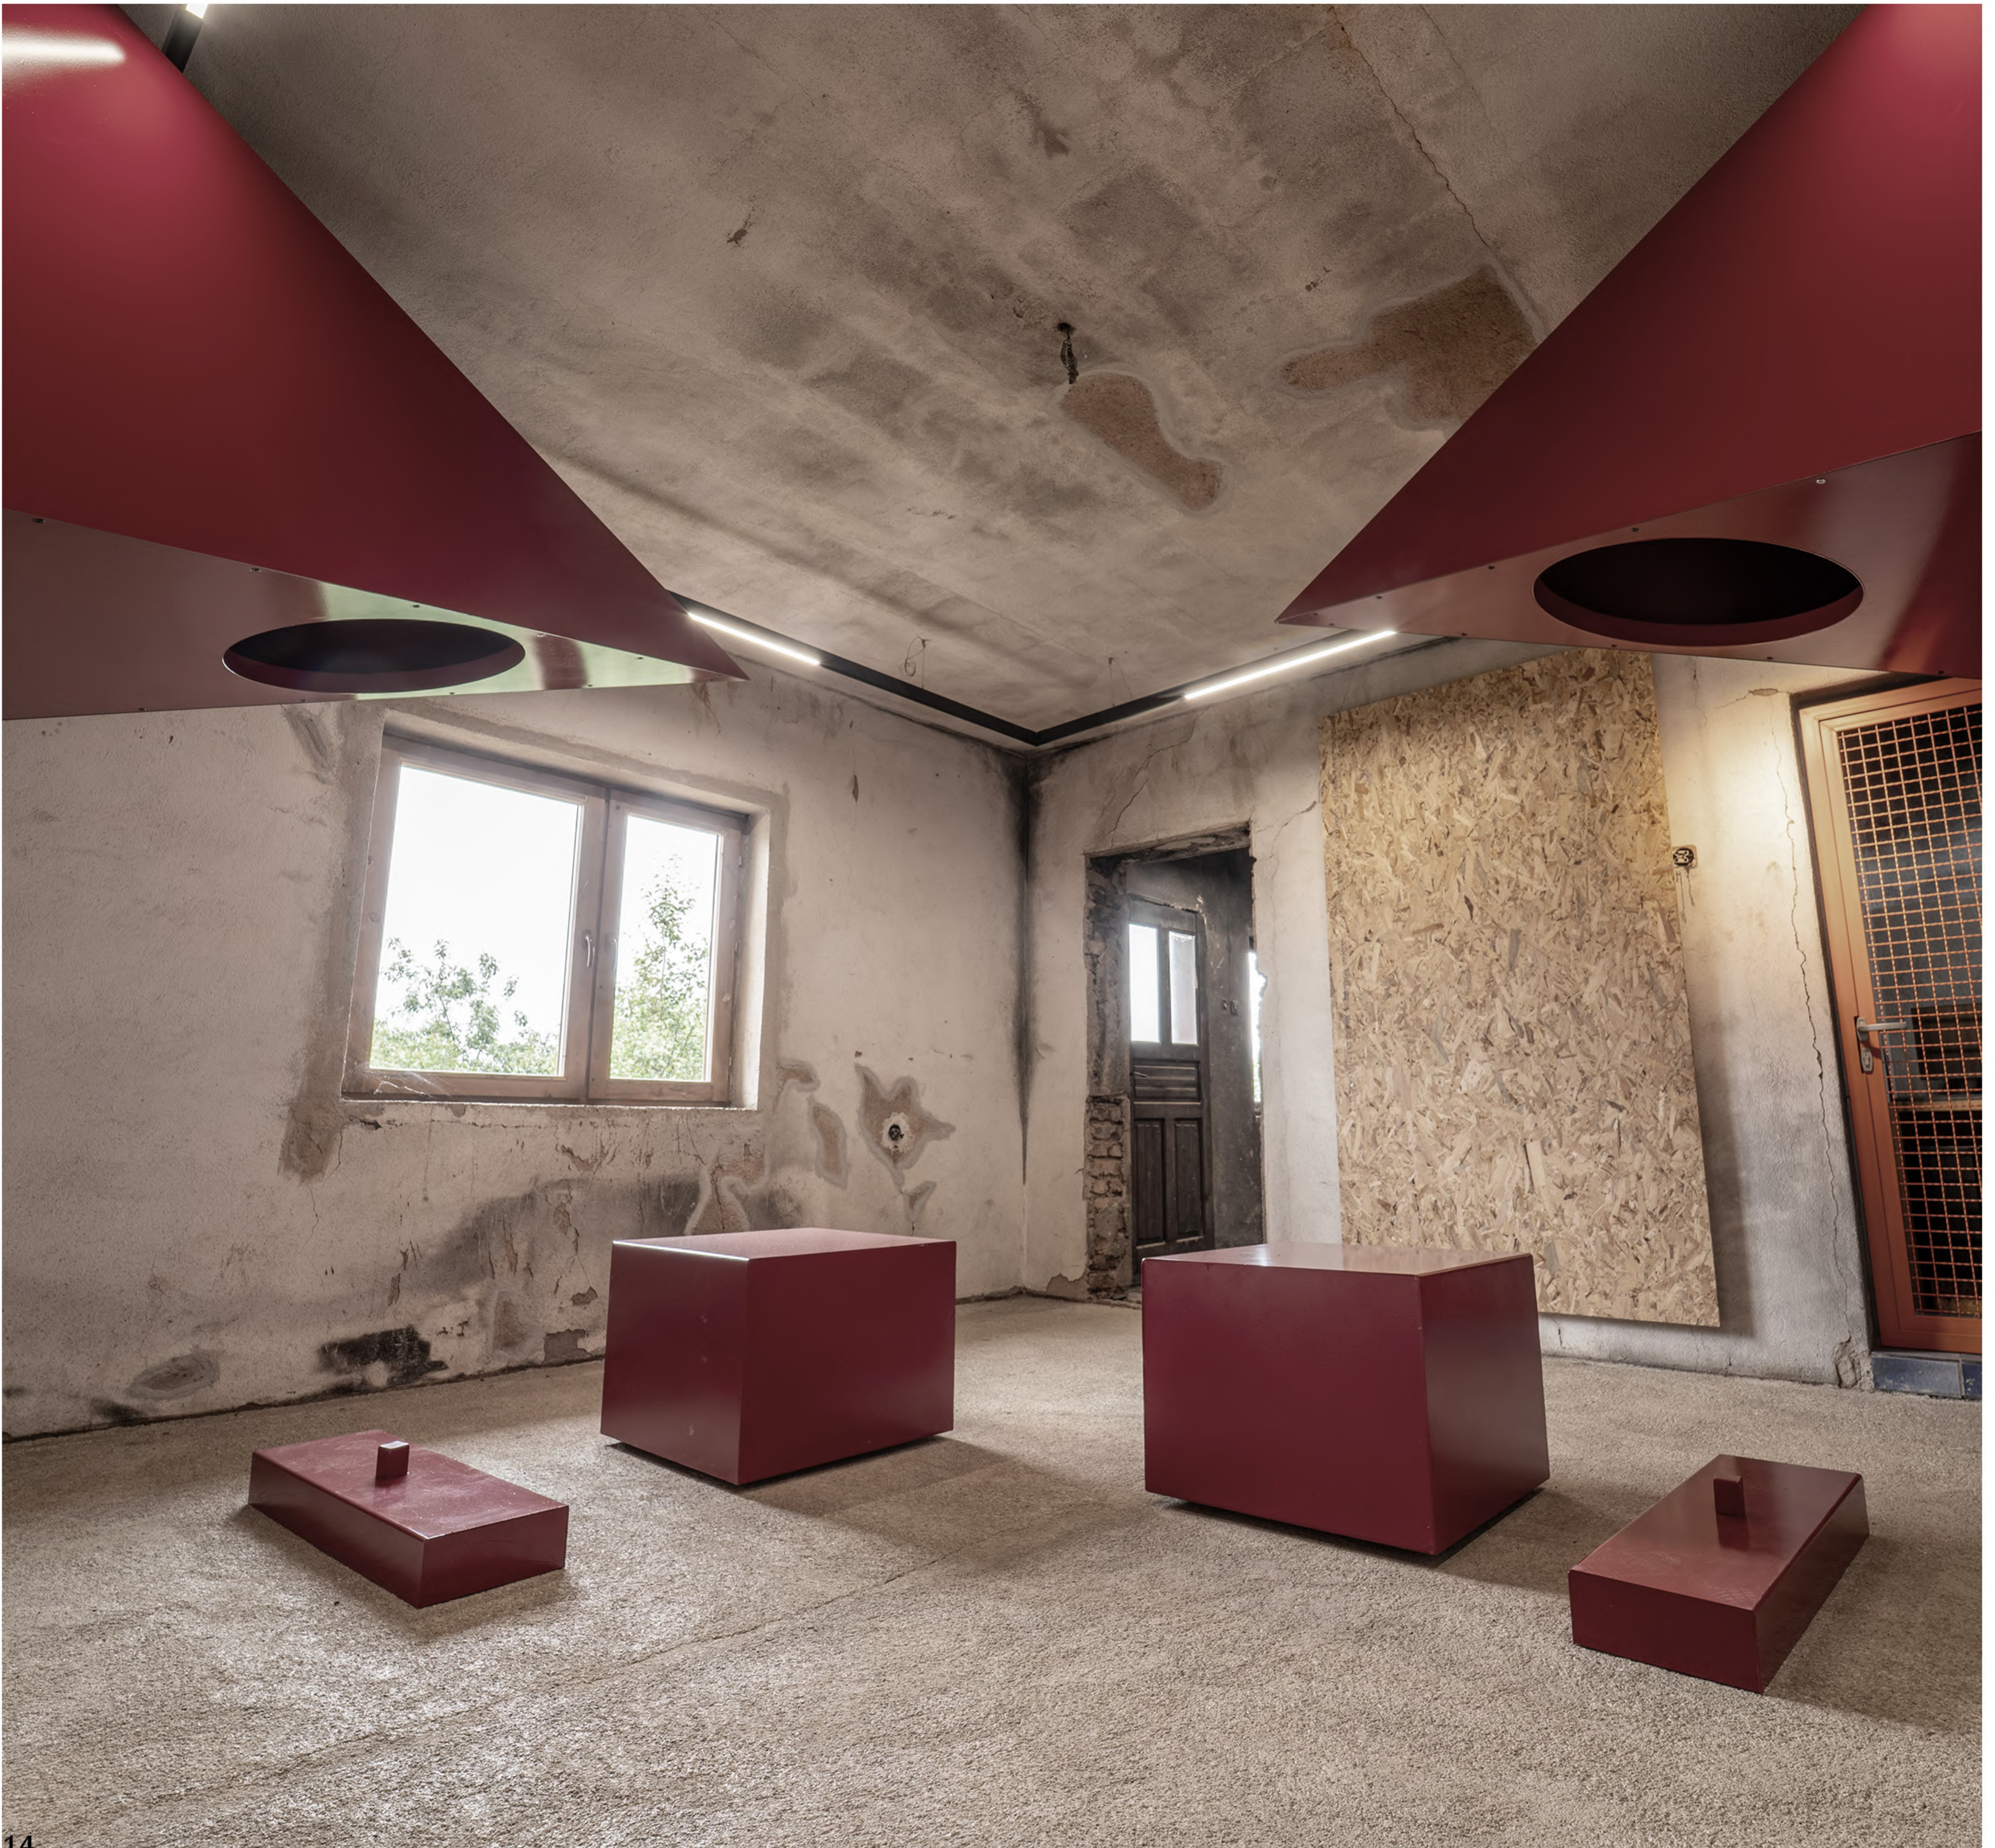
Using the booths as a means of storytelling tool by offering visitors an experience of the effects of the massacre.
