Conservation and Restoration Works on Revitalization  
of Roman Catholic Church of Our Lady of the Snows in Žabalj

## *Recovering authenticity through evidence-based restoration and contemporary interpretation*

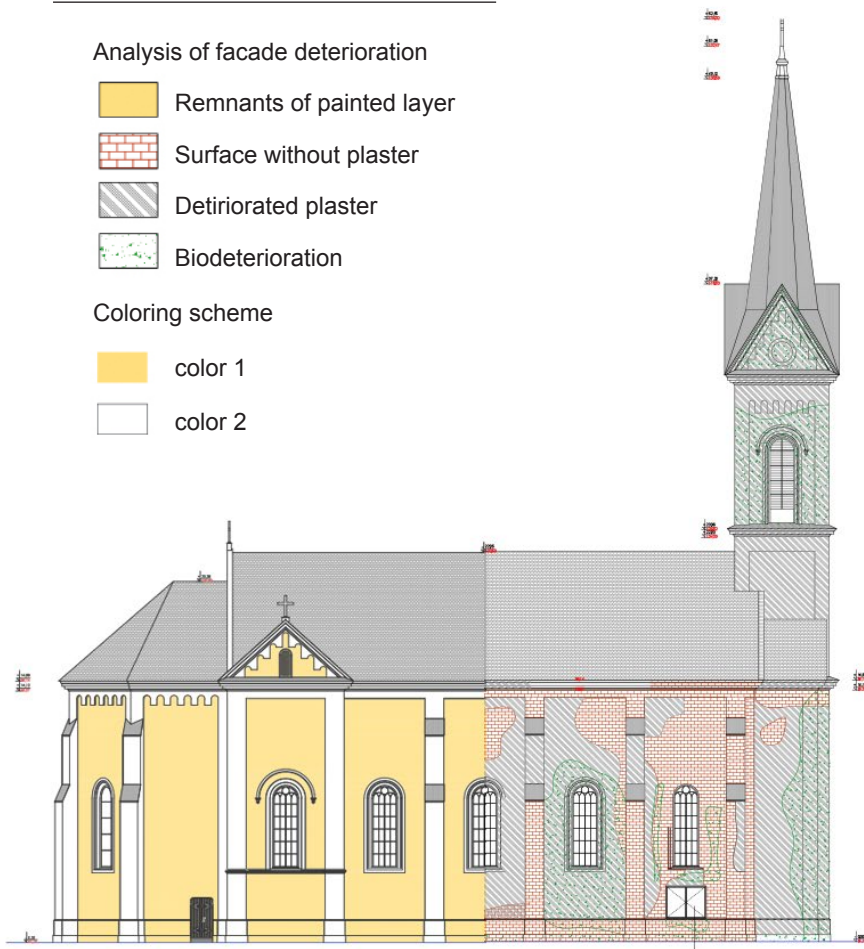
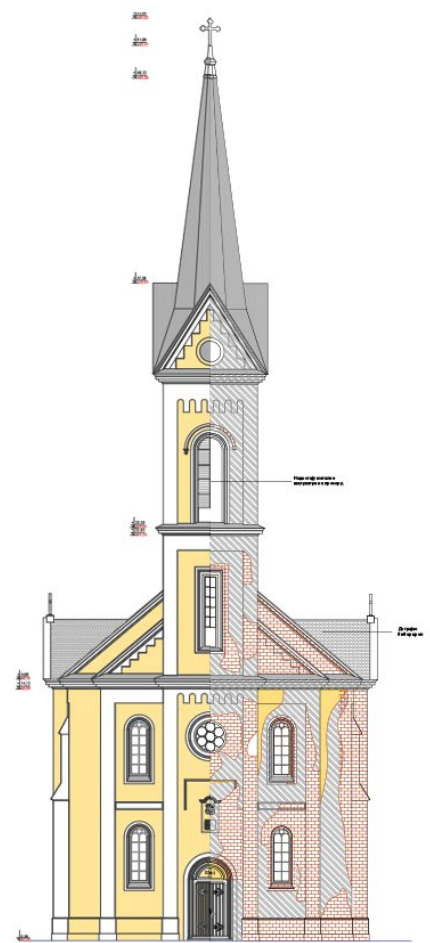
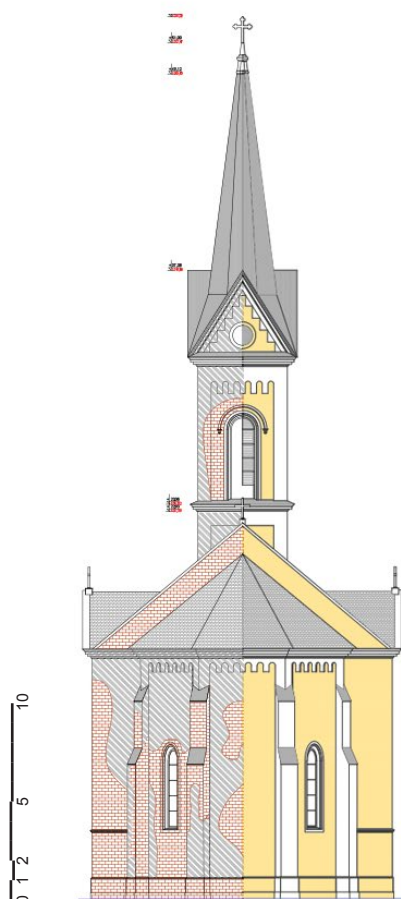
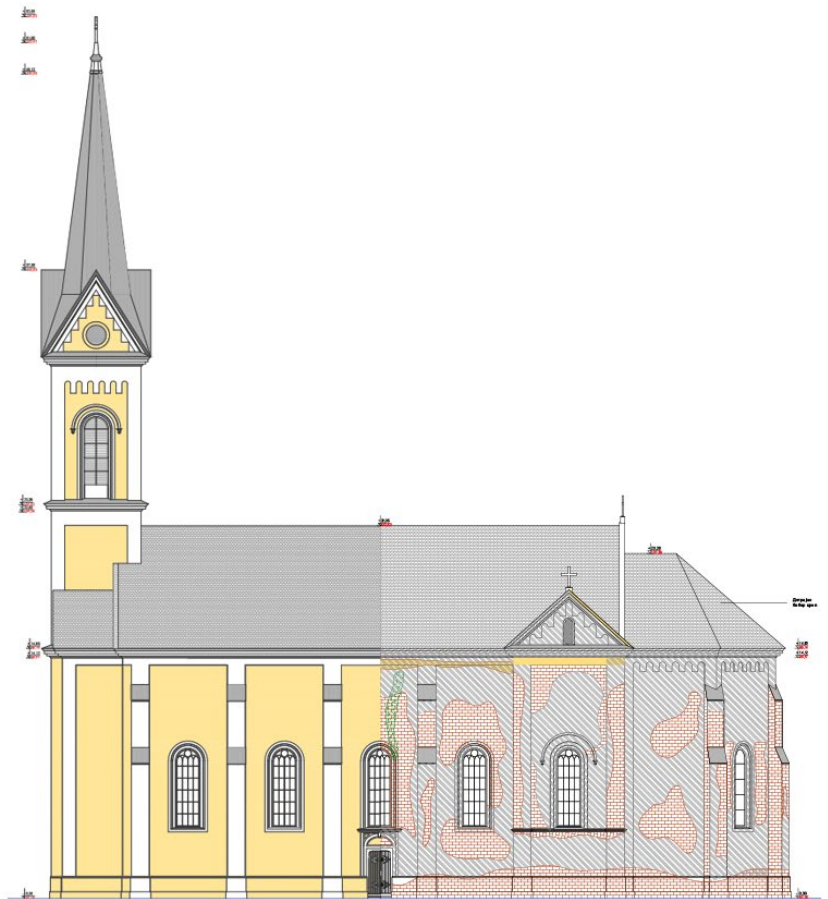
# Comparative Analysis - Facades

Existing Condition / Restaured Condition

Analysis of facade deterioration

- Remnants of painted layer
- Surface without plaster
- Detiriorated plaster
- Biodeterioration

Coloring scheme

- color 1
- color 2

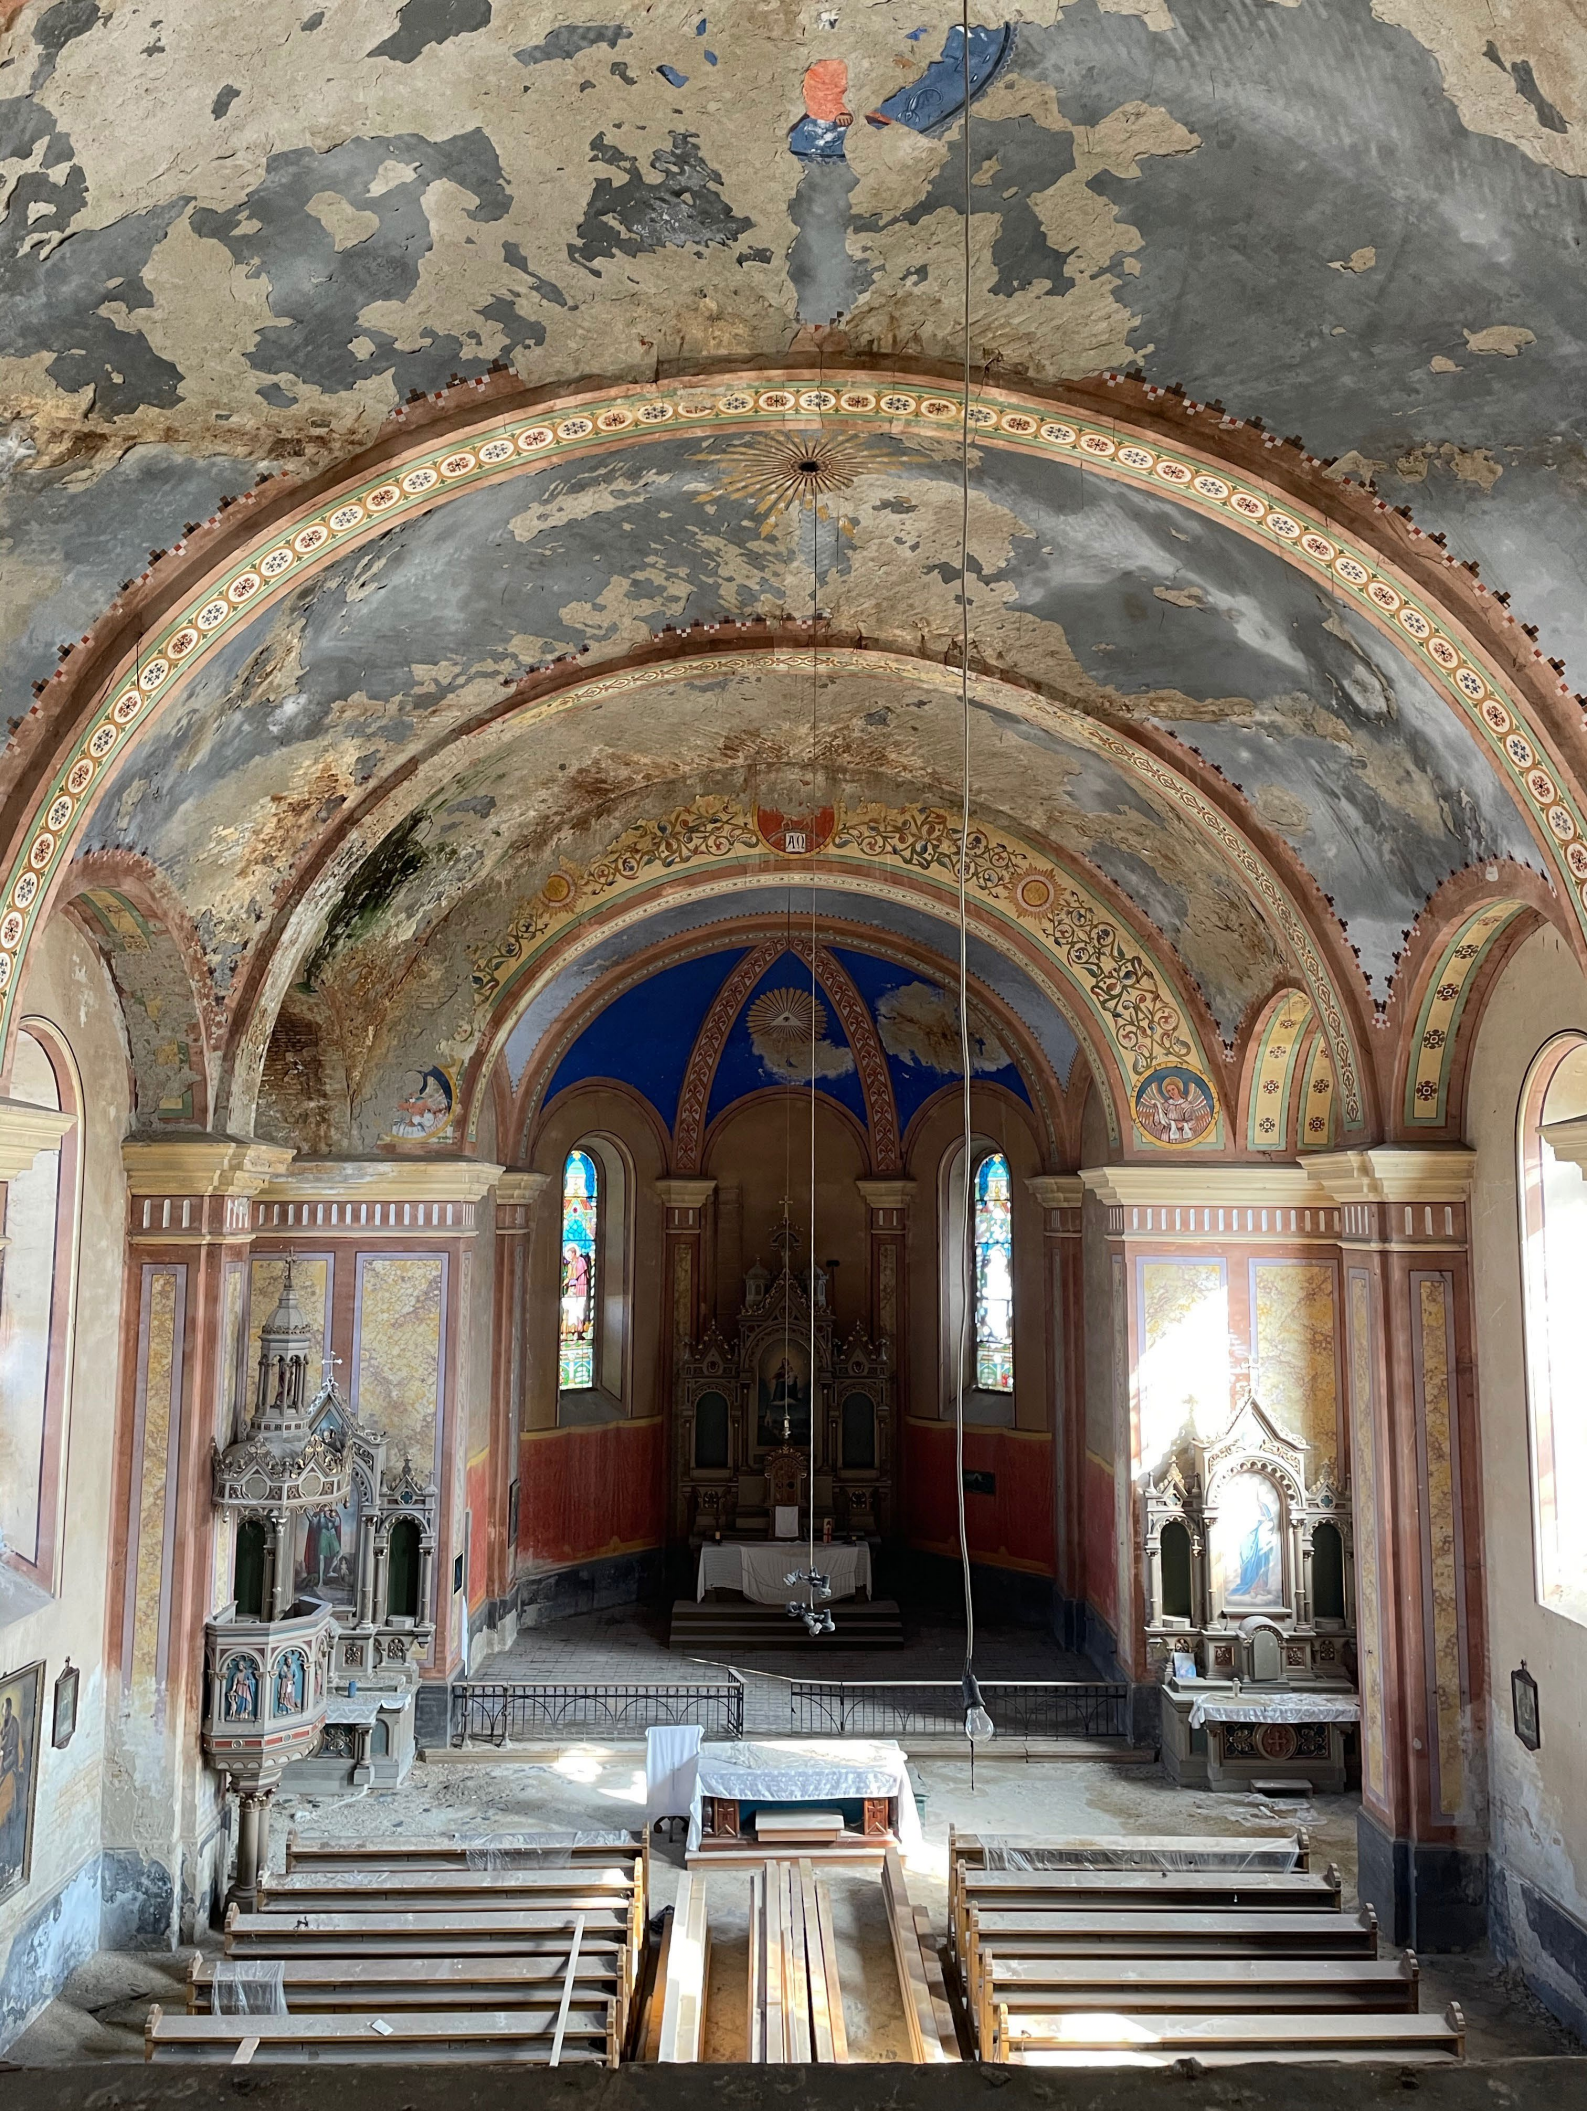
Before: View from the choir gallery towards the altar

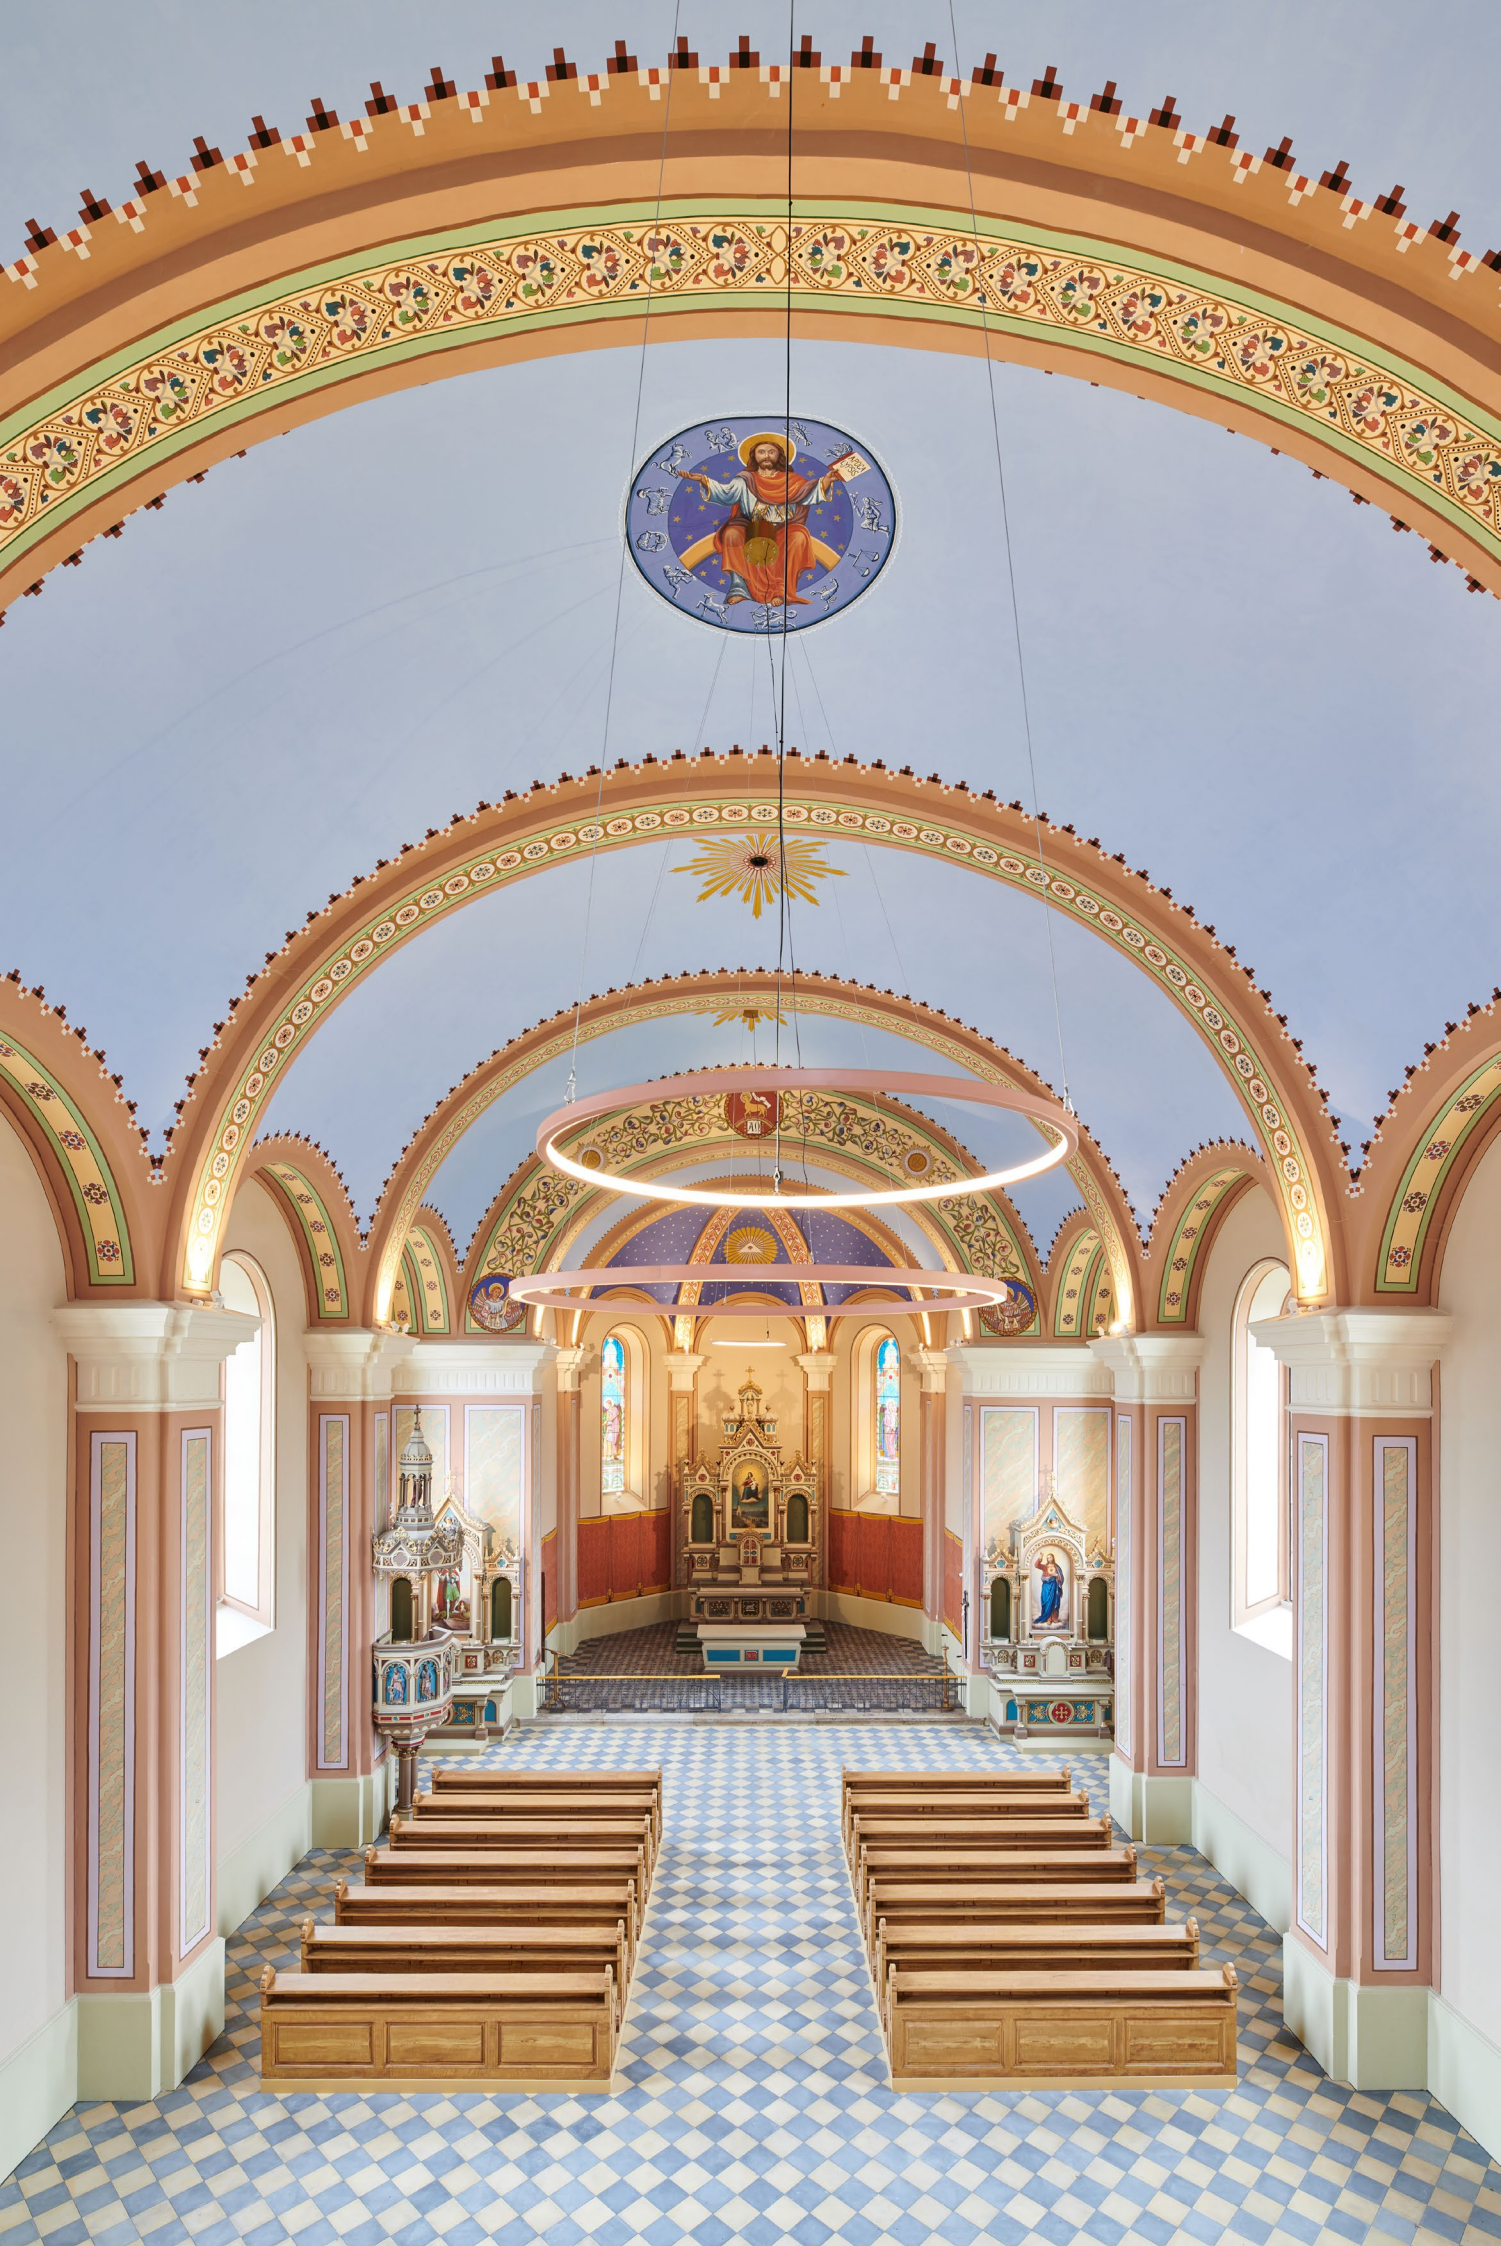
After: View from the choir gallery towards the altar

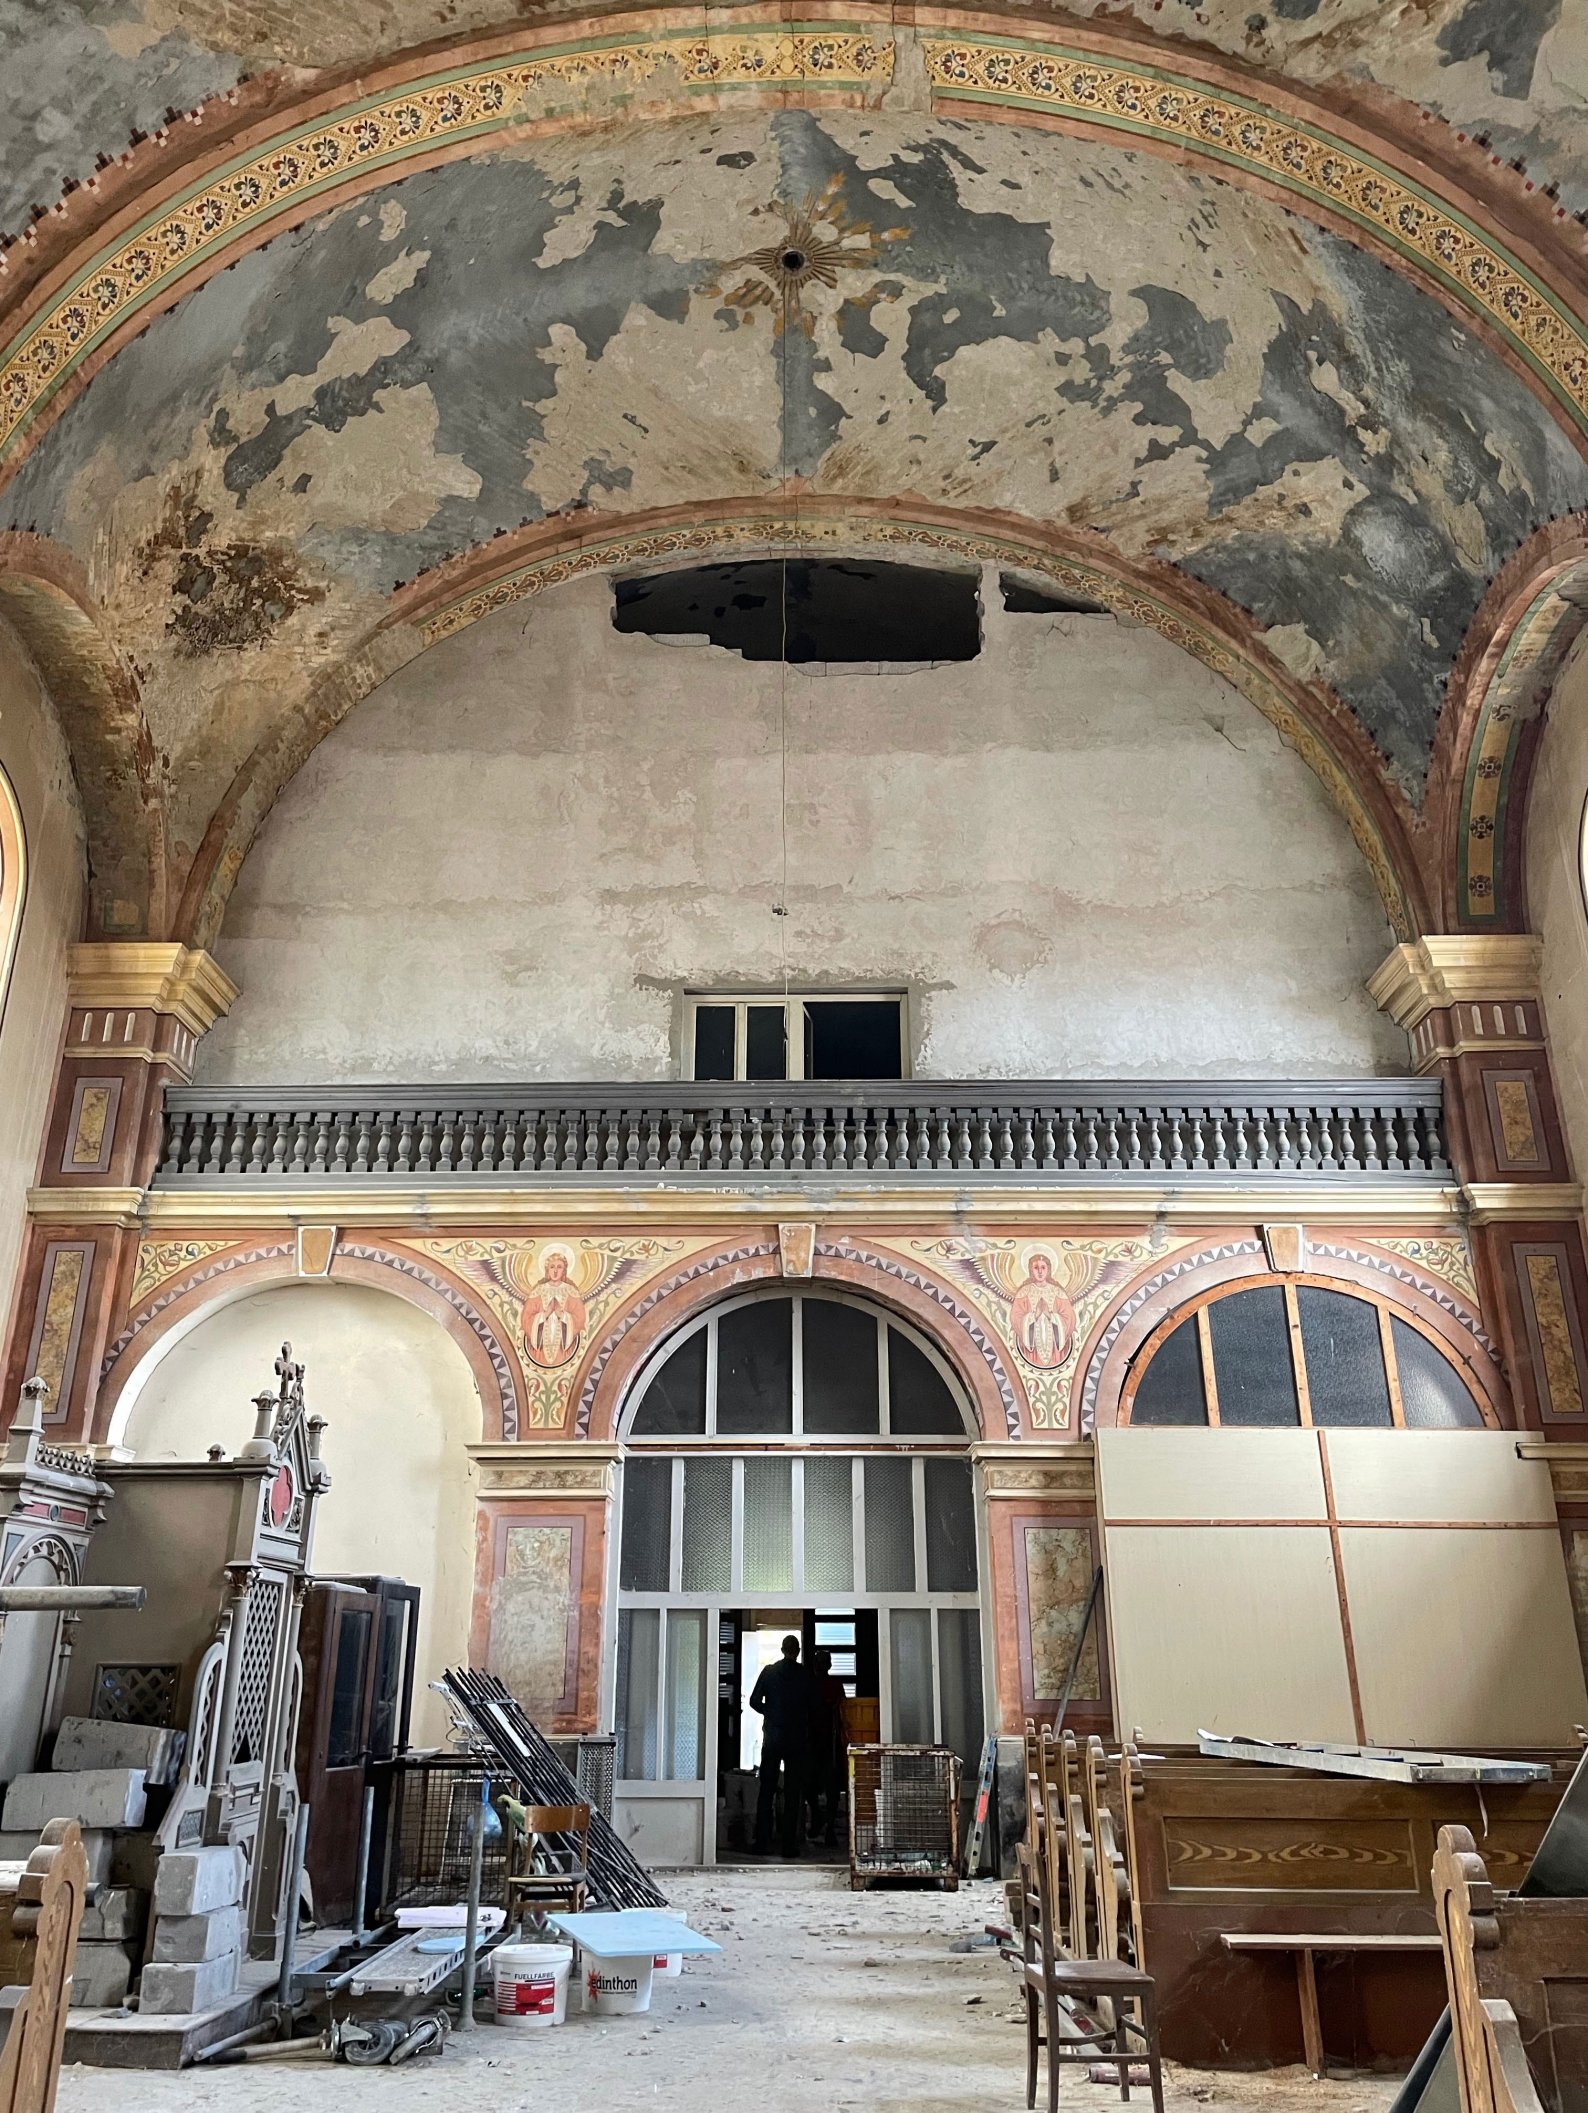
Before: View towards the choir gallery

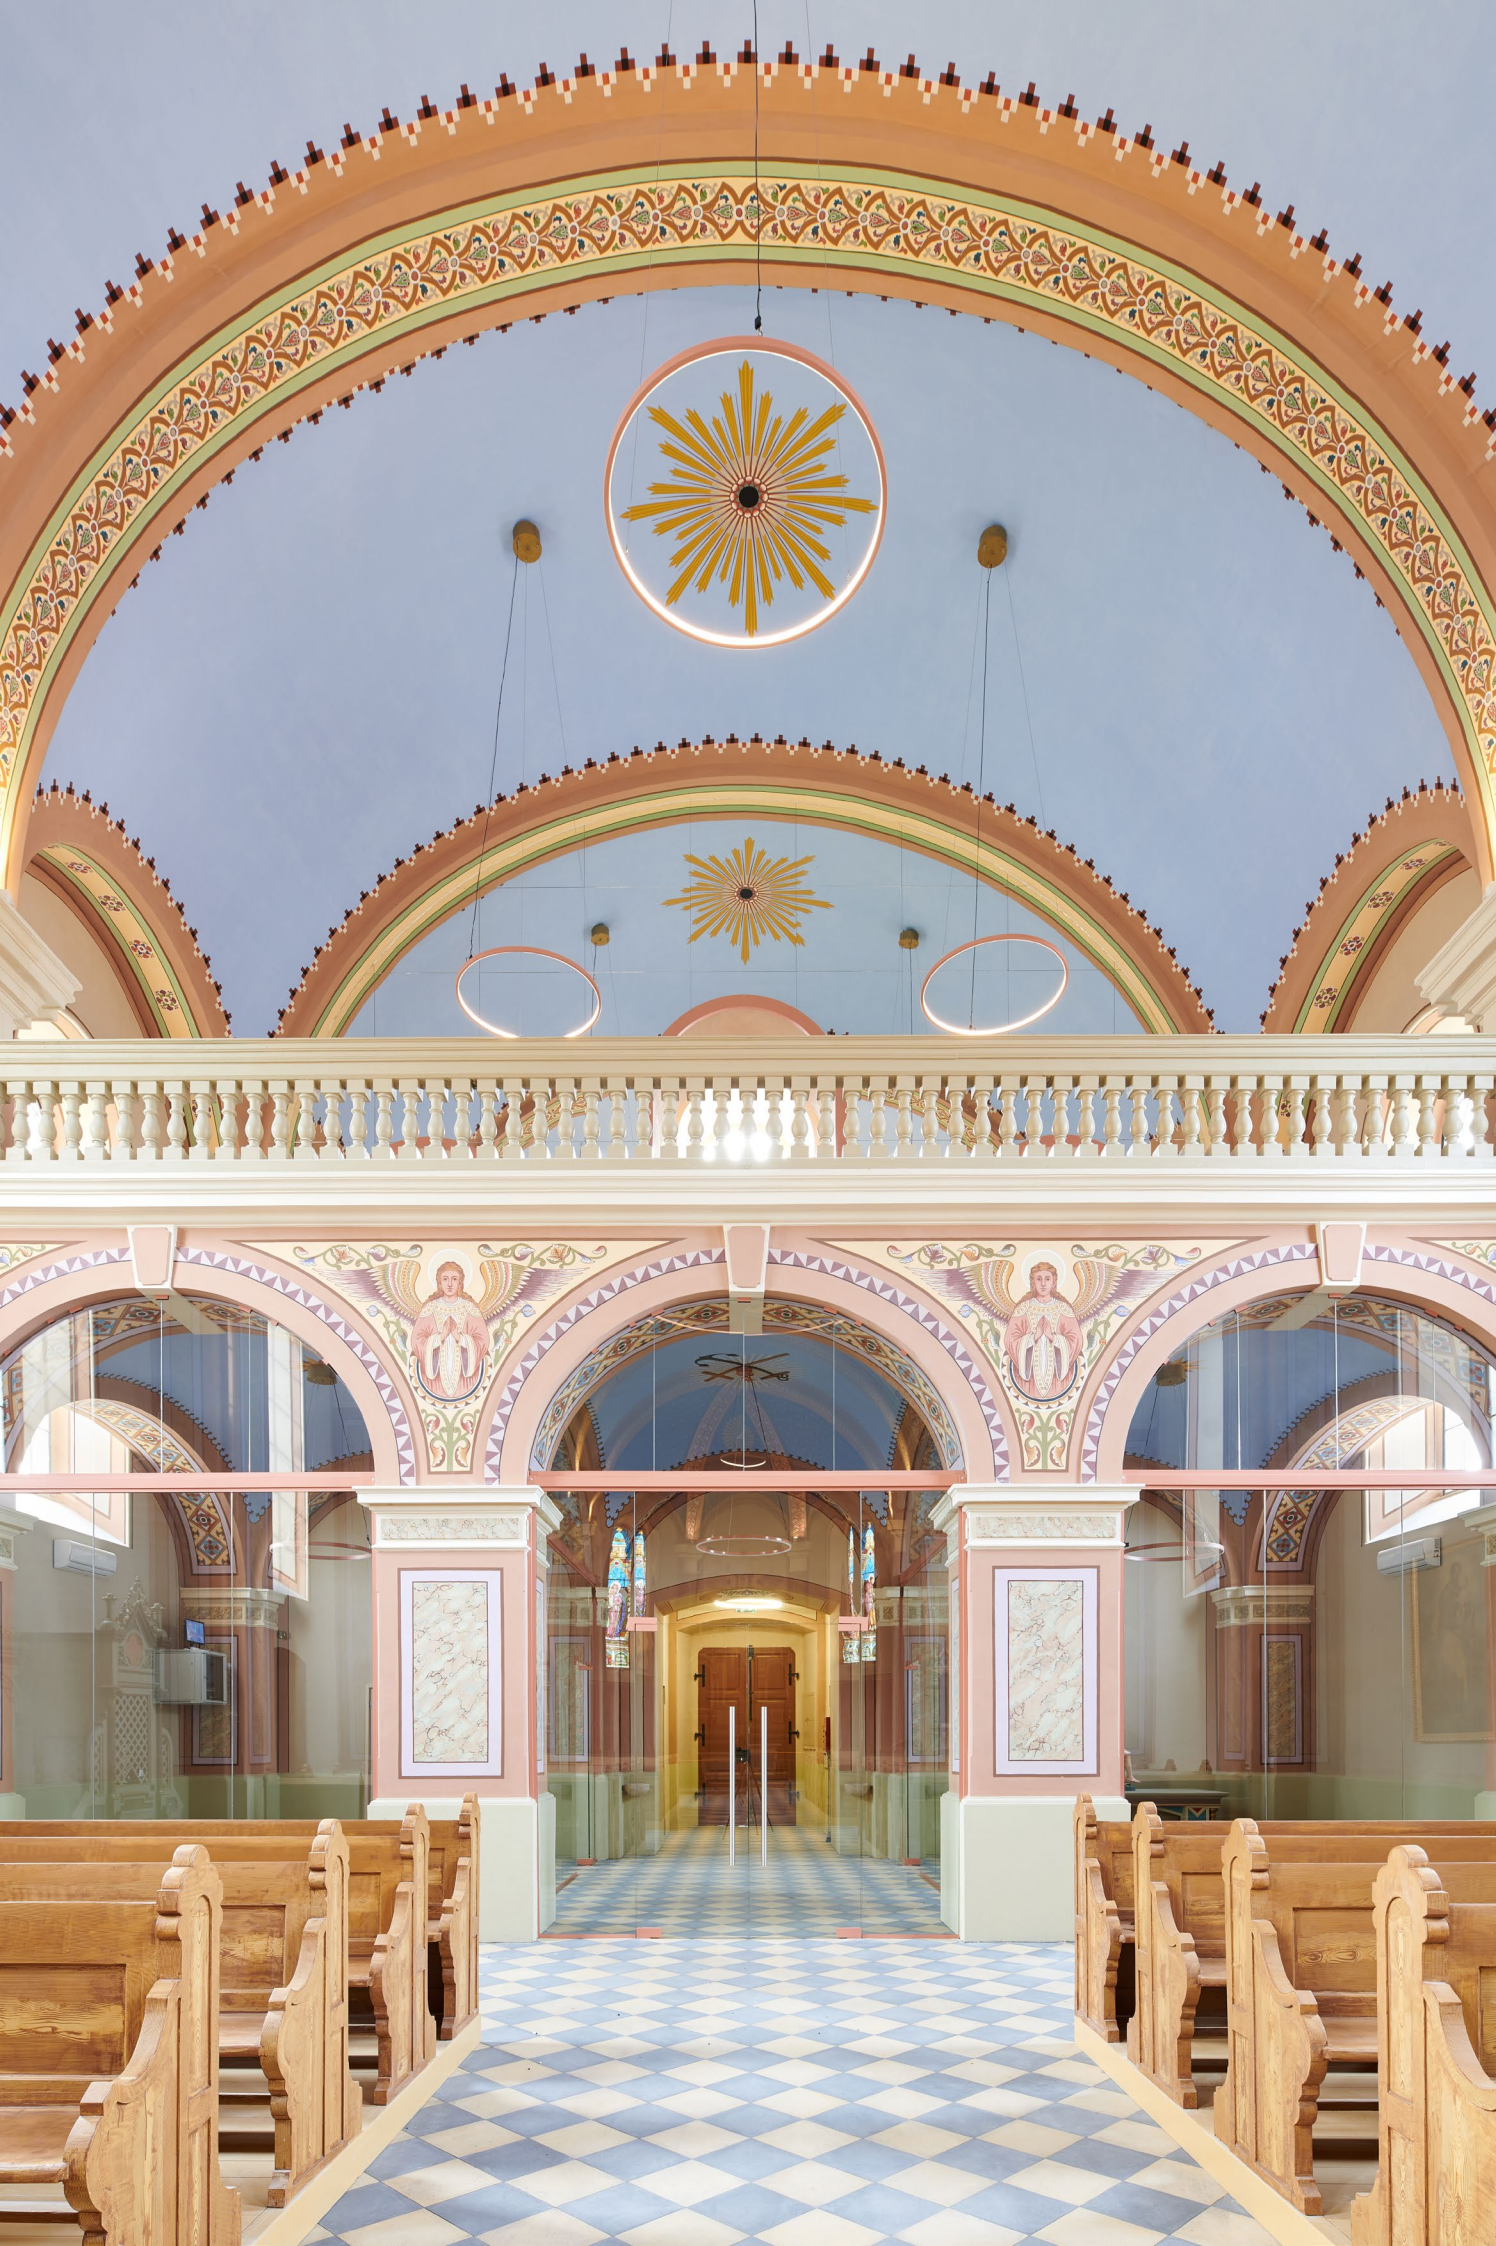
After: View towards the choir gallery

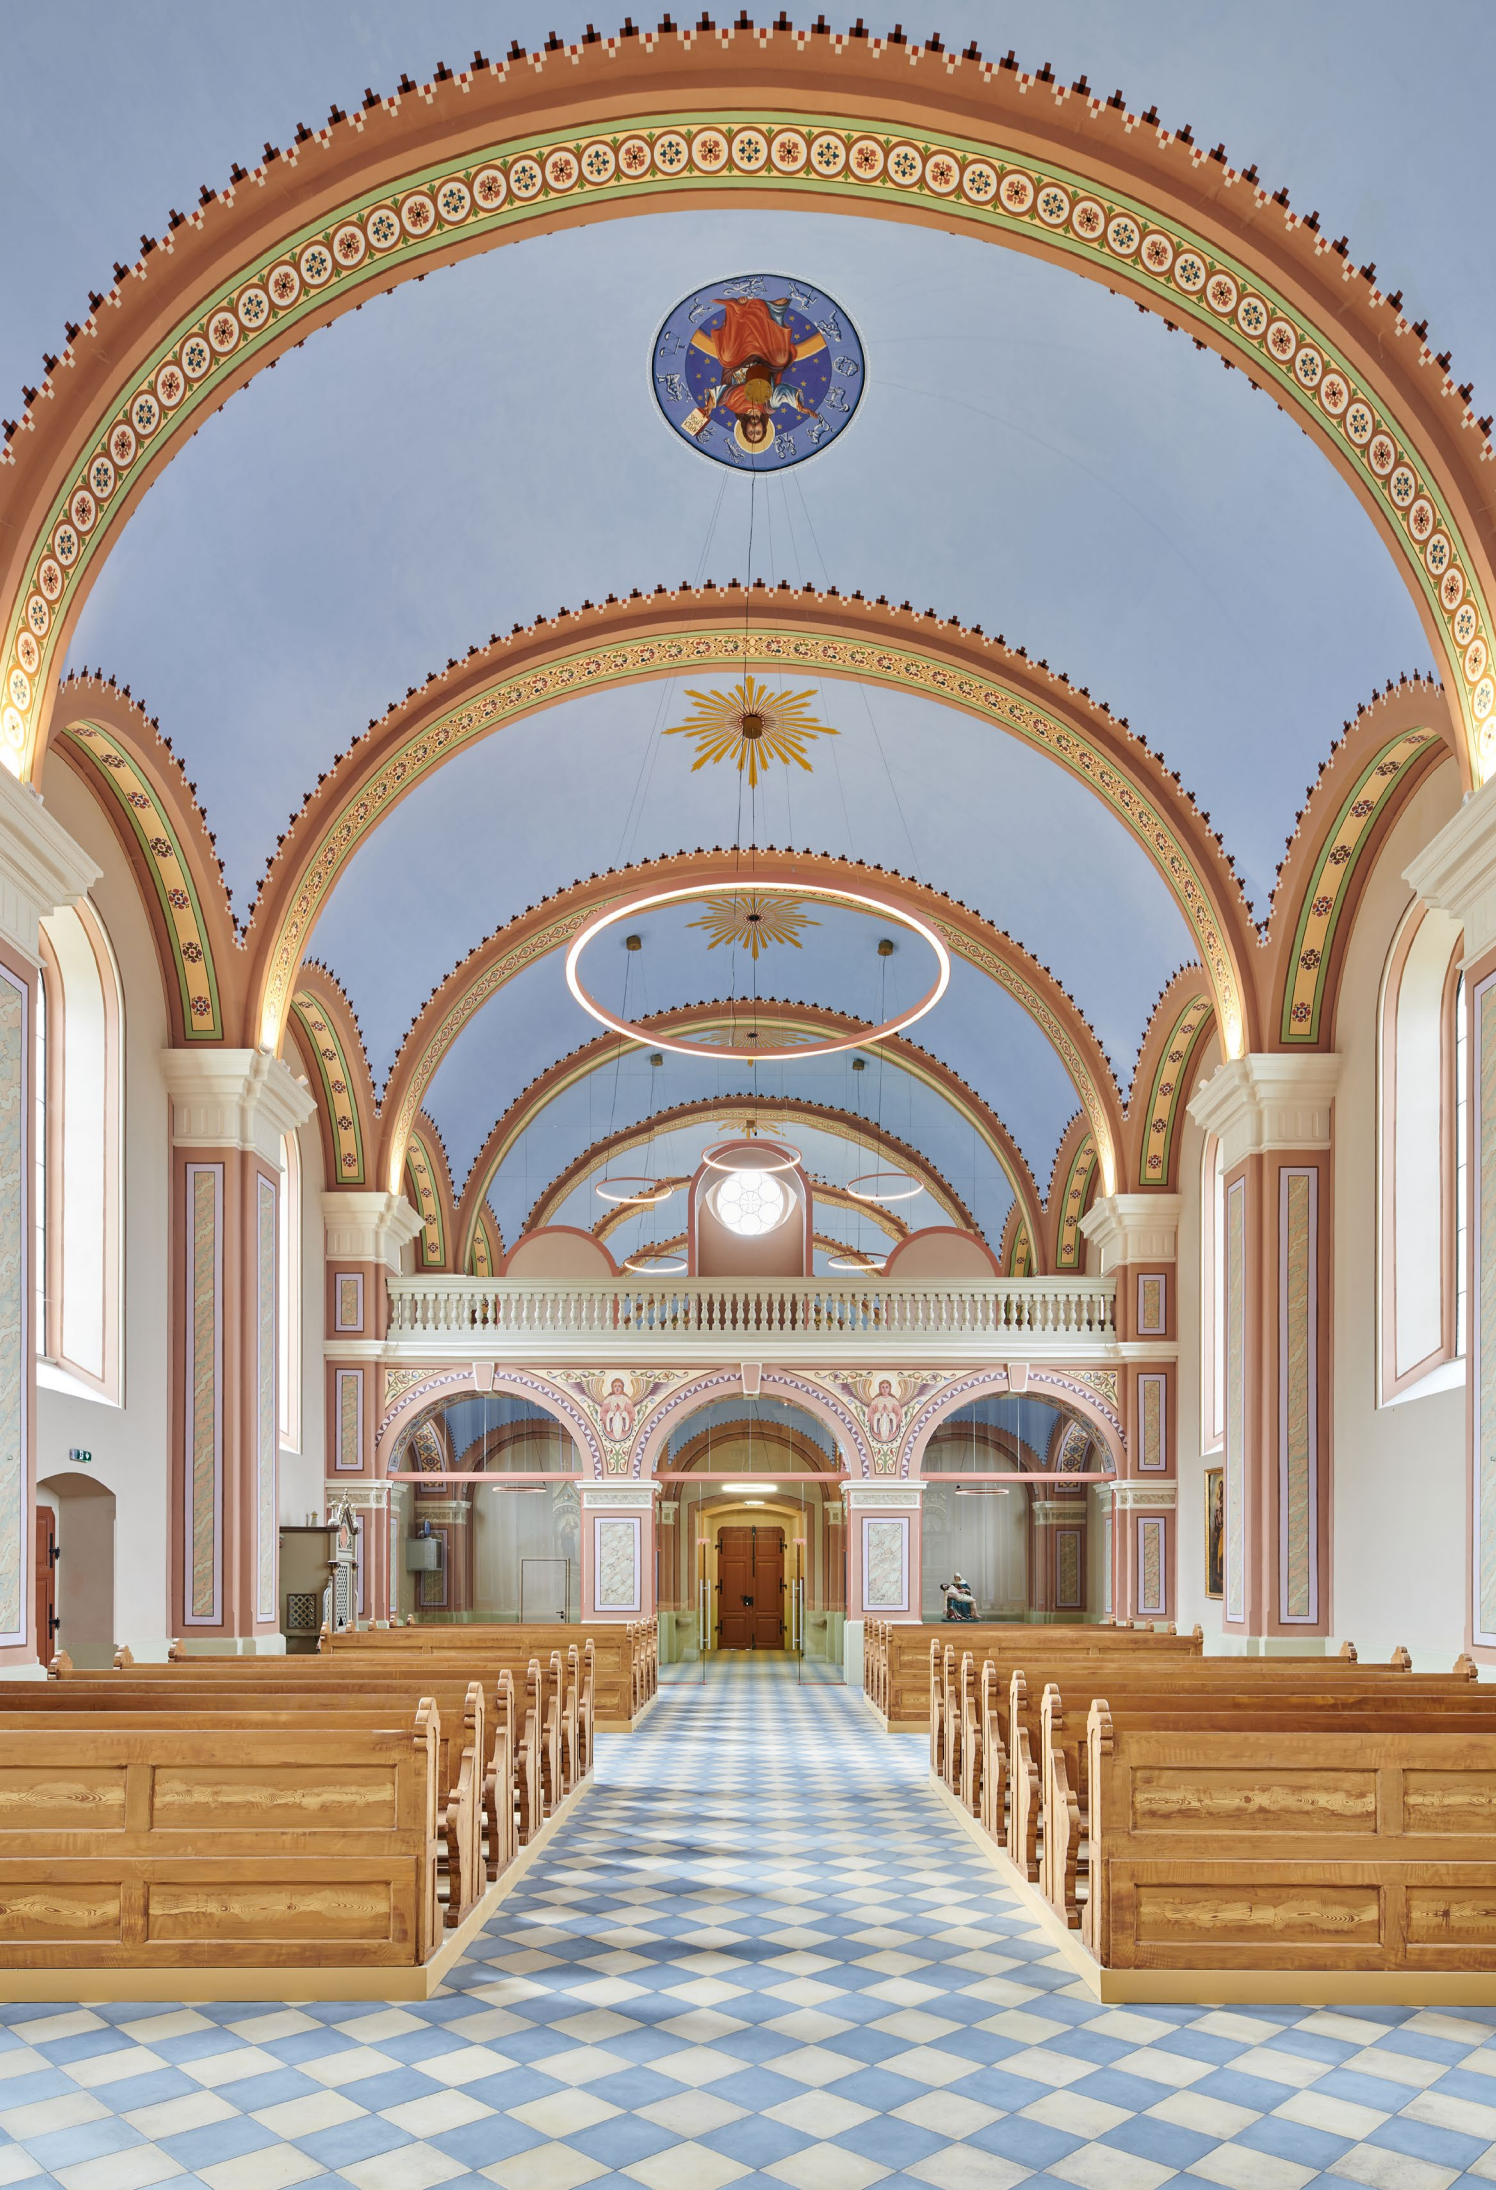
After: View towards the choir gallery

The new interior elements establish a dialogue between the historic fabric and contemporary additions, reinforcing the building's architectural and artistic values without compromising its heritage significance. Their design was guided by the analysis of lost or inadequately replaced historic elements, creating contemporary interventions that respect the original character of the space while remaining distinguishable as additions of the present day.

Where reliable evidence of the original appearance was unavailable, speculative reconstruction was avoided. Instead, contemporary solutions, such as the mirror installation, were introduced as reversible elements, preserving the authenticity of the historic interior while enhancing its spatial experience.

Particular attention was given to the integration of preserved materials with wall finishes (mirror), partitions, metalwork, and lighting, ensuring functional performance while supporting the long-term preservation of the historic structure.

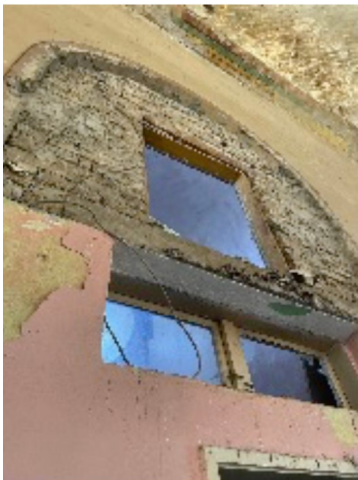
Discovery of arched entrance

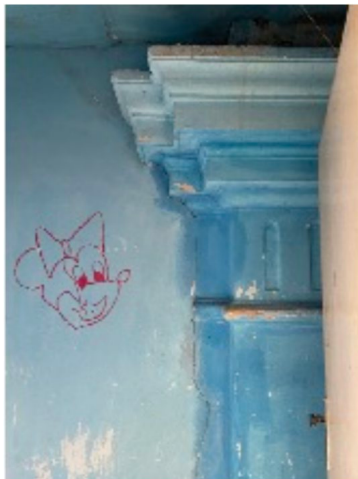
Overpainted decorative elements

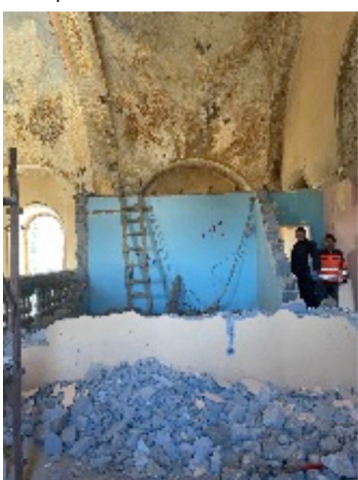
Demolition of inadequate structures

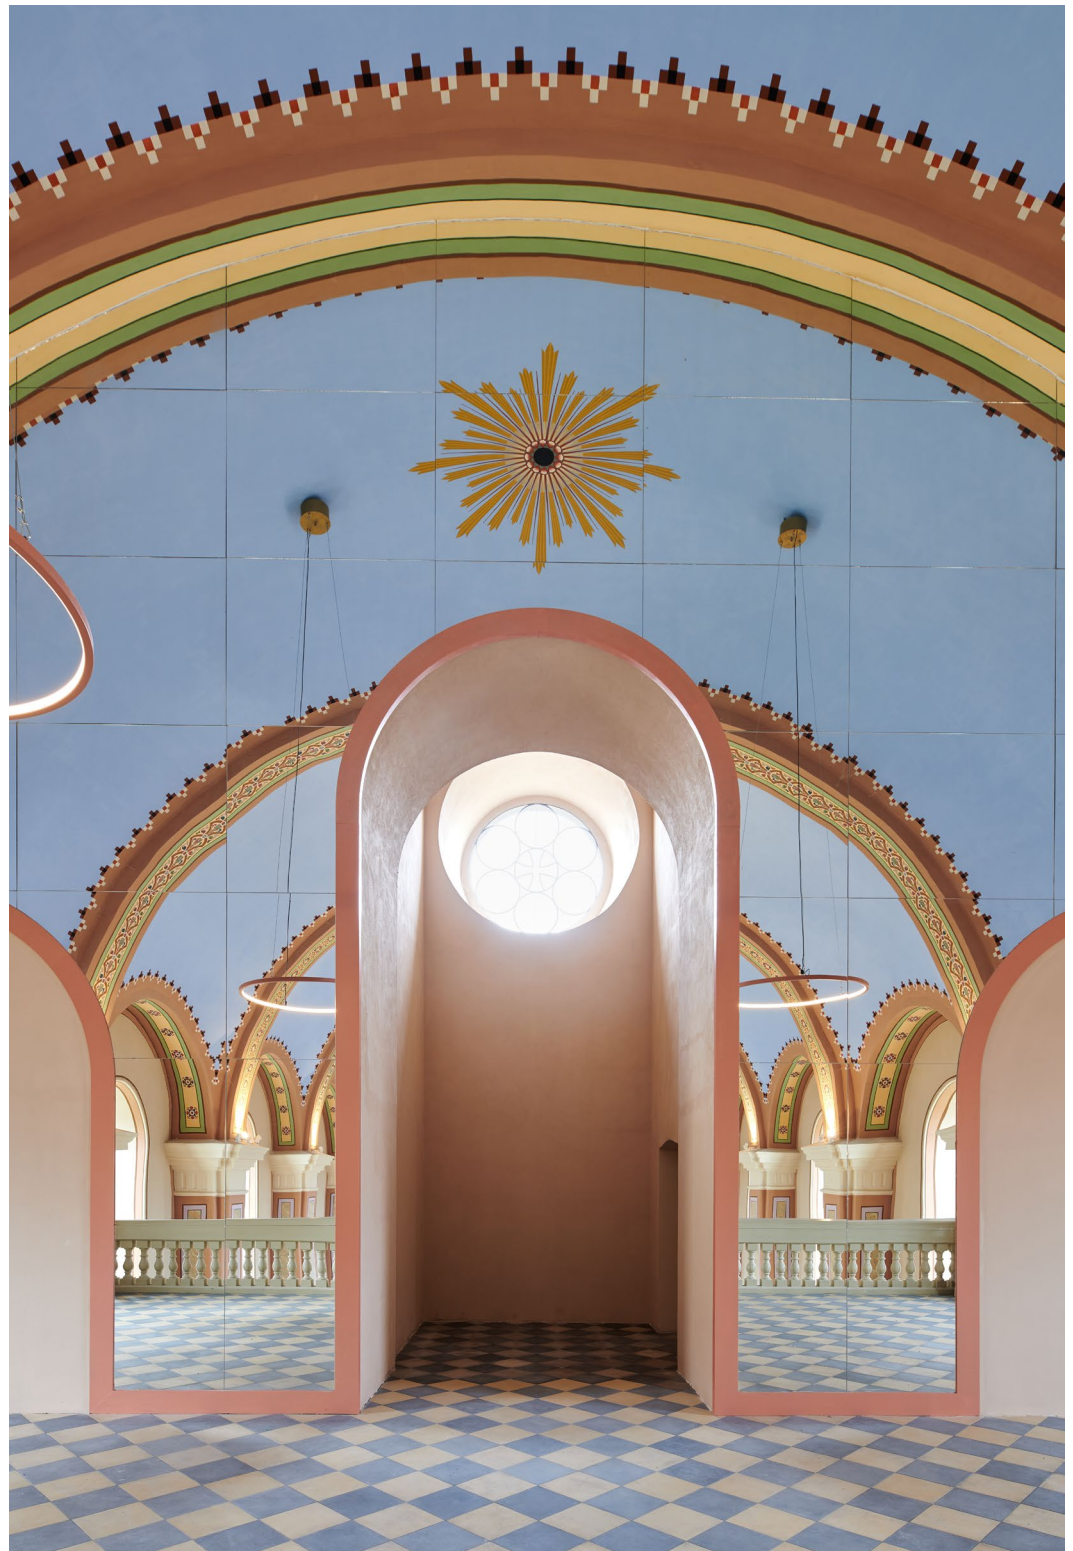
After: The choir gallery - mirror wall

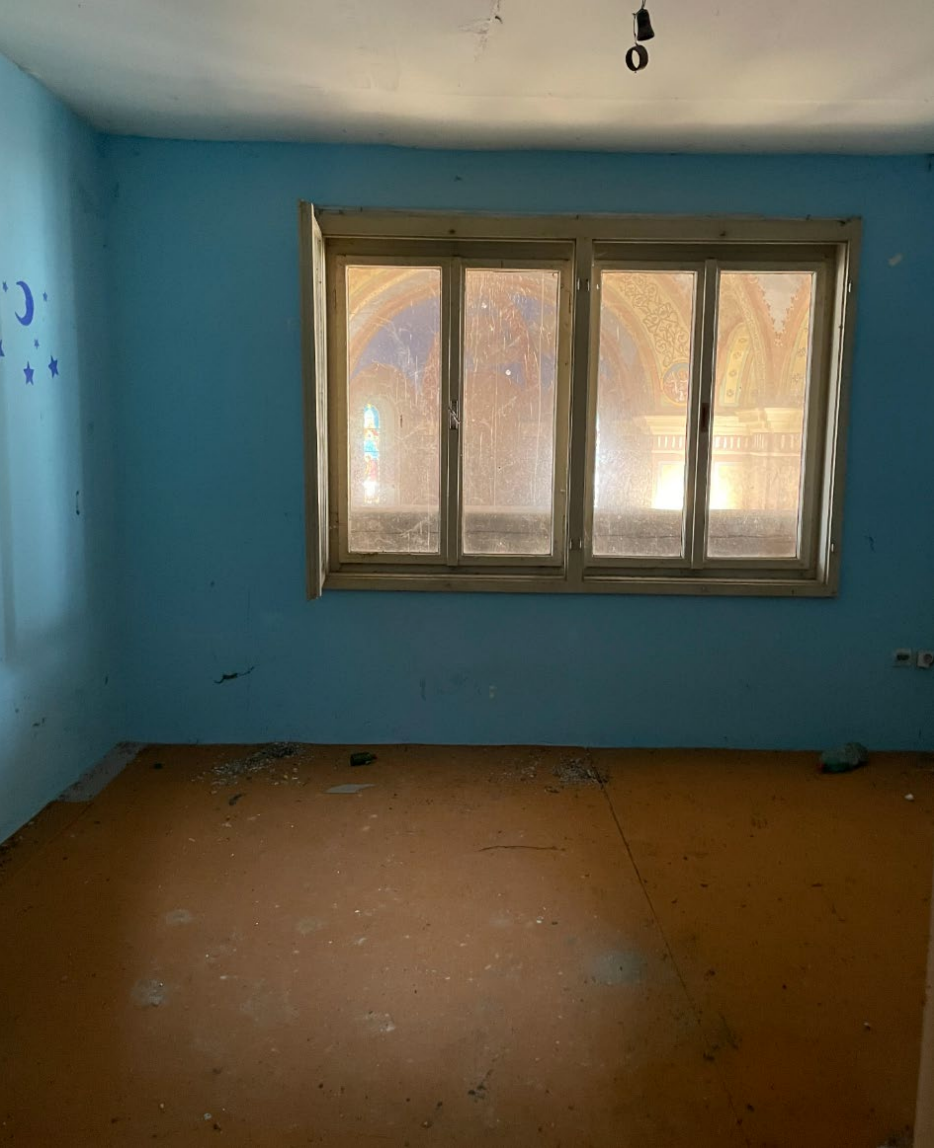
Photo: author  
Before: View from the the choir gallery towards the Altar
