Conservation and Restoration Works on Revitalization  
of Roman Catholic Church of Our Lady of the Snows in Žabalj

## *Recovering authenticity through evidence-based restoration and contemporary interpretation*

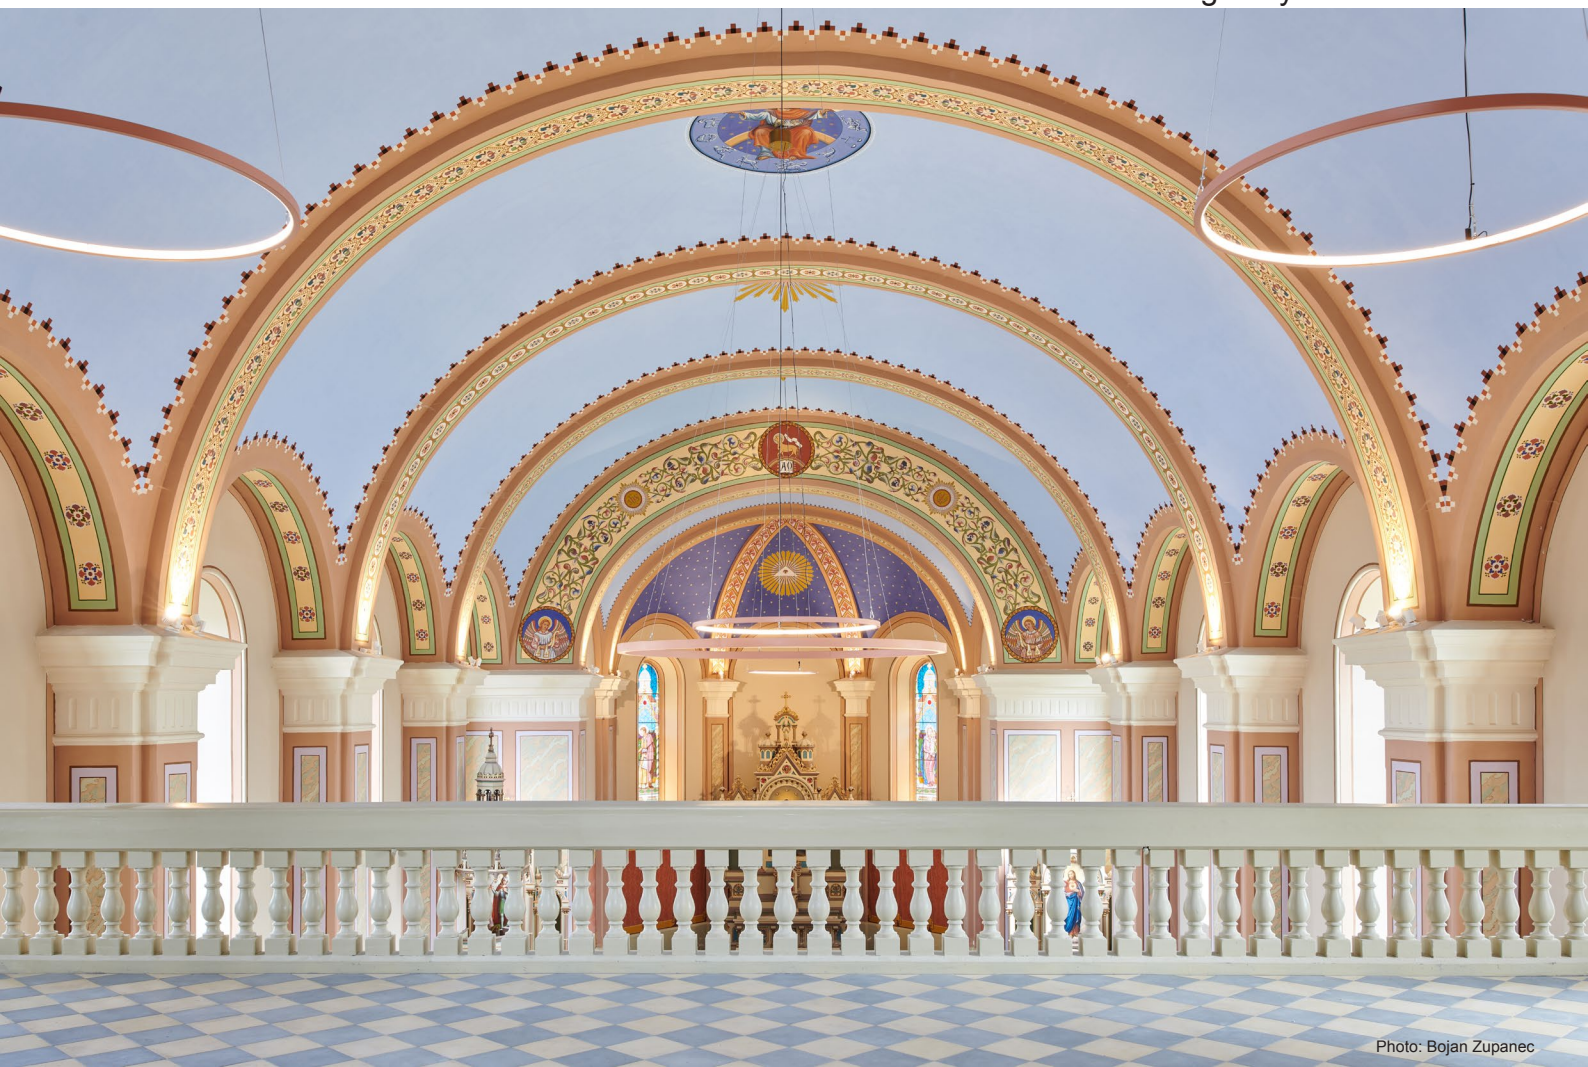
After: View from the the choir gallery towards the Altar

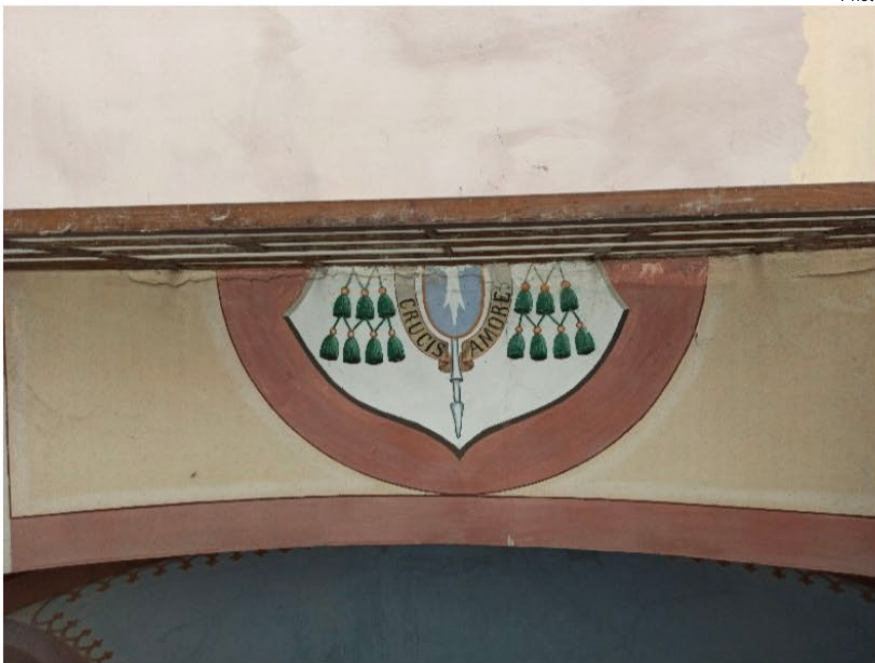
Before: Half of medallion

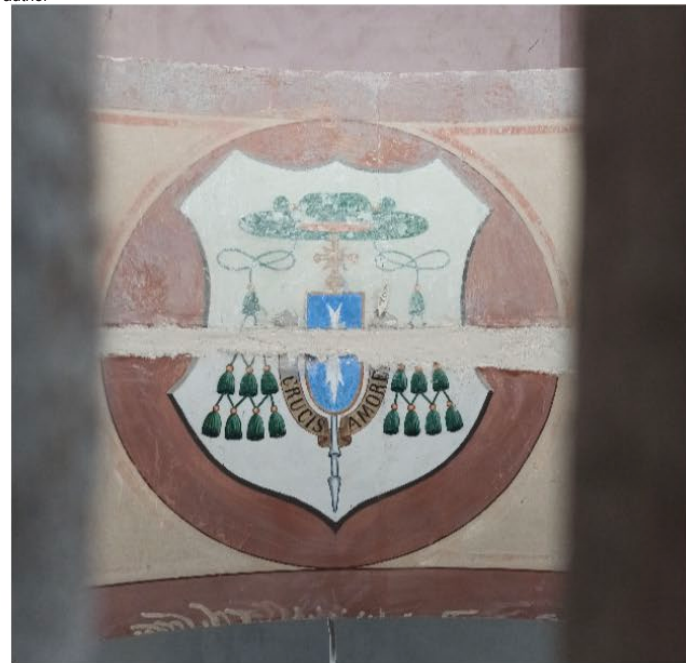
During: Discovery of the other half of medallion

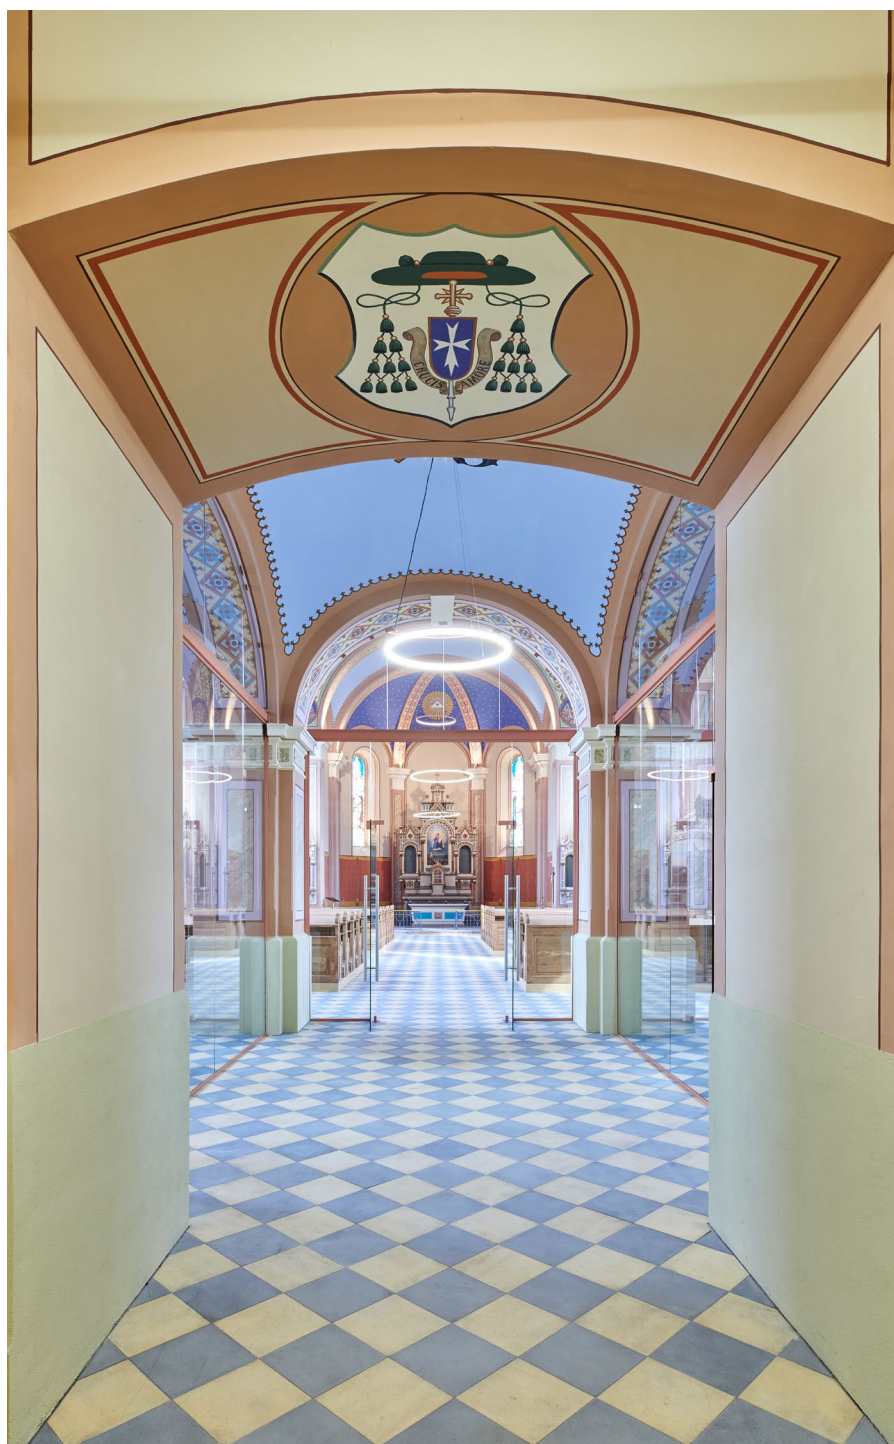
After: Entrance and restored and conserved medallion

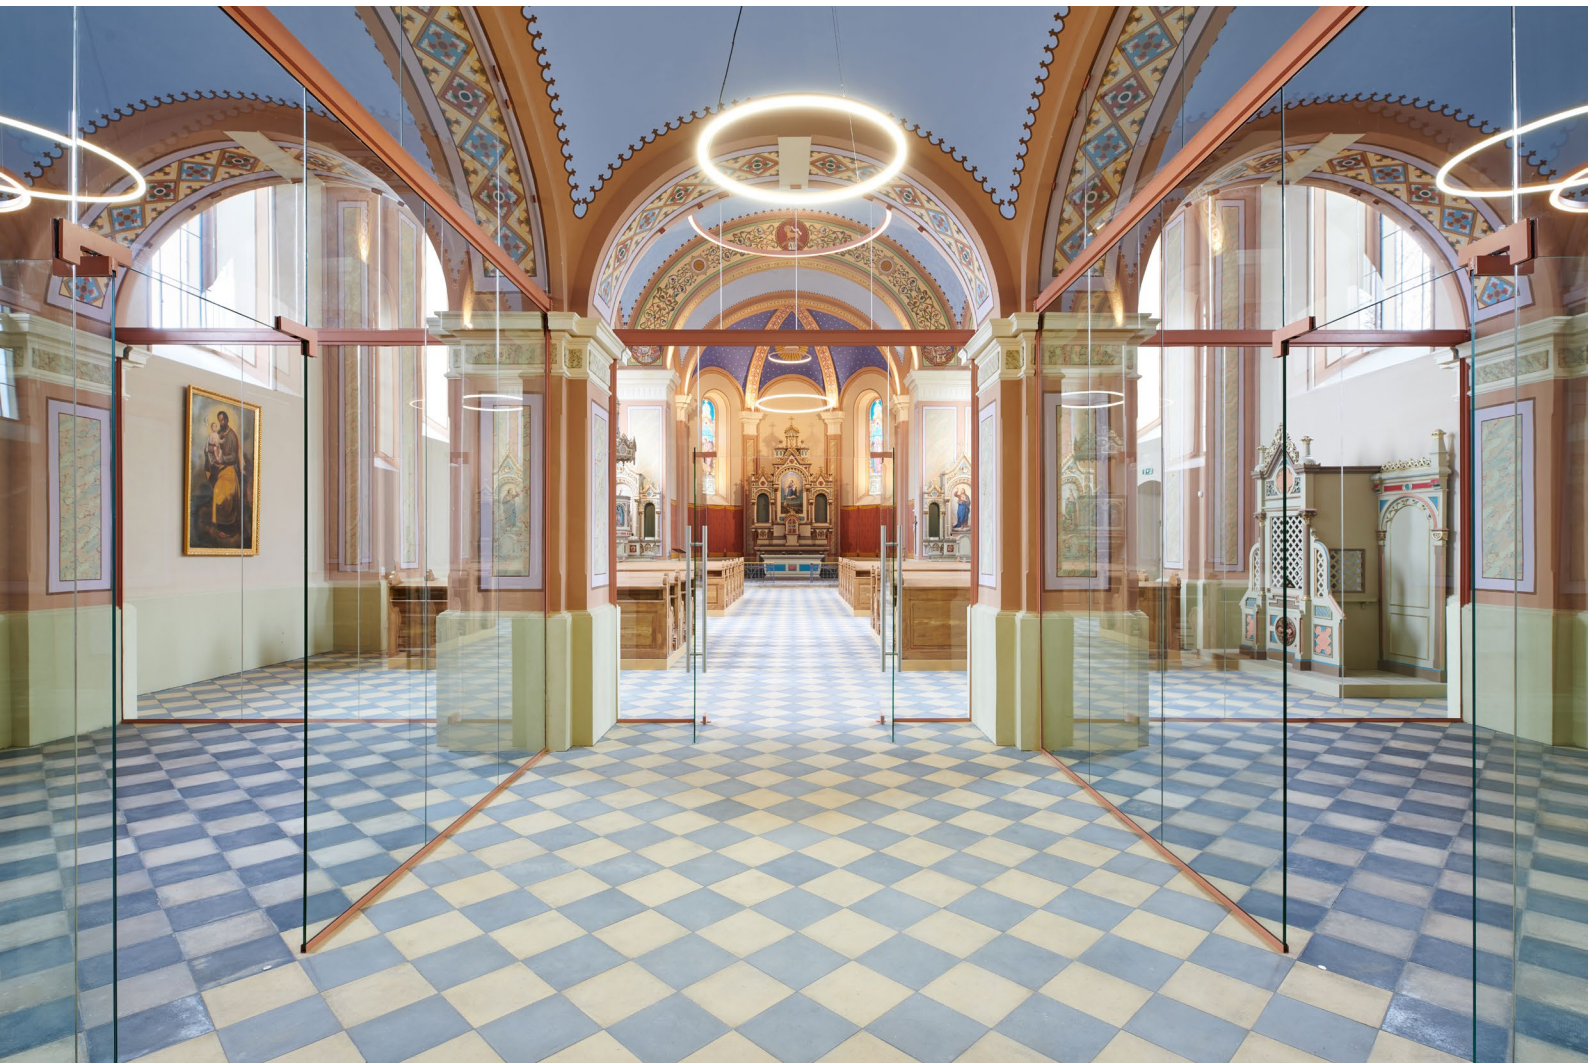
After: Entrance view showing the seamless integration of preserved original floor tiles with newly fabricated elements based on the original pattern.
