# UGRON CASTLE

Cristuru Secuiesc, Harghita country, Romania

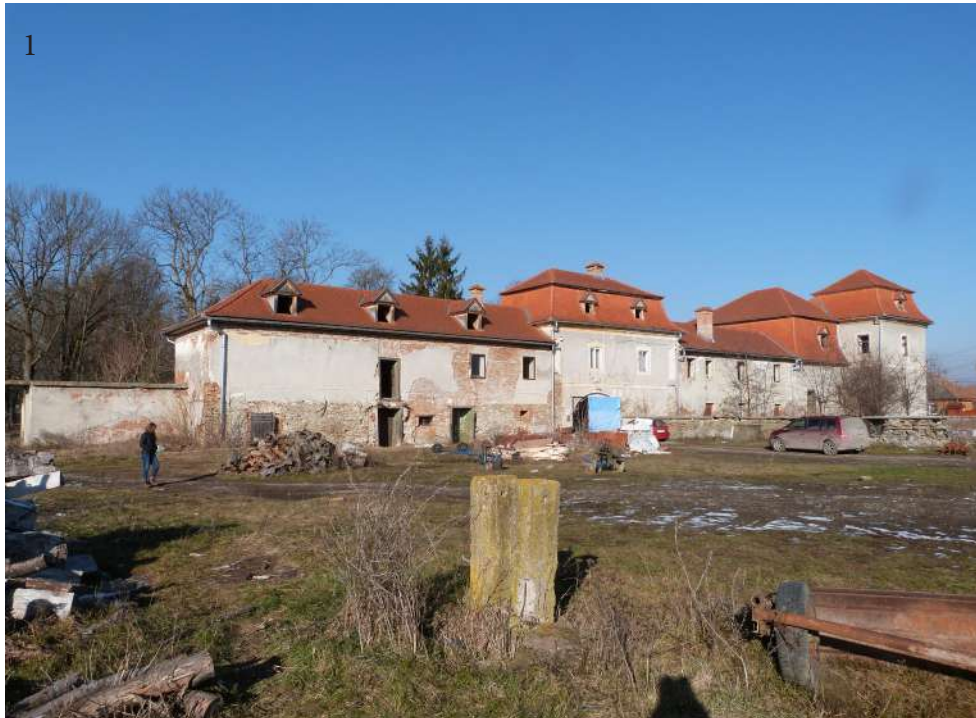
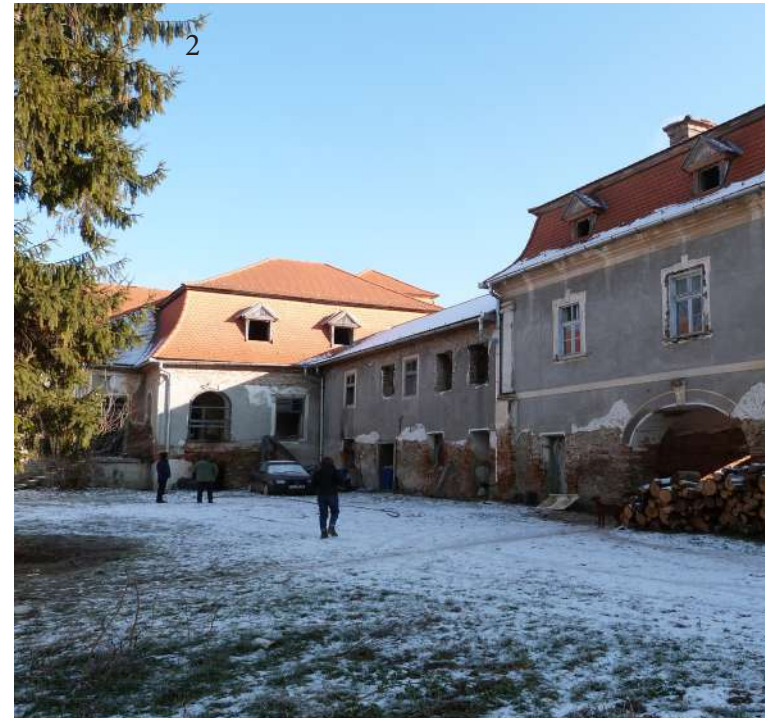
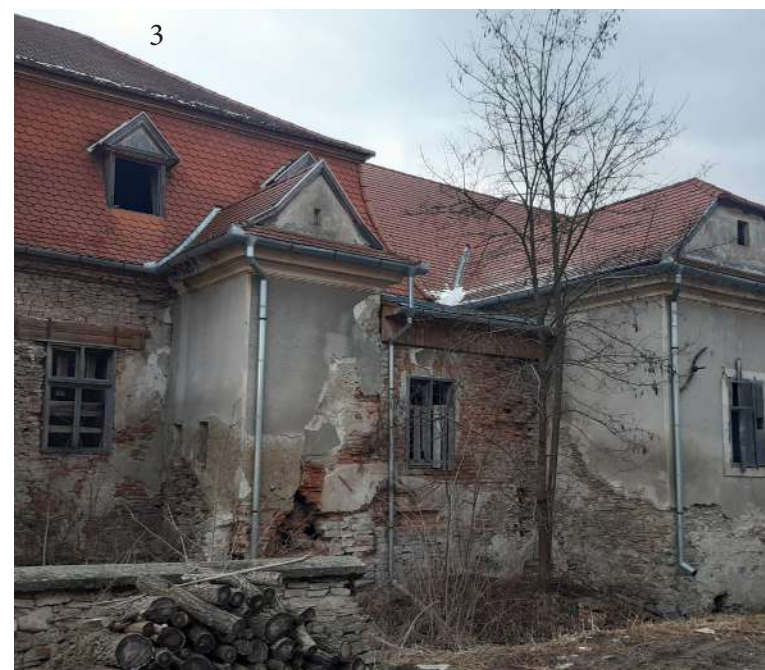
Before restoration, the Ugron Castle complex stood in a severely deteriorated condition, with critical structural instability, damaged architectural elements, and extensive material decay. Despite its poor state, the estate preserved exceptional historical value through its castle, gate tower, granary, gardens, and surviving connections between the residential and agricultural areas.

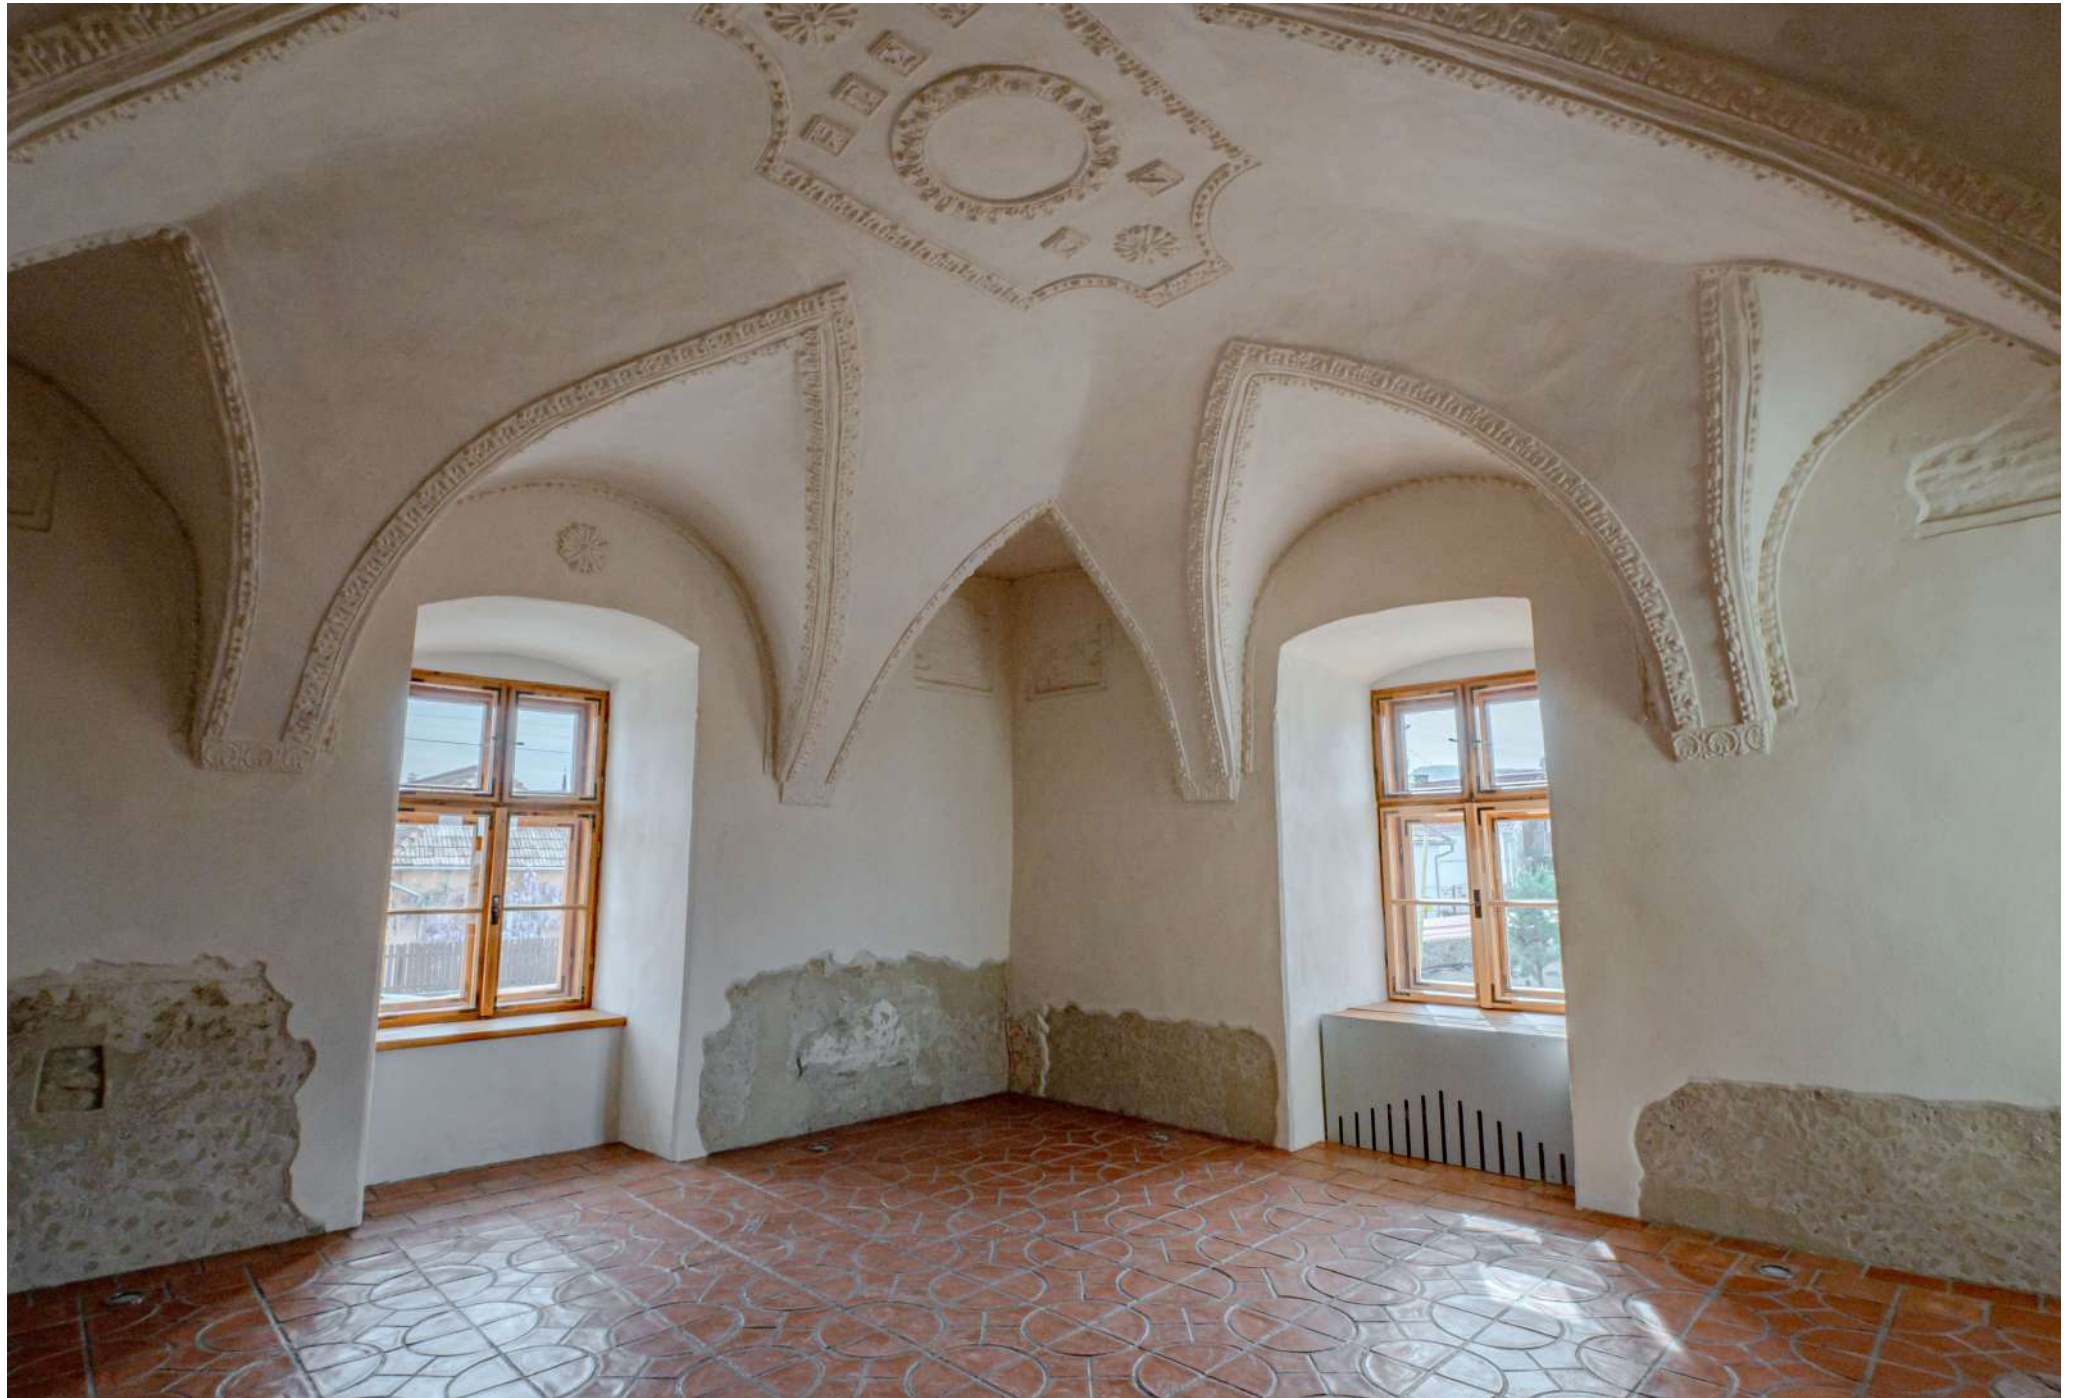
The reception acts as the central transition space of the castle. From here, visitors enter the ecumenical chapel on one side and the main event hall on the other. The entrance to the hall was designed following the proportions and composition of the Renaissance stone door fragments discovered during the archaeological investigations, creating a contemporary interpretation rooted in the original fabric.

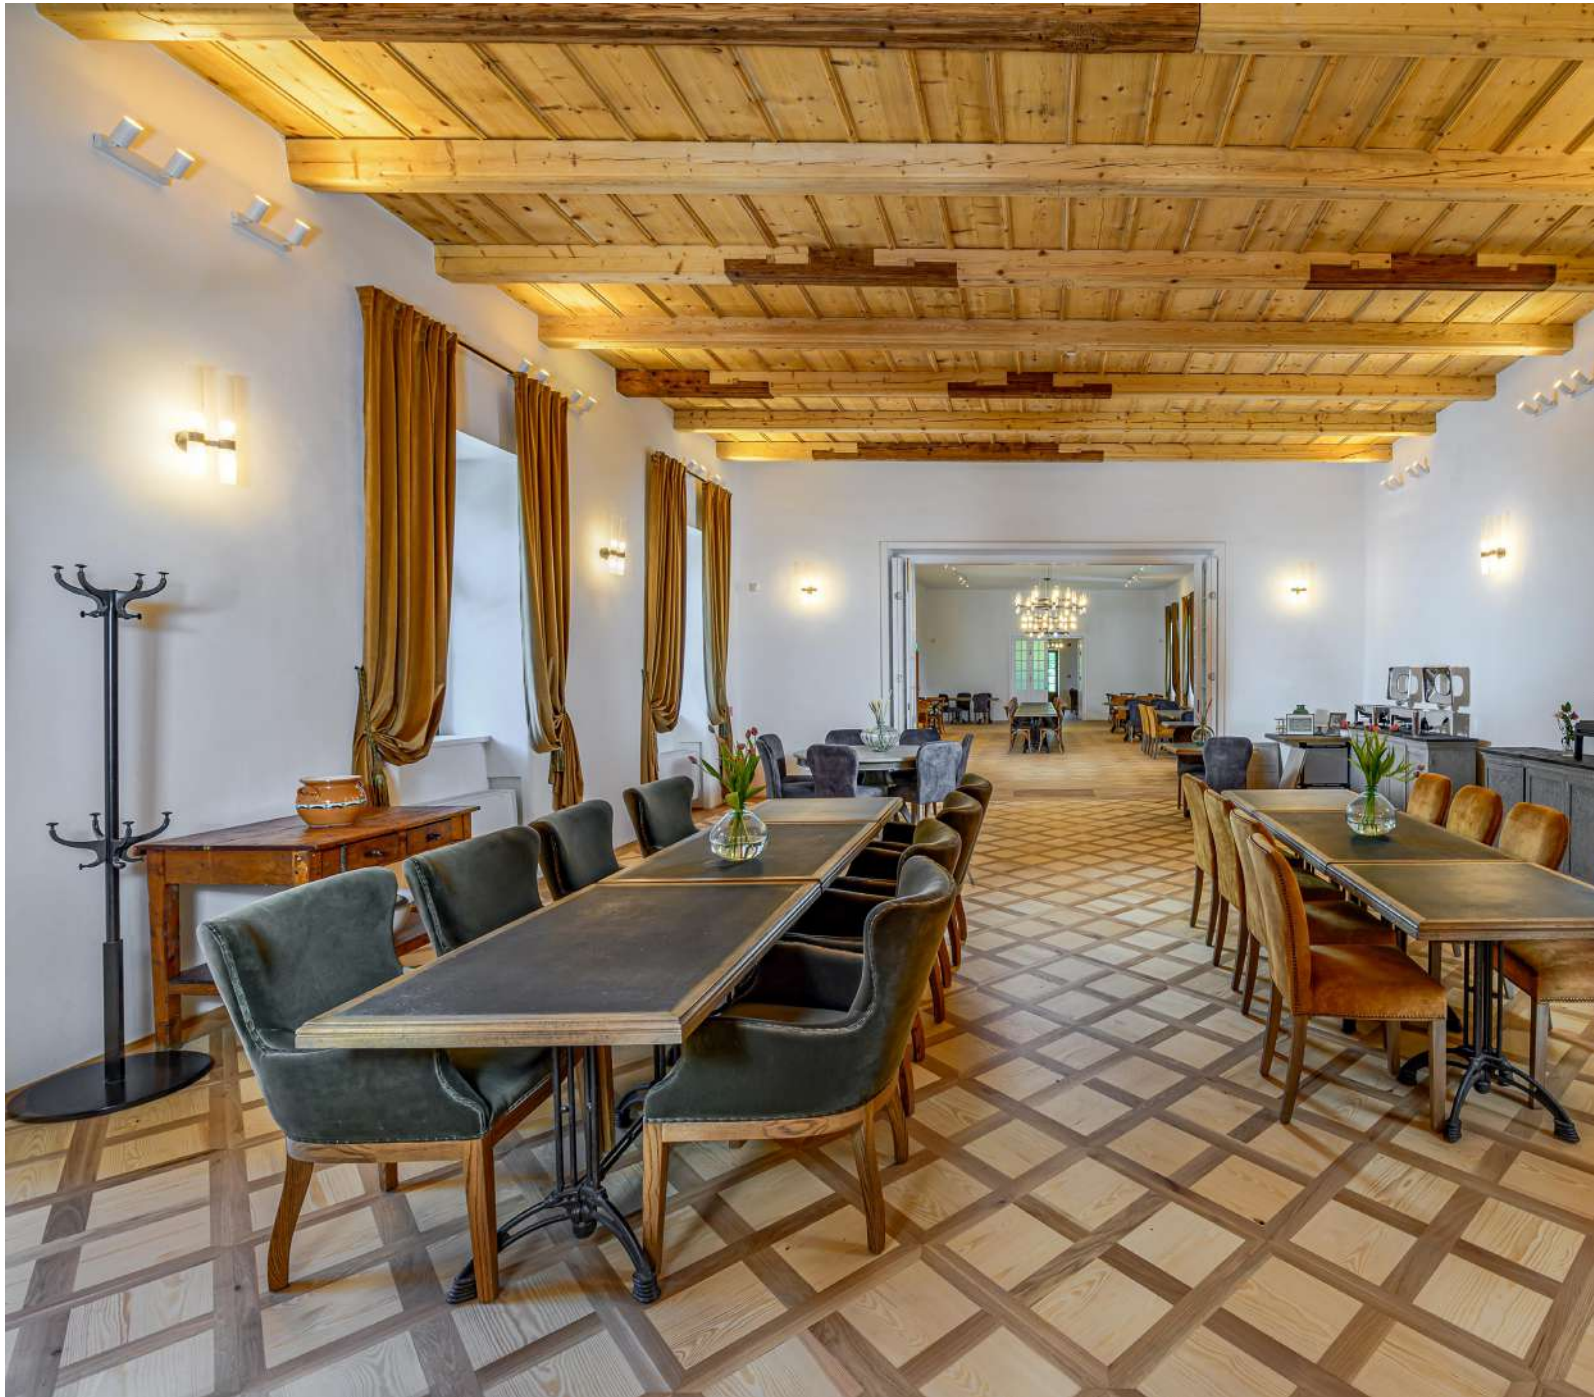
The sequence of representative rooms can be opened into one continuous event space. In the main palace hall, the original Baroque parquet floor was reconstructed, while a preserved section of the authentic flooring remains in situ as a witness of the historic fabric. In the adjoining halls, the parquet pattern subtly references the original design, creating continuity throughout the interconnected spaces.

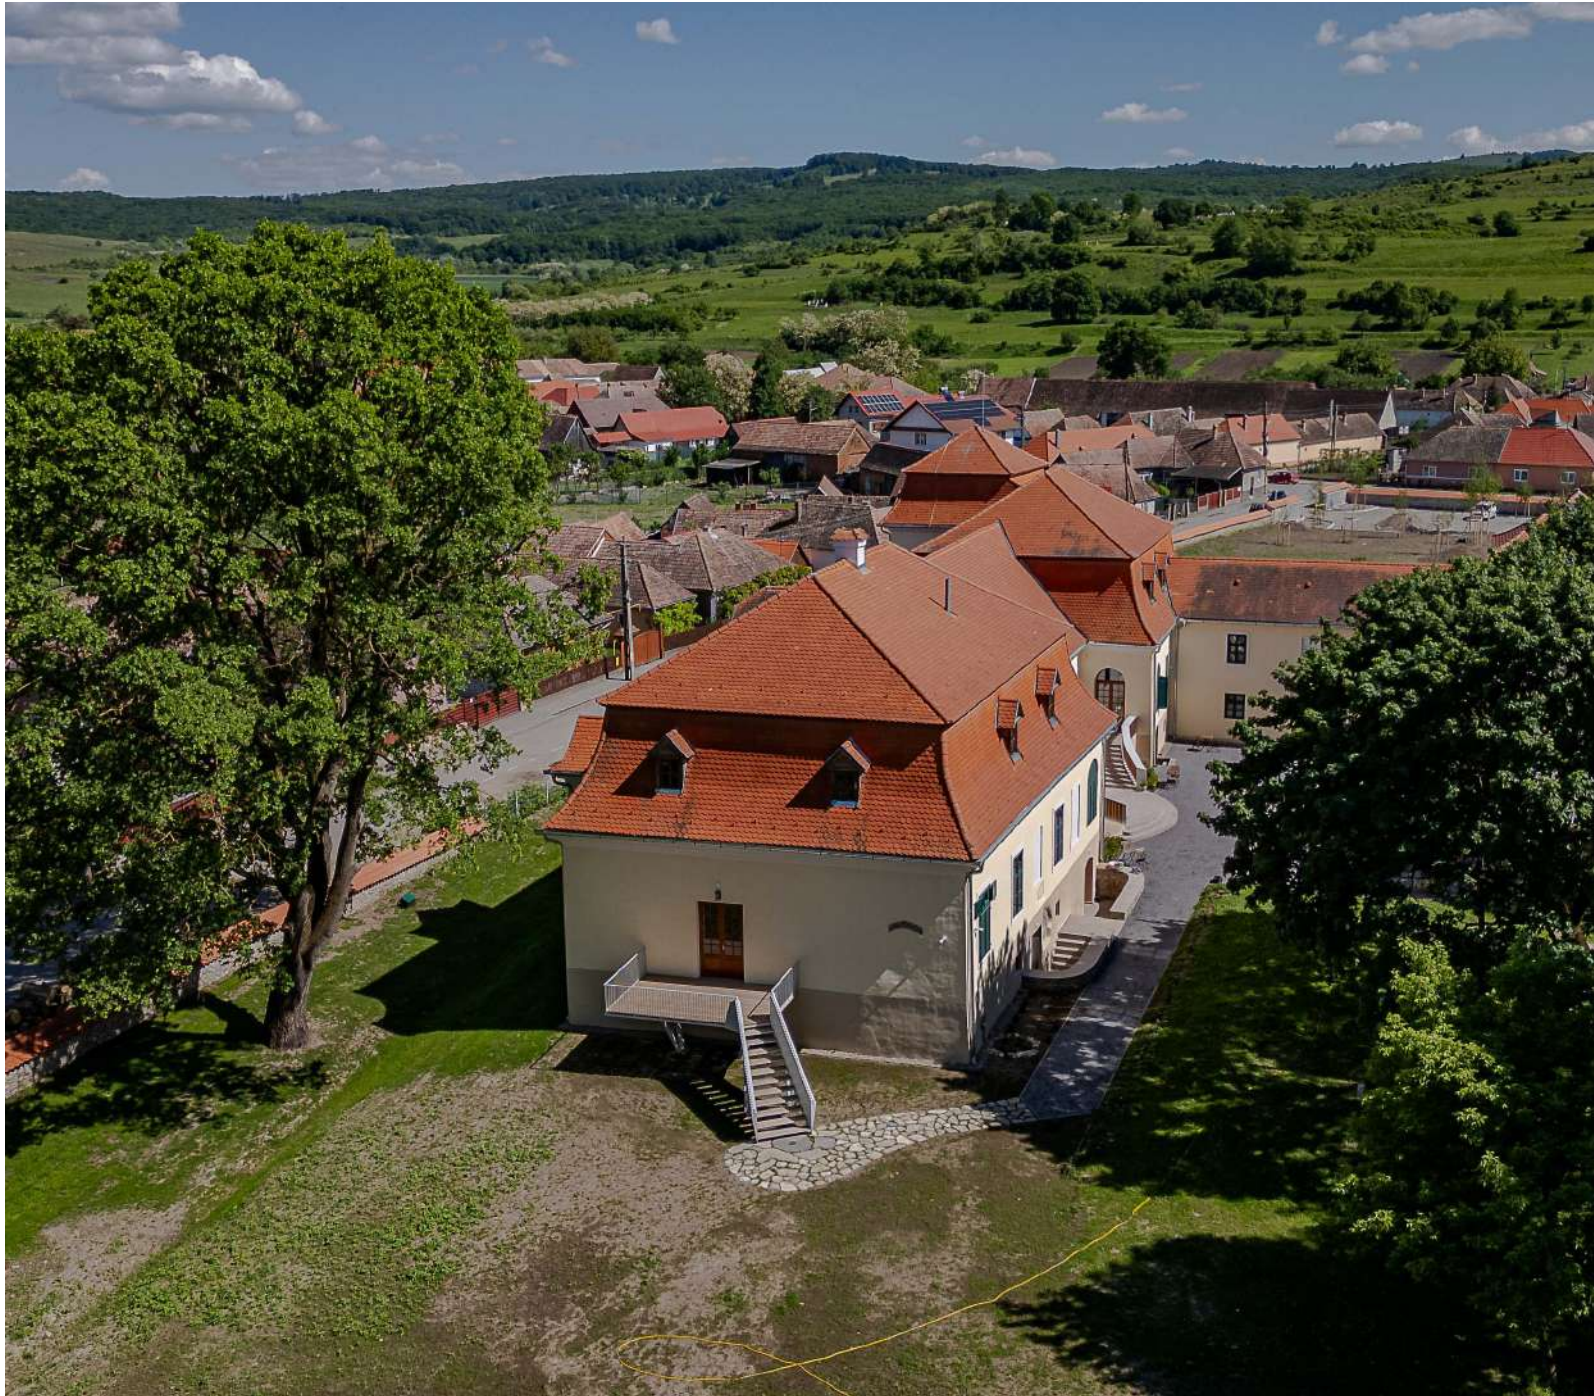
The original design proposed a terraced staircase with a substantial foundation. During excavation, previously unknown archaeological remains were discovered beneath the planned structure. As there was insufficient time and budget for a full archaeological investigation within this phase, the remains were documented, conserved and reburied. The staircase was subsequently redesigned with a modified structural system that avoids disturbing the buried remains while ensuring structural stability.
