# REHABILITATION OF THE ROMANO-CATHOLIC PARISH HOUSE

The Roman Catholic parish building was built in 1867, in Gyergyószárhegy.

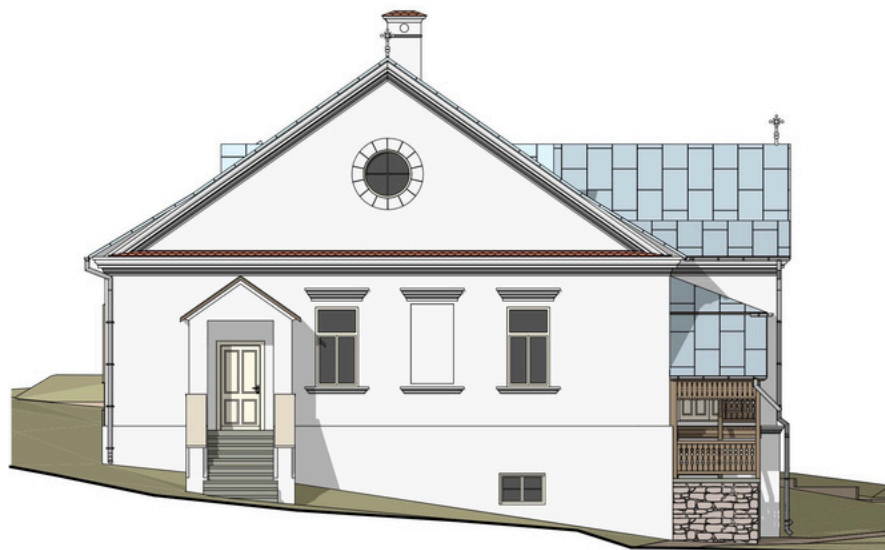
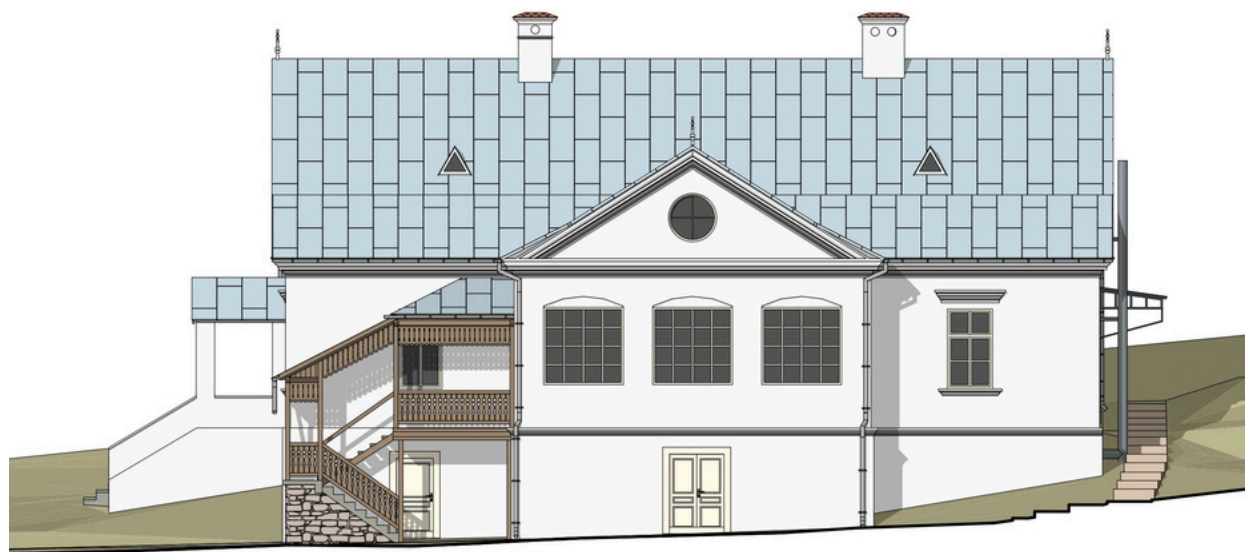
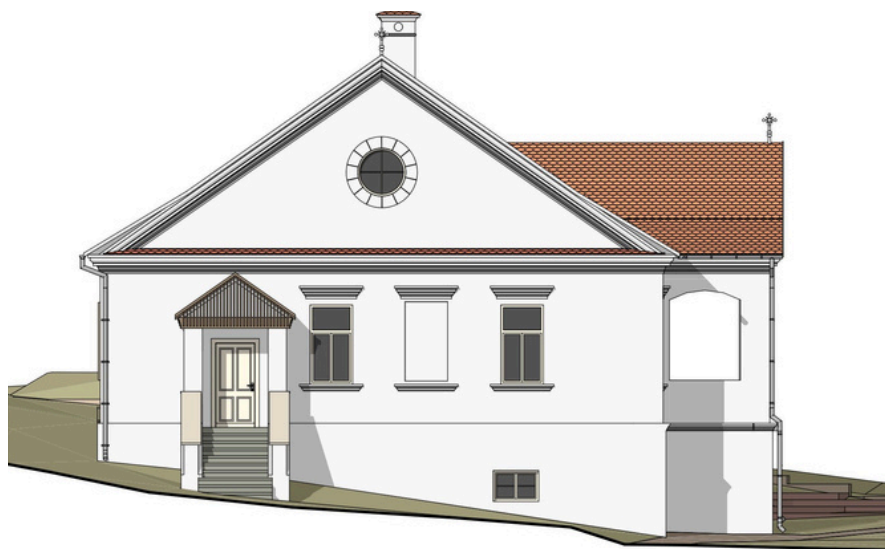
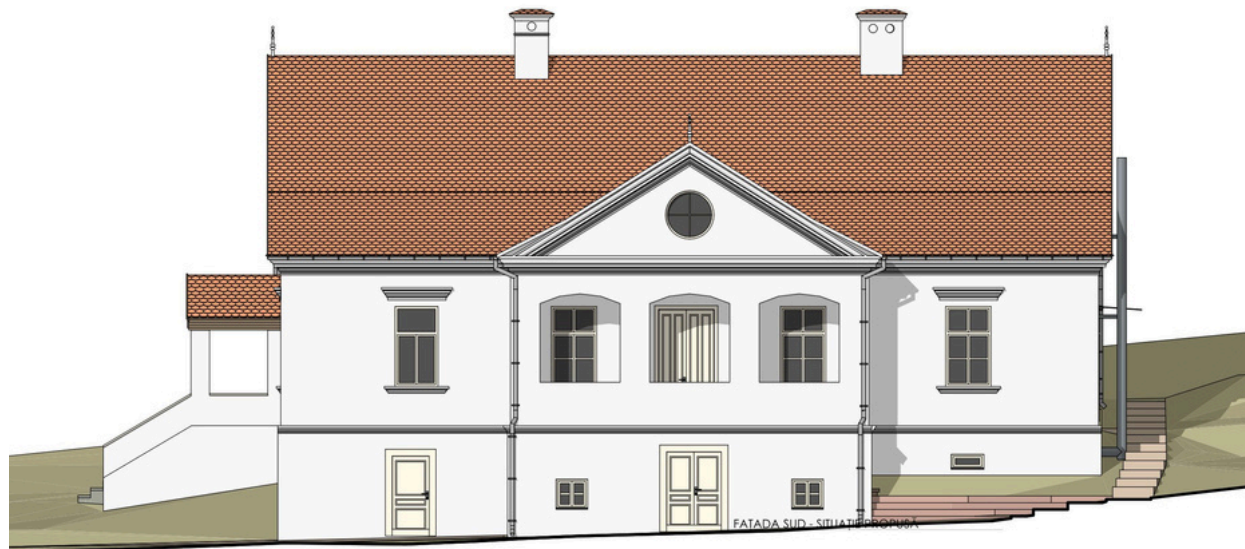
1:250

The parasitic staircase was removed, the loggia was reopened by removing the carpentry, the original access through the loggia was restored, the window from the back area was reopened.

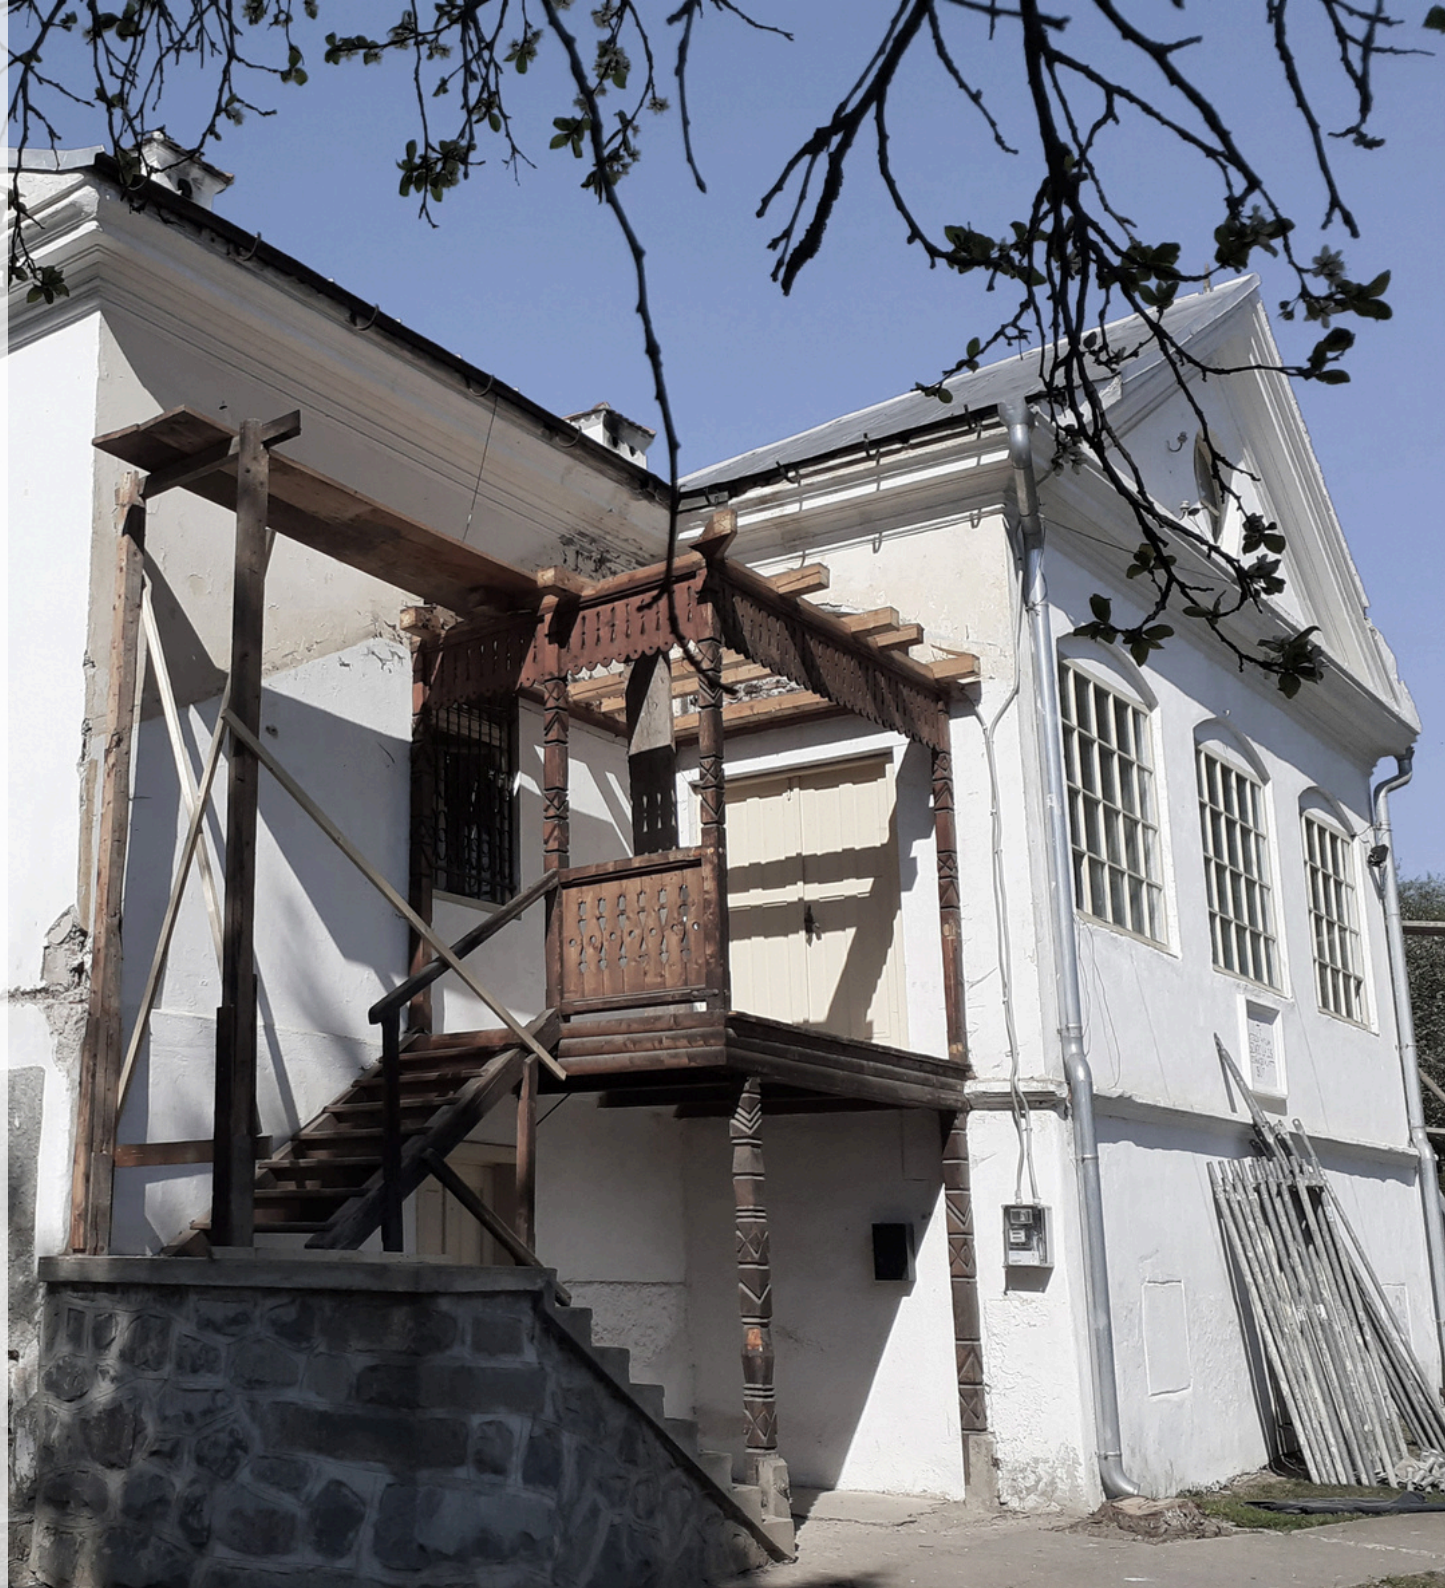
The loggia was closed with a row of windows.

The building was returned to its original form,  
with almost complete preservation of the historical substance.

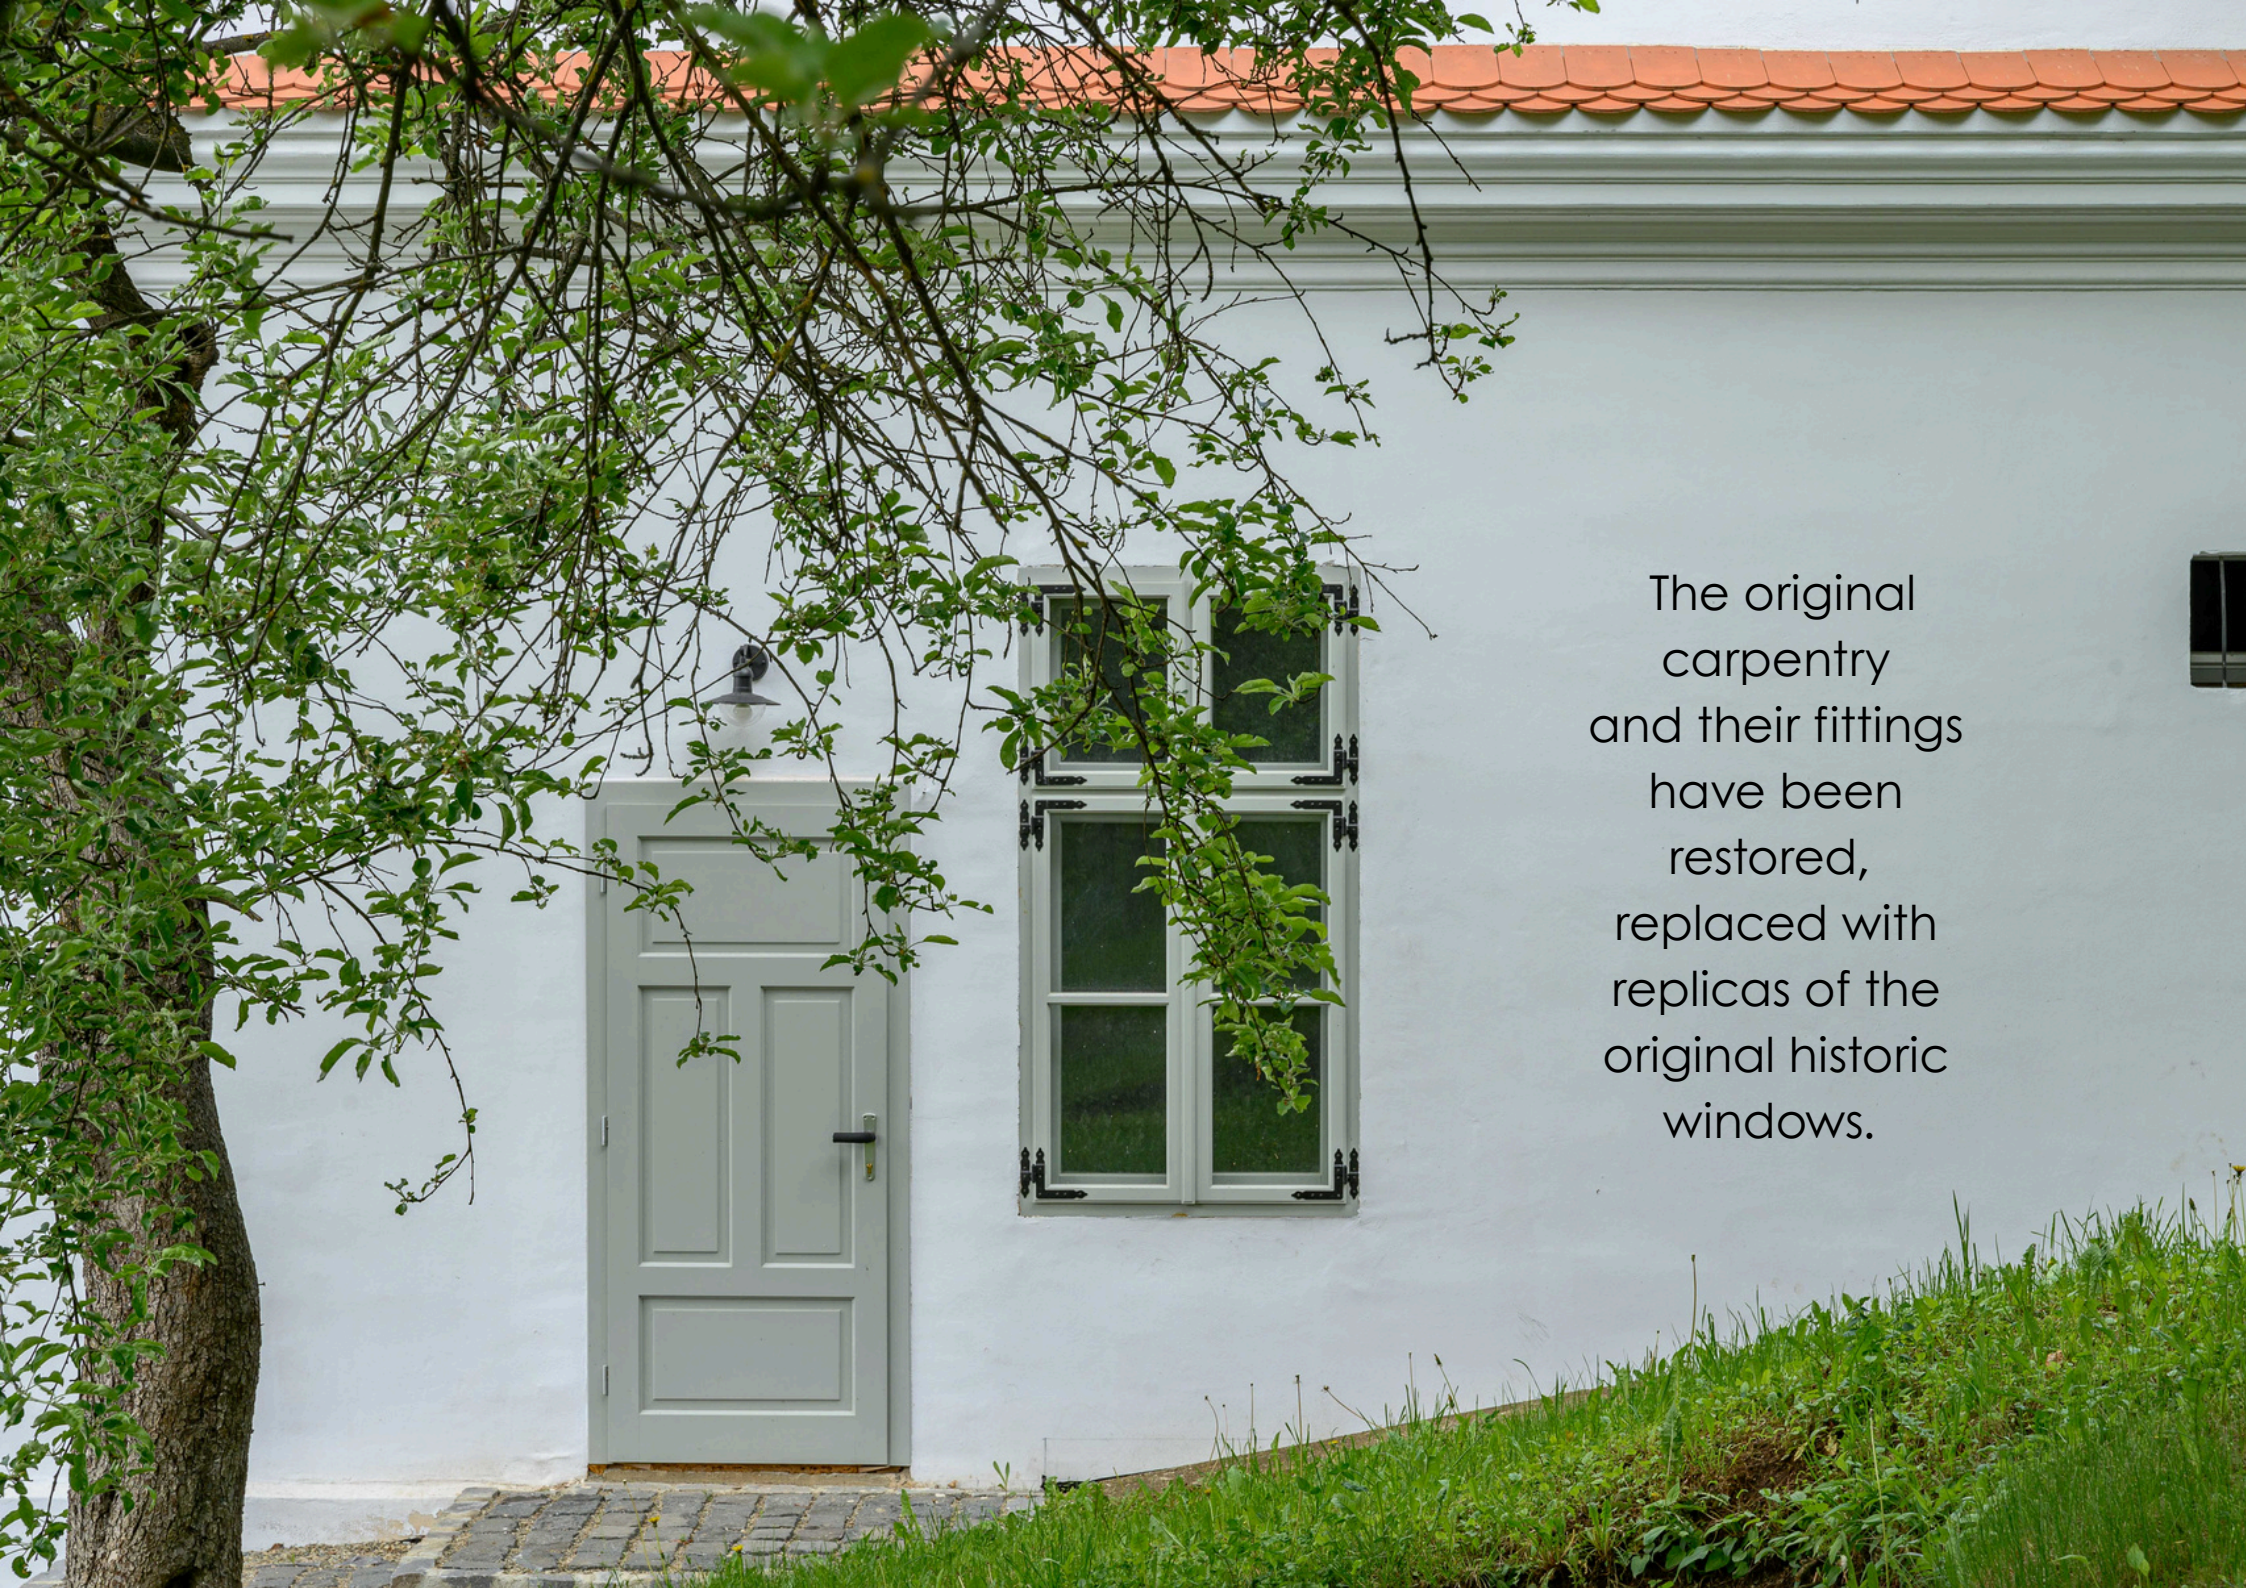
The original  
carpentry  
and their fittings  
have been  
restored,  
replaced with  
replicas of the  
original historic  
windows.

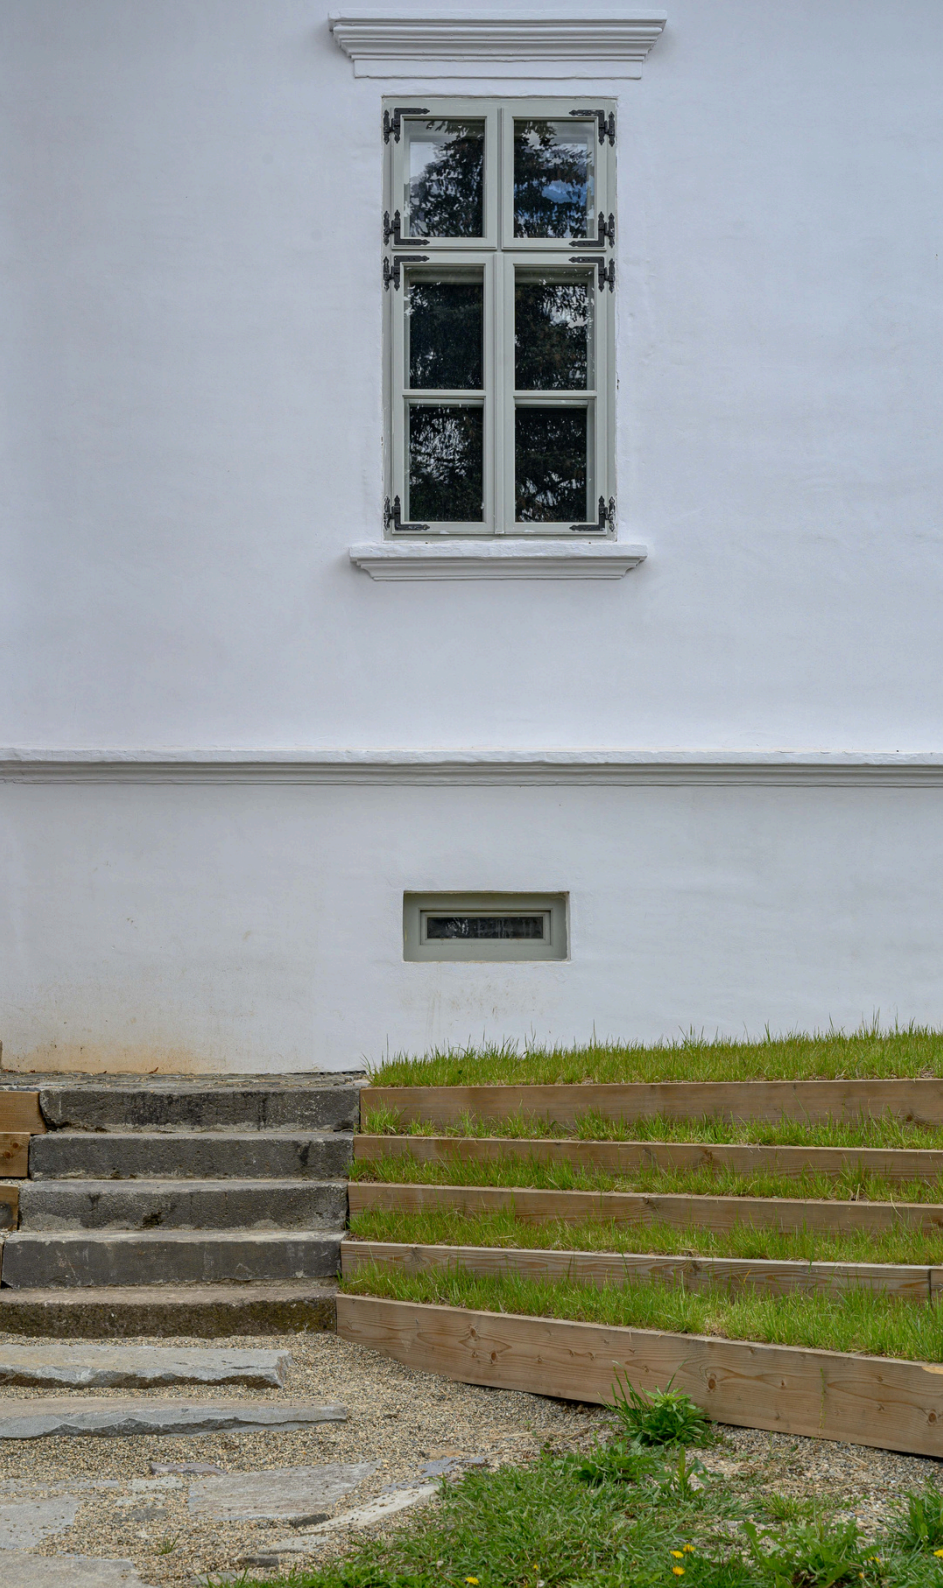
The steps of the stairs were  
made of stone steps  
recovered from old,  
demolished houses in the  
area.
